# VEHICLE INSPECTION REPORT

**FP69HGC**

## Daf CF 260

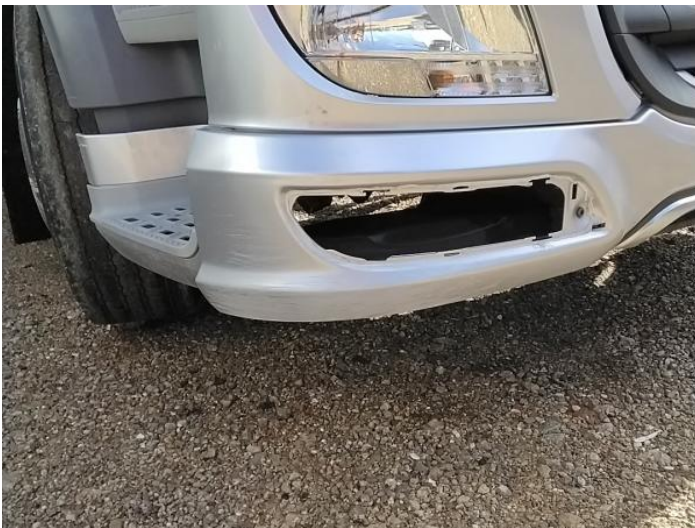
1: Bumper Front Moulding  
Missing  
Replace

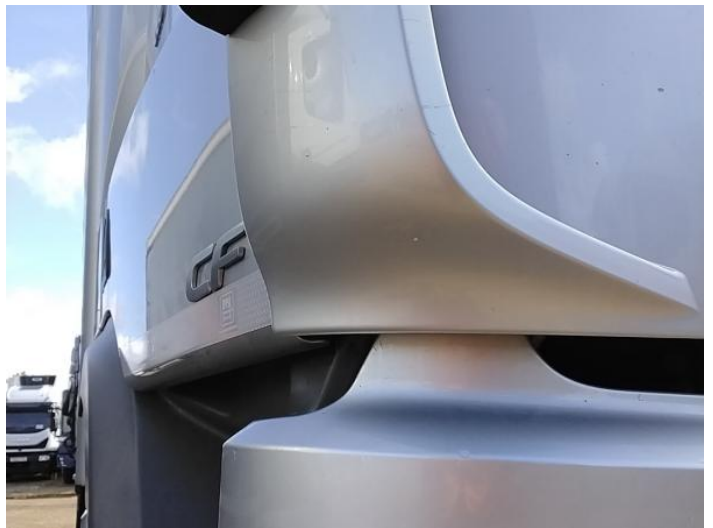
2: Wing osf  
Scratched  
UpTo 25mm Thru Paint

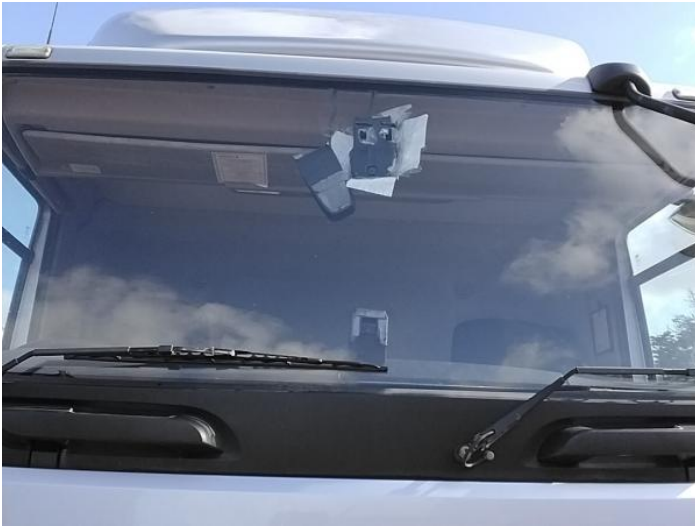
3: Screen Front  
Chipped  
UpTo 10mm

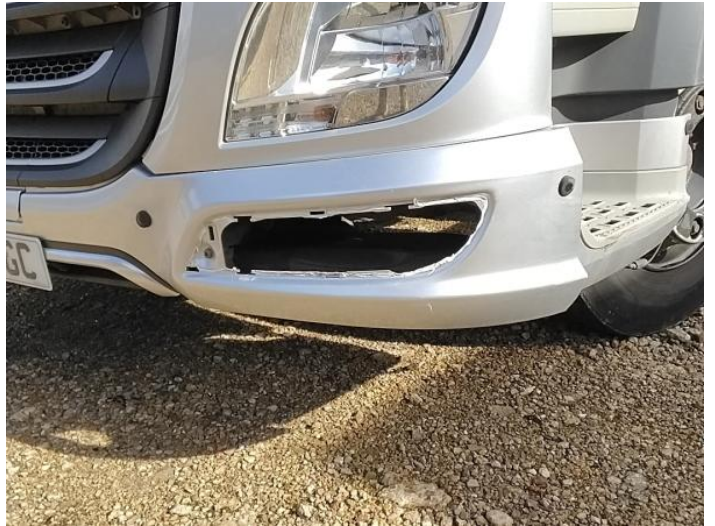
4: Bumper Front Moulding  
Missing  
Replace

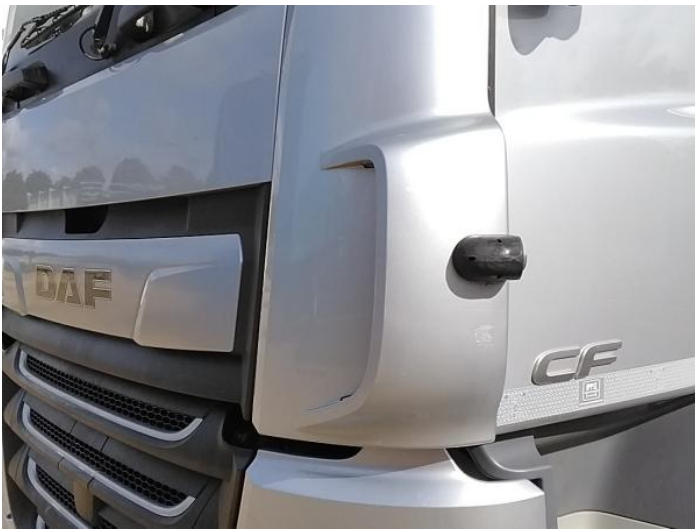
5: Wing nsf  
Scratched  
UpTo 25mm Thru Paint

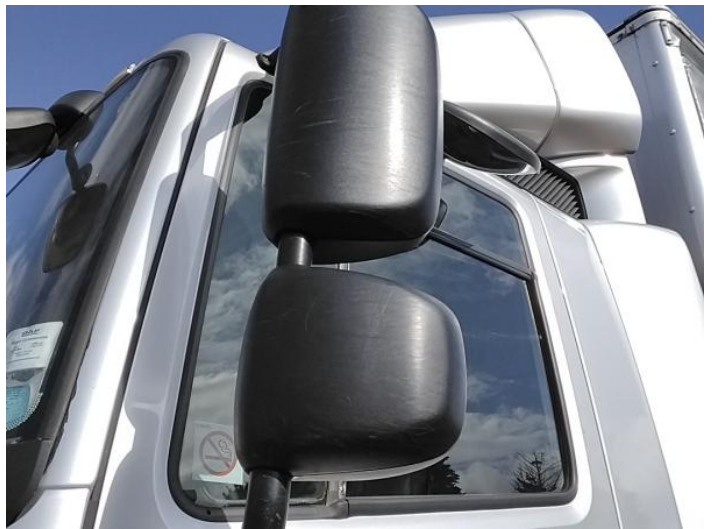
6: Door Mirror Assy nsf  
Scuffed (Unpainted)  
UpTo 100mm

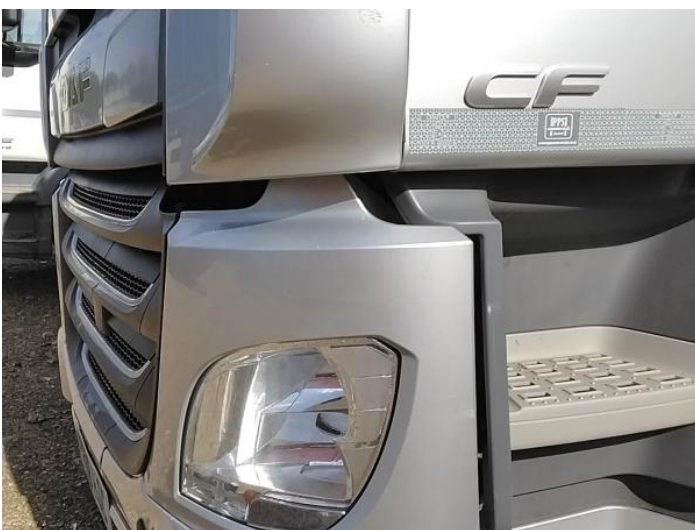
7: Fog Lamp Surround ns  
Scratched (Painted)  
UpTo 25mm Not Thru Paint

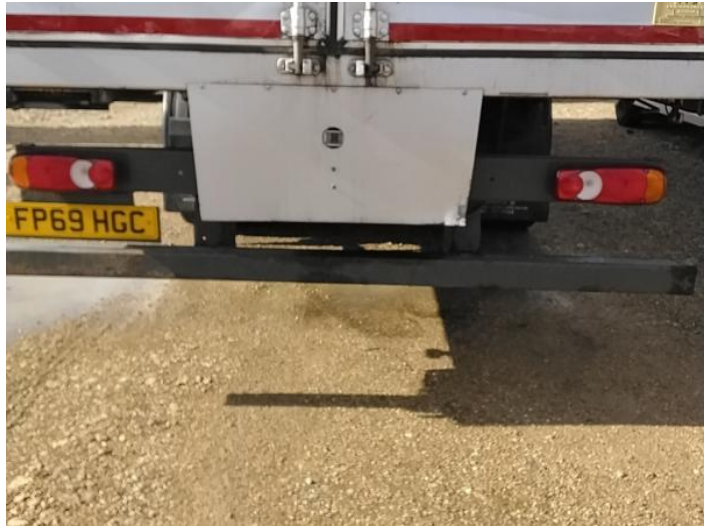
10: Bumper Rear  
Rusted  
Over 5mm

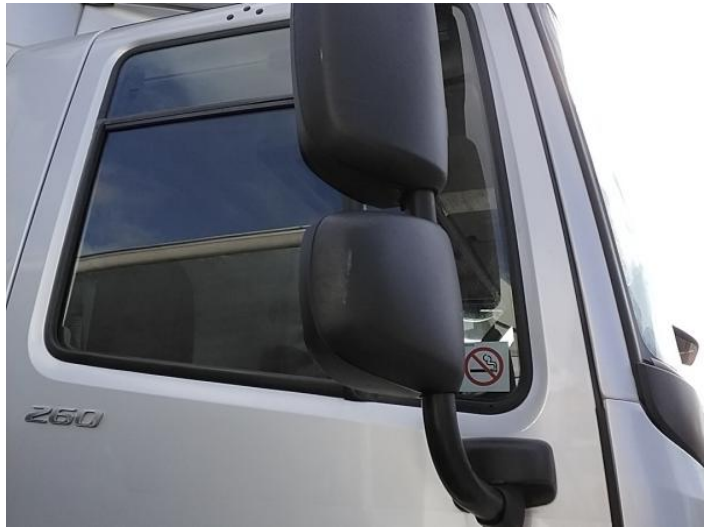
12: Door Mirror Assy osf  
Scuffed (Unpainted)  
UpTo 100mm
