VEHICLE INSPECTION REPORT

PE17HRP

Daf CF 440

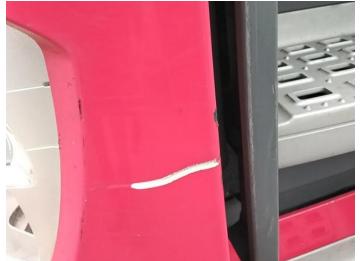
2: Bumper Front Scratched 25 to 100mm Thru Paint

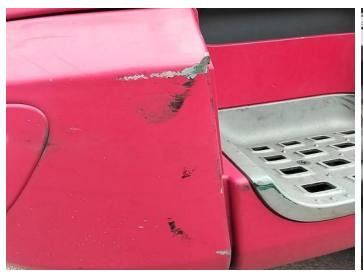
3: Bumper Front Scratched Over 100mm Thru Paint

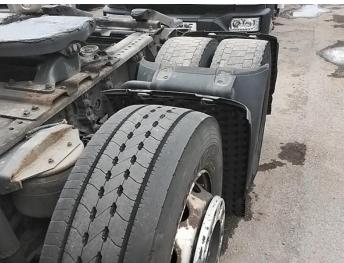
4: Qtr Panel Arch Extension ns Missing Replace

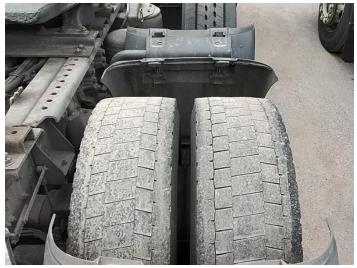
5: Qtr Panel Arch Extension os Missing Replace

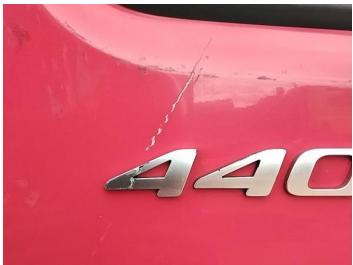
6: Door osf Scratched Over 25mm Thru Paint

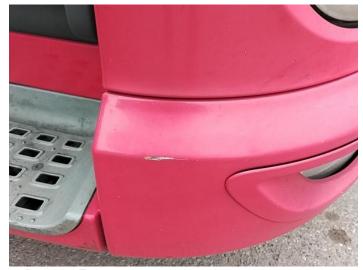
7: Bumper Front Scratched UpTo 25mm Thru Paint
