VEHICLE INSPECTION REPORT

LN69WKG

Mercedes-Benz Actros 2546

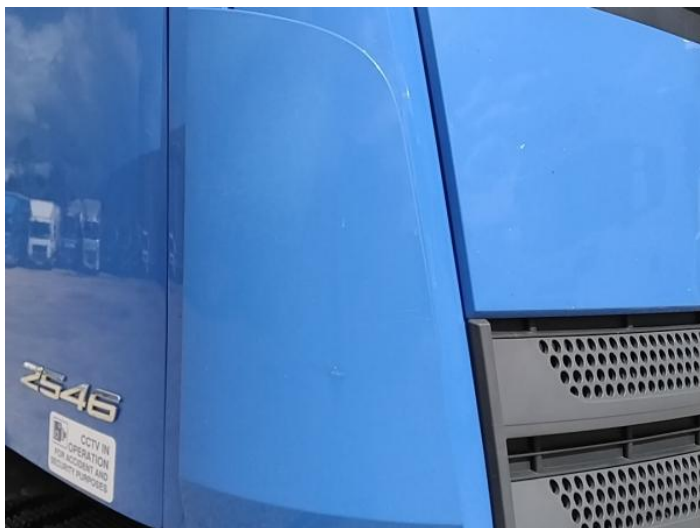
1: Wing osf
Chipped
Multiple Chips

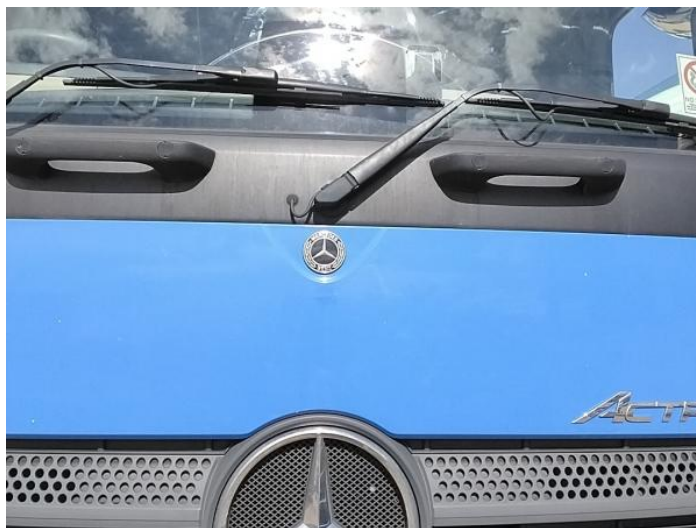
2: Bonnet
Chipped
Multiple Chips

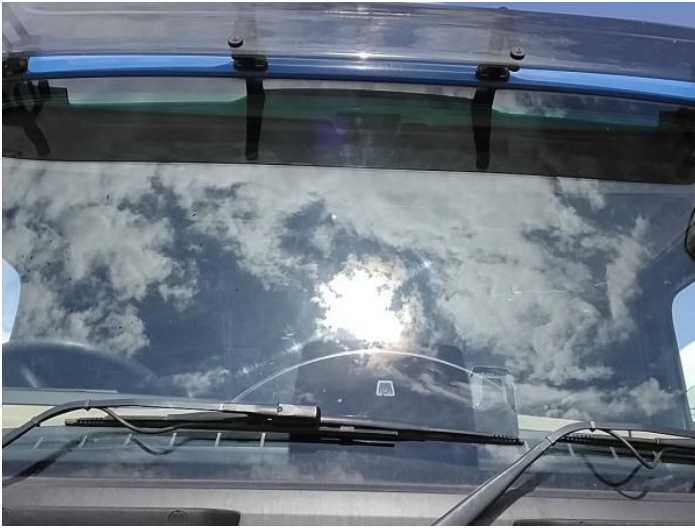
3: Screen Front
Chipped
UpTo 10mm

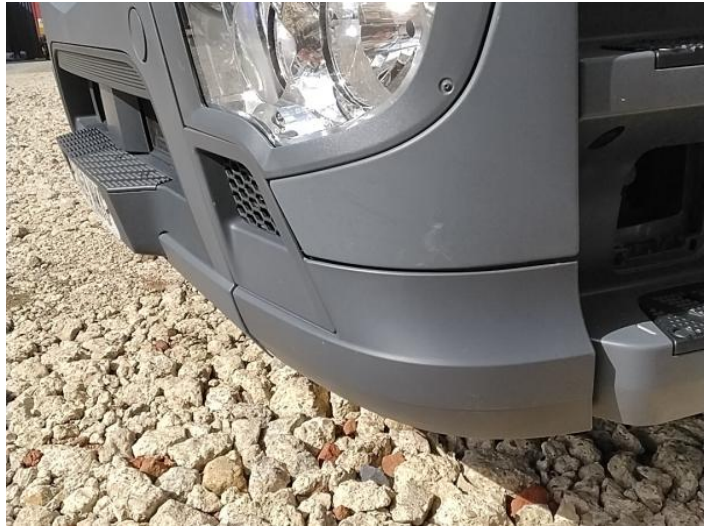
4: Fog Lamp Surround ns
Scuffed (Unpainted)
UpTo 100mm

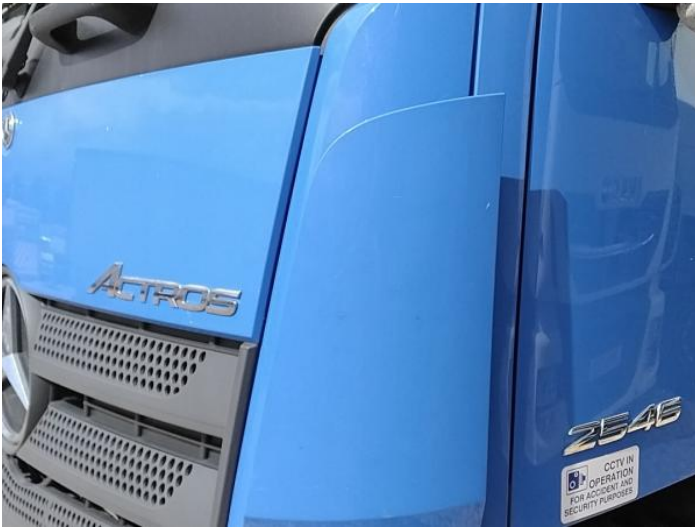
5: Wing nsf
Chipped
Multiple Chips

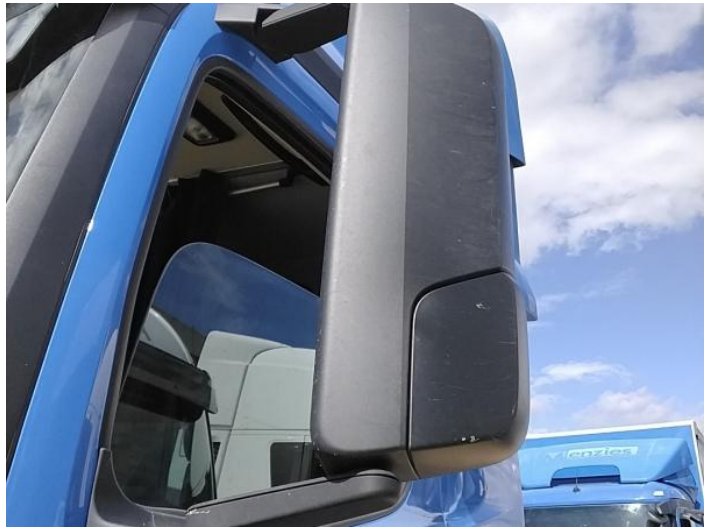
6: Door Mirror Assy osf
Scuffed (Unpainted)
UpTo 100mm

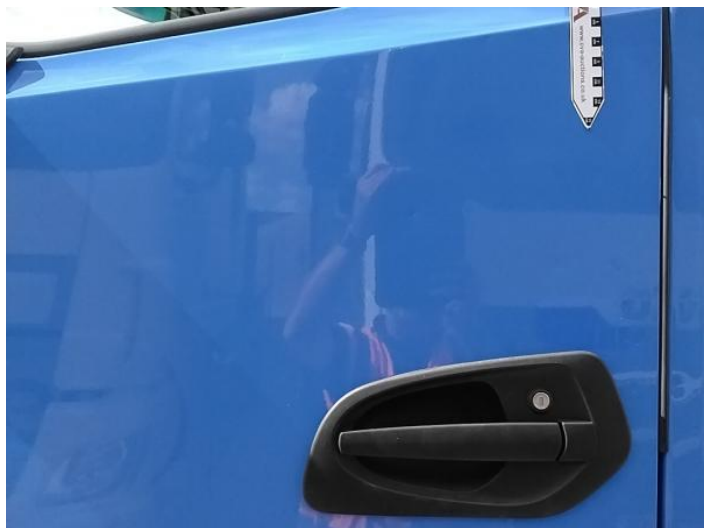
8: Door nsf
Dented
2 Or Less UpTo 10mm

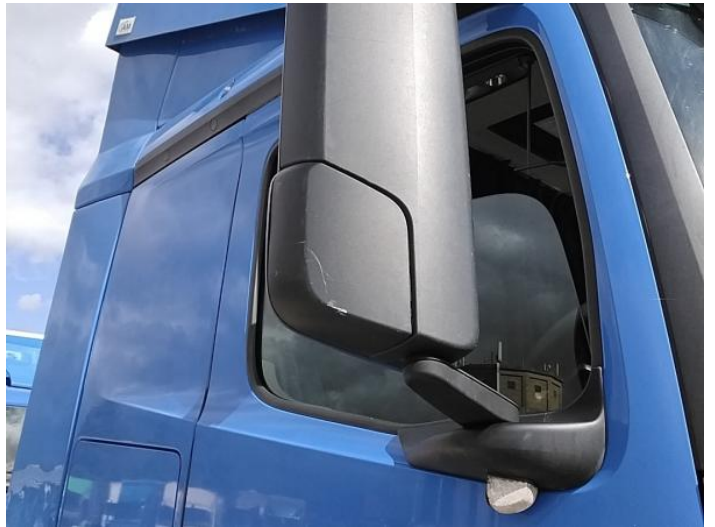
12: Door Mirror Assy osf
Scuffed (Unpainted)
UpTo 100mm
