VEHICLE INSPECTION REPORT

PO70YLH

Mercedes-Benz Antos 2532

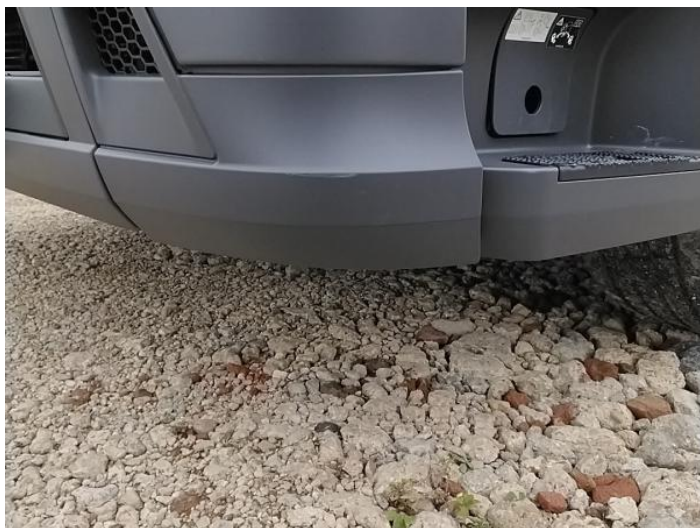
1: Bumper Front Moulding
Scuffed (Unpainted)
UpTo 100mm

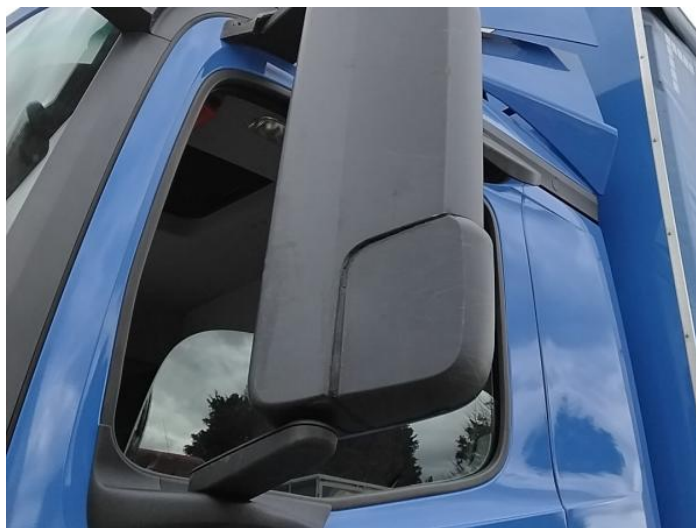
2: Door Mirror Assy nsf
Scuffed (Unpainted)
UpTo 100mm

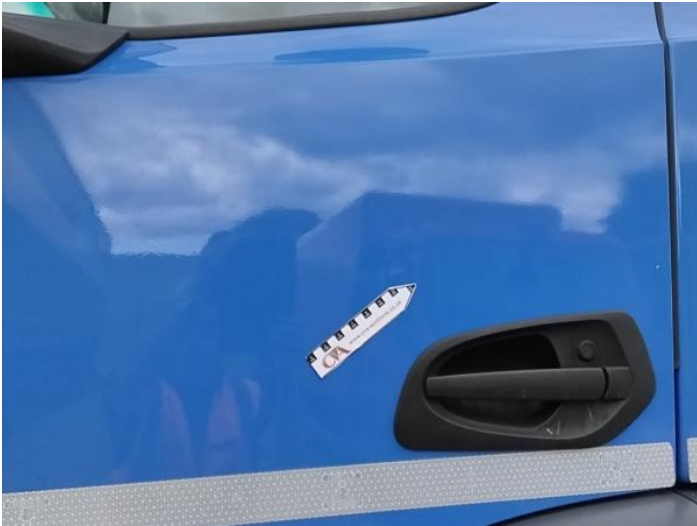
3: Door nsf
Dented
2 Or Less UpTo 10mm

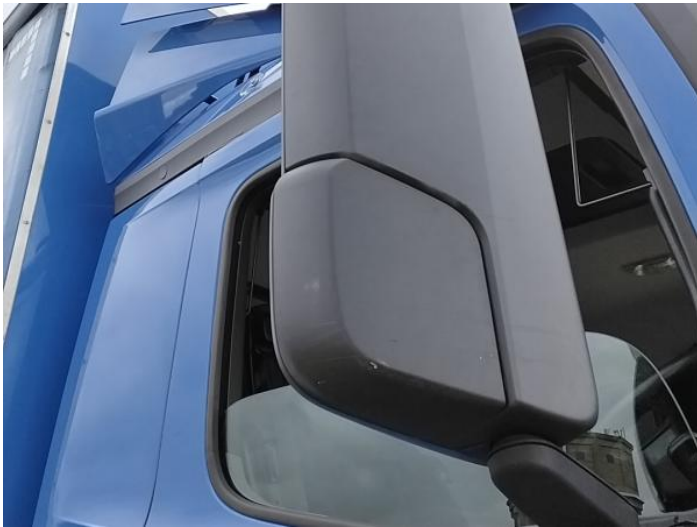
6: Door Mirror Assy osf
Scuffed (Unpainted)
UpTo 100mm

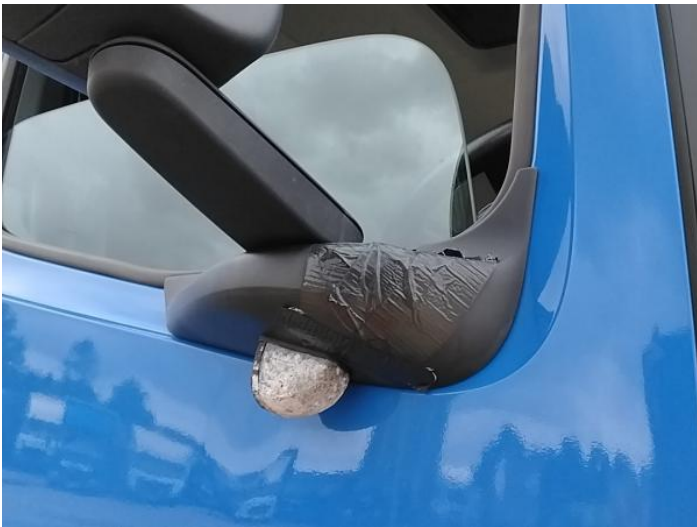
7: Door Mirror Assy osf
Broken
Replace
