VEHICLE INSPECTION REPORT

LN70XSJ

Mercedes-Benz Antos 2530

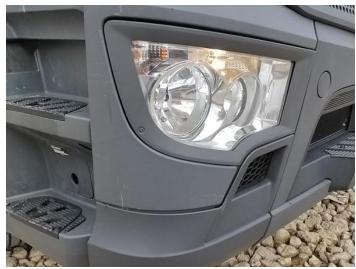
1: Fog Lamp Surround os Scuffed (Unpainted) UpTo 100mm

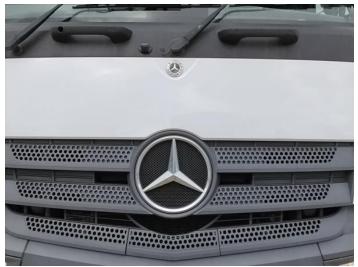
2: Bonnet Chipped Multiple Chips

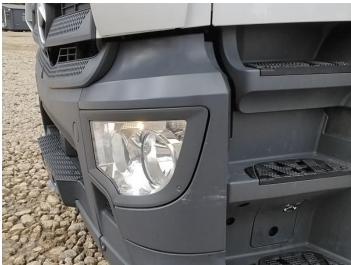
3: Fog Lamp Surround ns Scuffed (Unpainted) UpTo 100mm

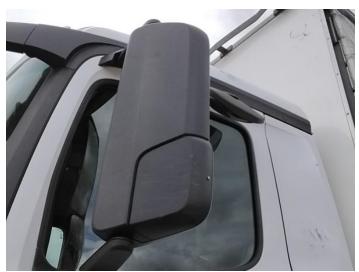
4: Door Mirror Assy nsf Scuffed (Unpainted) UpTo 100mm

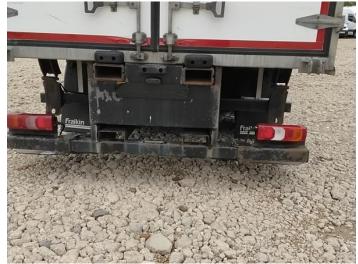
7: Bumper Rear Rusted Over 5mm

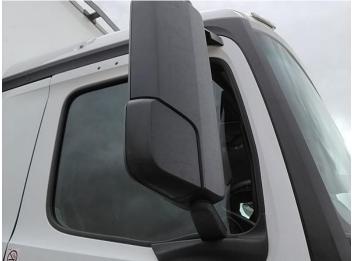
8: Door Mirror Assy osf Scuffed (Unpainted) UpTo 100mm

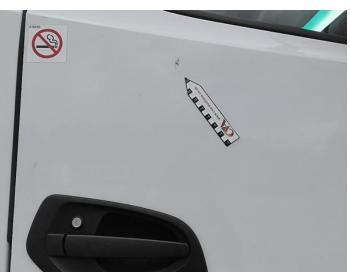
10: Door osf Scratched UpTo 25mm Thru Paint
