VEHICLE INSPECTION REPORT

CU64FJP

Ford Transit 350 2.2 TDCI 100PS

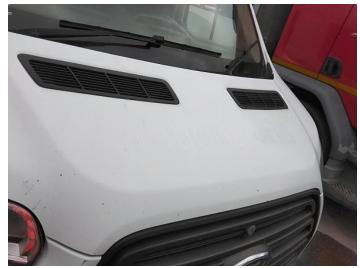
1: Bonnet Chipped Multiple Chips

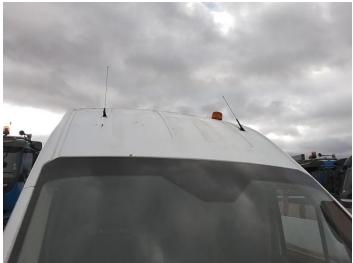
2: Roof Chipped Multiple Chips

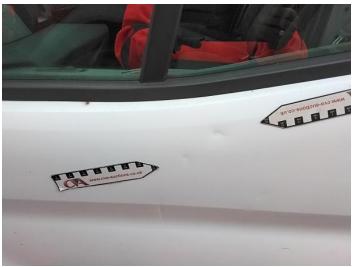
3: Door nsf Dented Over 30mm

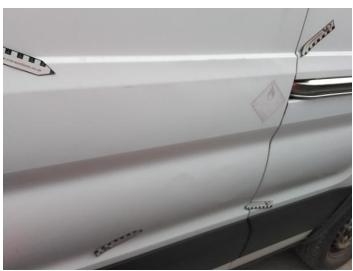
4: Qtr Panel nsr Dented Over 30mm

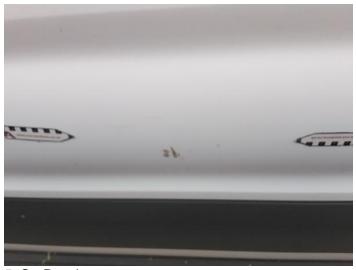
5: Qtr Panel nsr Scratched Over 25mm Thru Paint

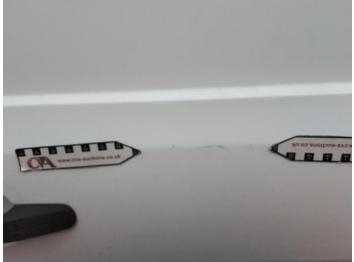
6: Qtr Panel nsr Scratched Over 25mm Thru Paint

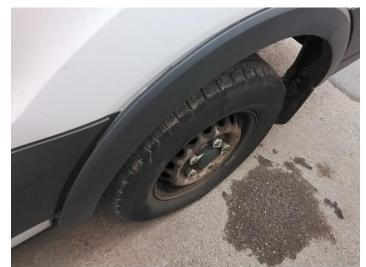
7: Qtr Panel Moulding ns Broken Replace

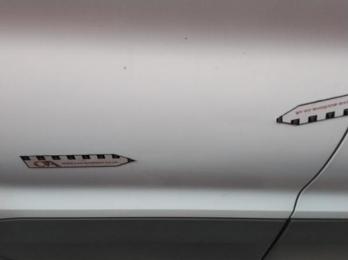
10: Qtr Panel osr Dented With Paint Damage

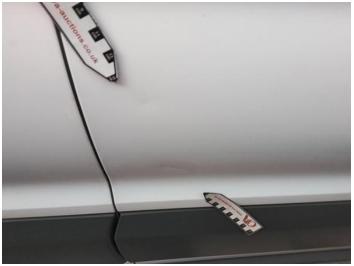
11: Qtr Panel osr Dented With Paint Damage

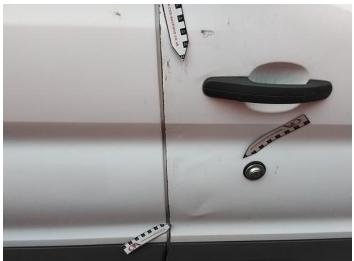
12: Door osf Dented With Paint Damage

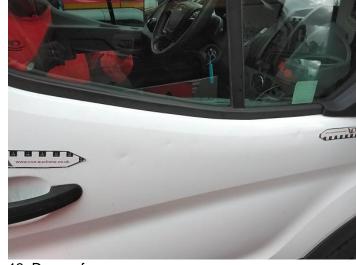
13: Door osf Dented Over 30mm

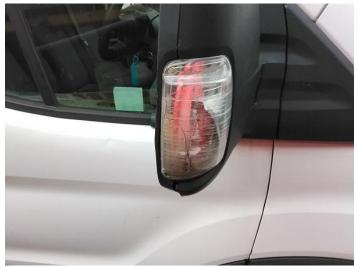
14: Door Mirror Assy osf Broken Replace

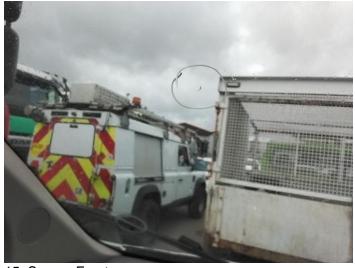
15: Screen Front Chipped Over 10mm

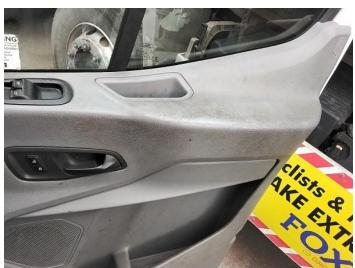
16: Door Pad osf Soiled Heavy

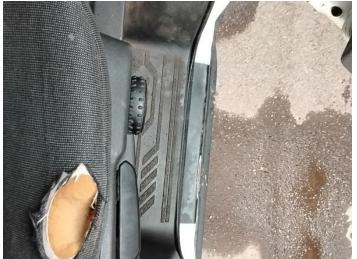
17: Seat Base Cover osf Holed Over 3mm

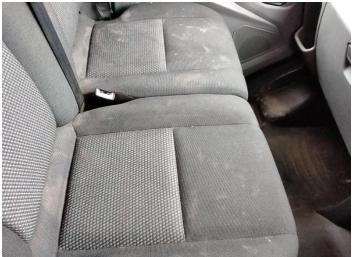
18: Seat Base Cover nsf Soiled Heavy
