VEHICLE INSPECTION REPORT

FN69ASU

Daf CF 260

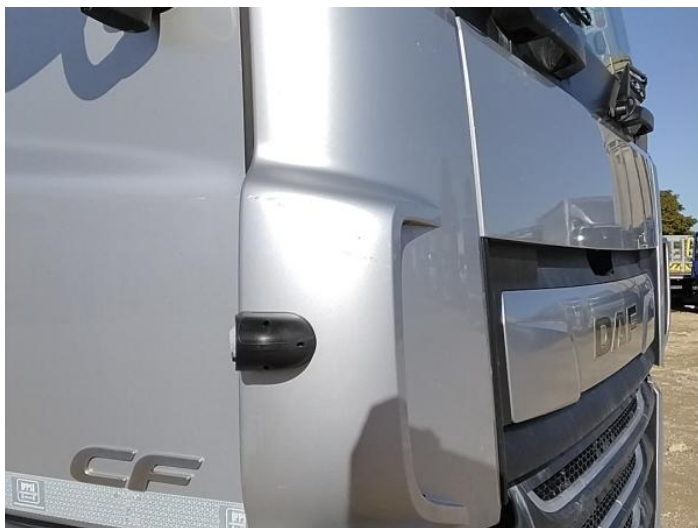
1: Wing osf
Scratched
UpTo 25mm Thru Paint

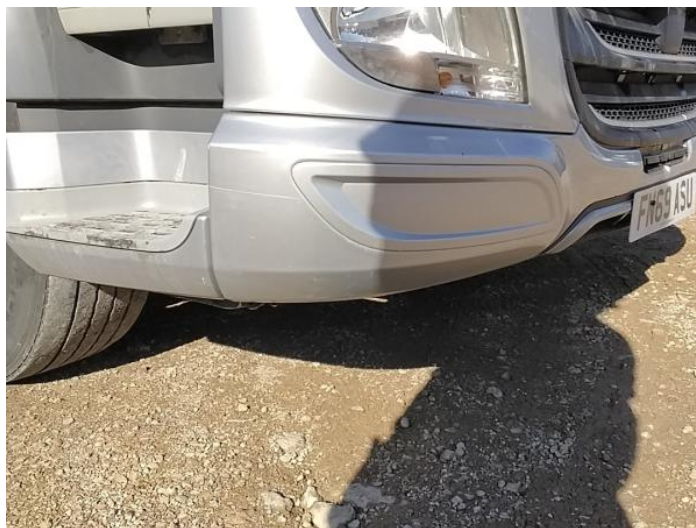
2: Bumper Front
Scratched
UpTo 25mm Thru Paint

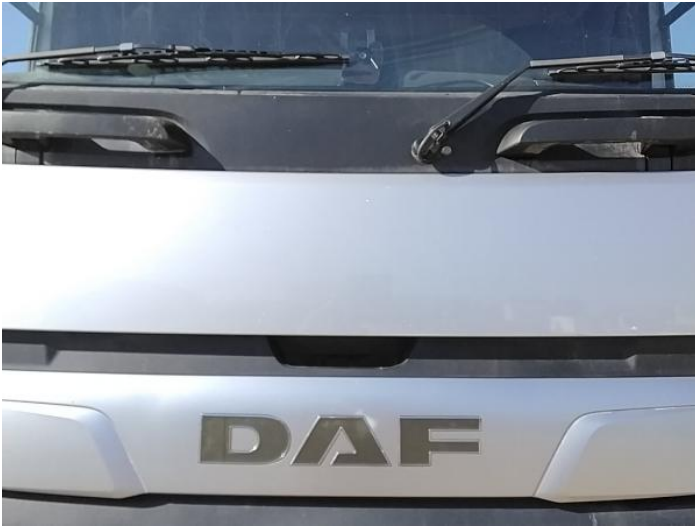
3: Bonnet
Chipped
Multiple Chips

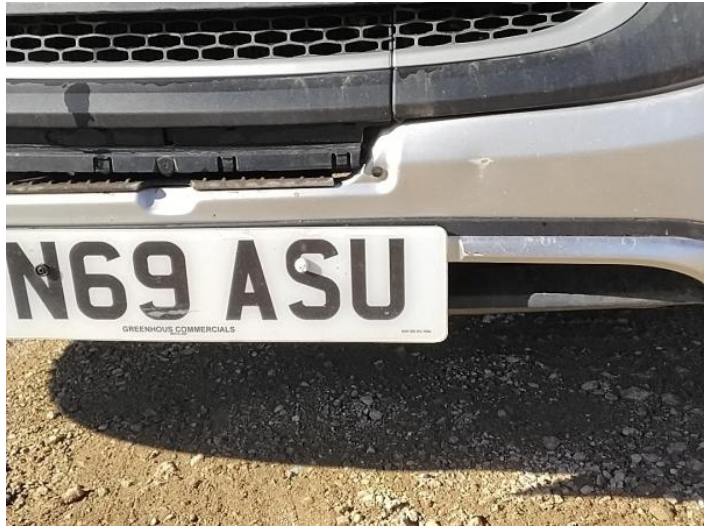
4: Bumper Front
Dented
Between 10mm + 30mm

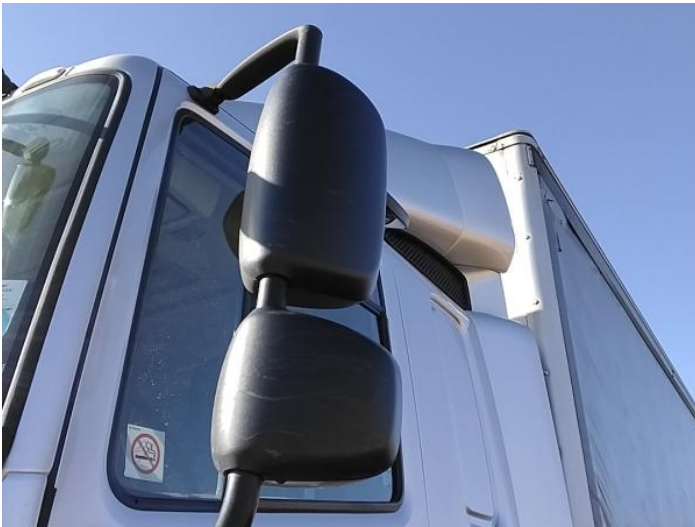
5: Door Mirror Assy nsf
Scuffed (Unpainted)
UpTo 100mm

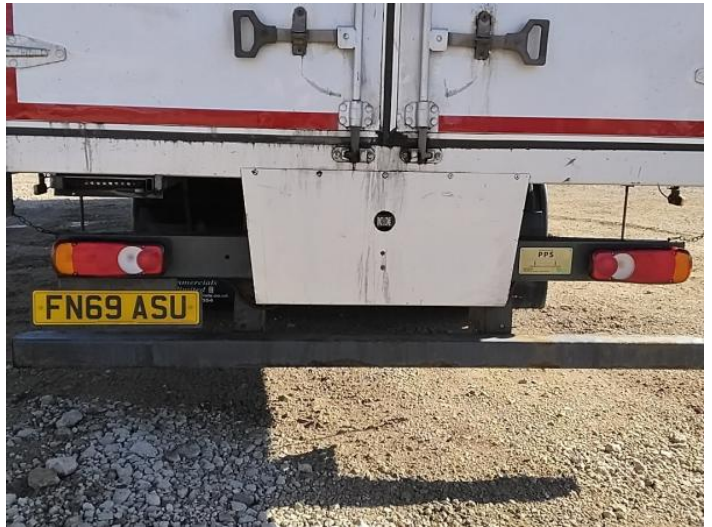
6: Bumper Rear
Rusted
Over 5mm

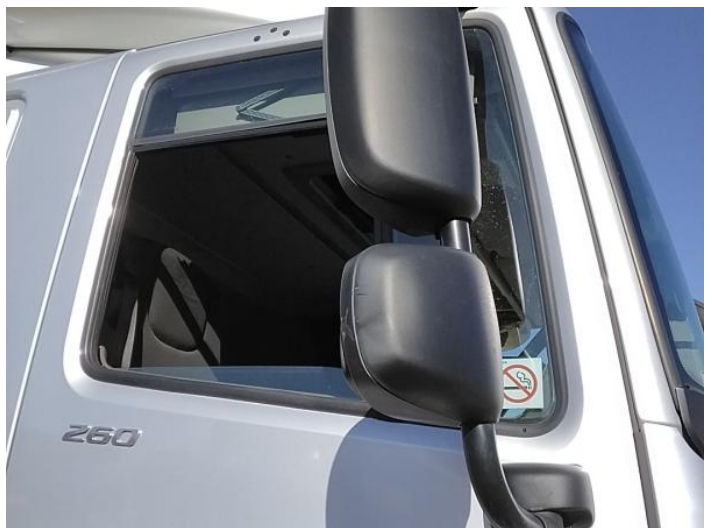
8: Door Mirror Assy osf
Scuffed (Unpainted)
UpTo 100mm
