VEHICLE INSPECTION REPORT

DE68BWV

Man TGL 8.190

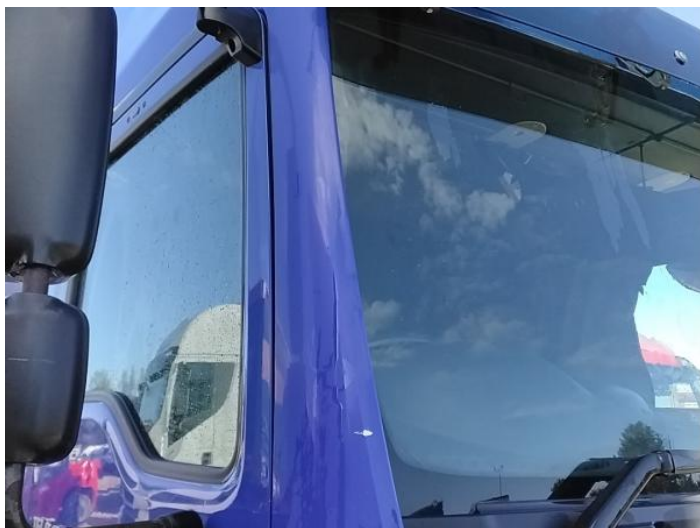
1: A Post os
Scratched
UpTo 25mm Thru Paint

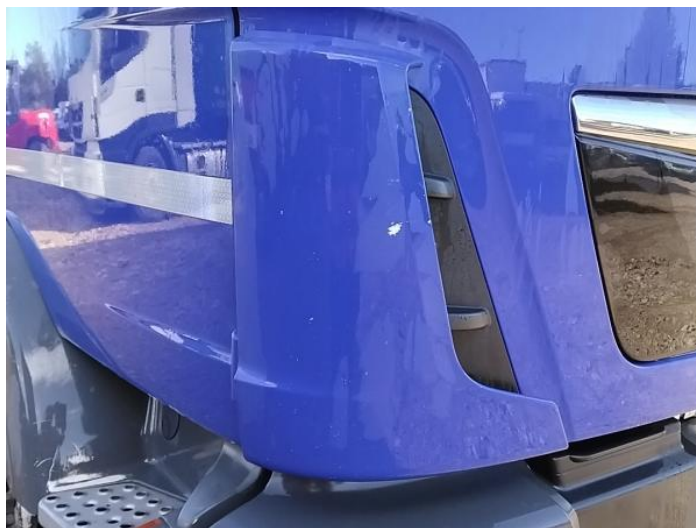
2: Wing osf
Scratched
UpTo 25mm Thru Paint

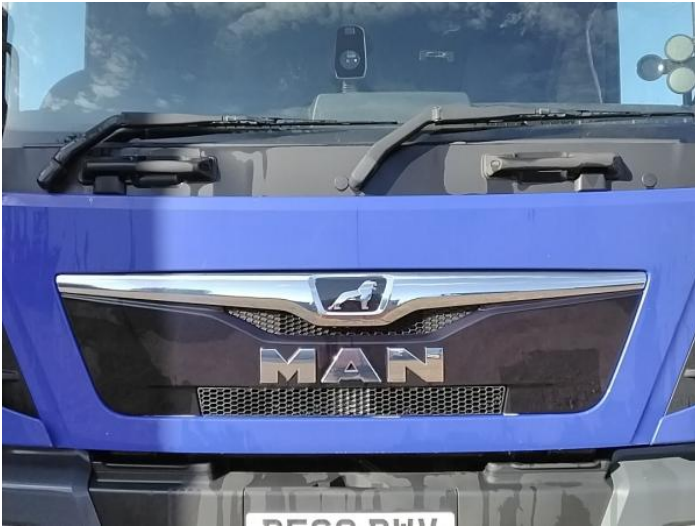
3: Bonnet
Chipped
Multiple Chips

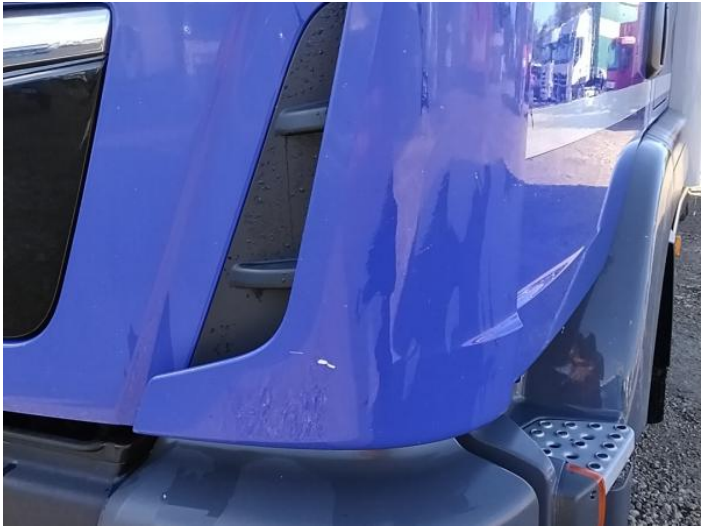
4: Wing nsf
Scratched
UpTo 25mm Thru Paint

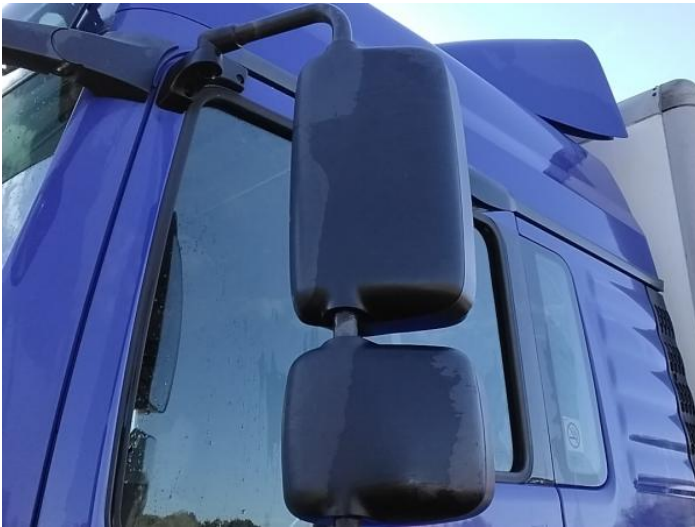
5: Door Mirror Assy nsf
Scuffed (Unpainted)
UpTo 100mm

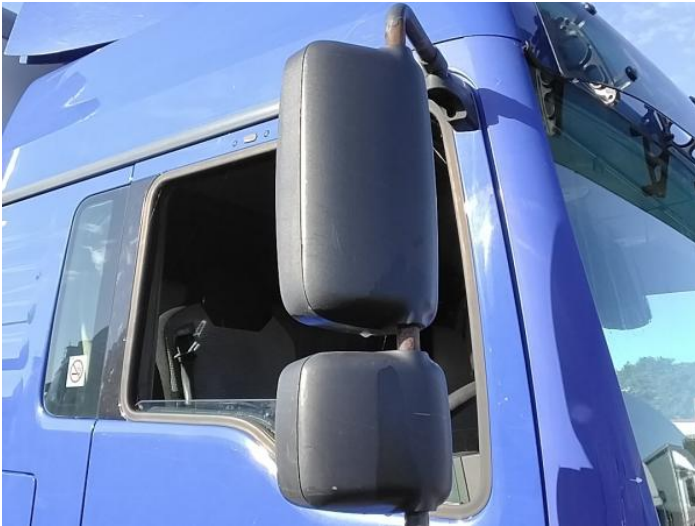
9: Door Mirror Assy osf
Scuffed (Unpainted)
UpTo 100mm

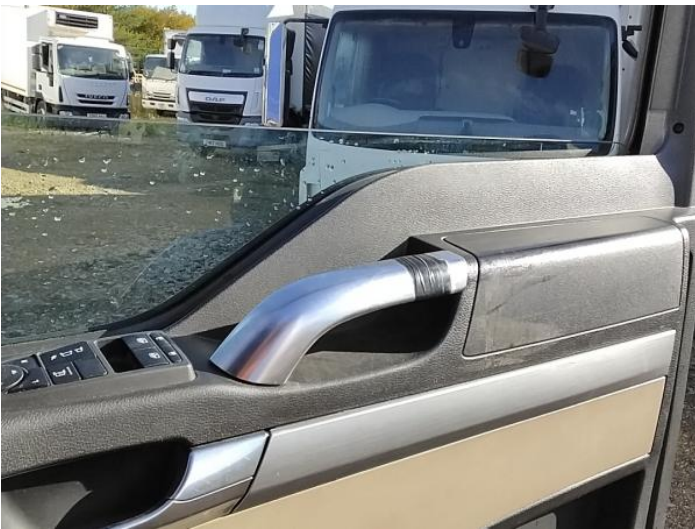
12: Handle Inner osf
Damaged
Replace
