VEHICLE INSPECTION REPORT

WJ65YVP

Isuzu D-Max 2.5 TD TURBO

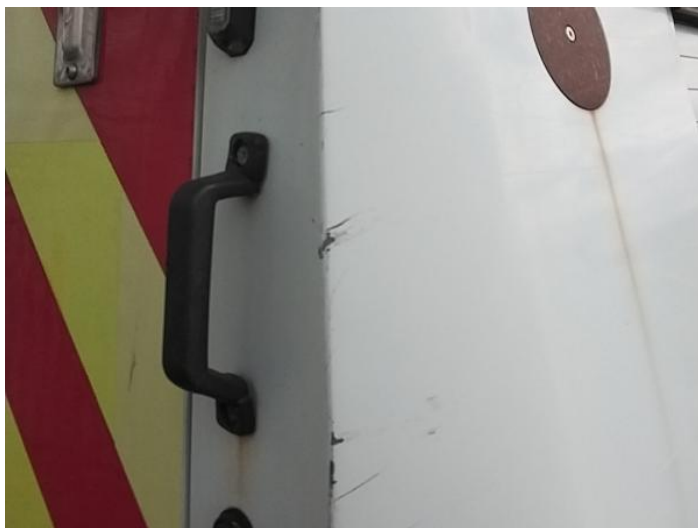
1: Boot Lid
Scratched
Over 25mm Thru Paint

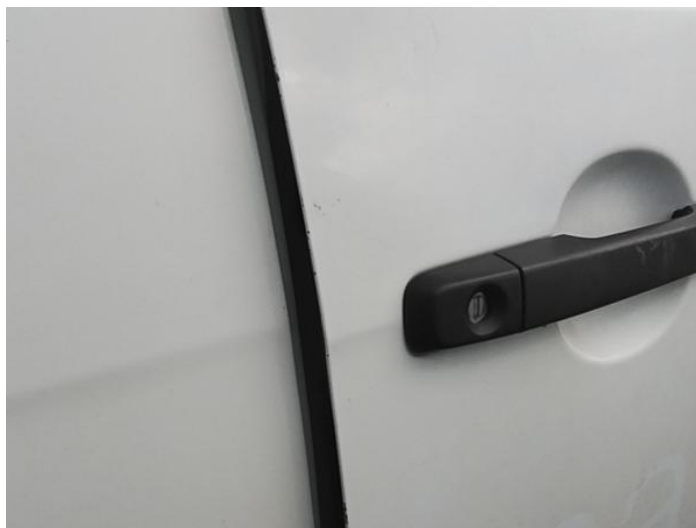
2: Door osf
Chipped
Edge Chip

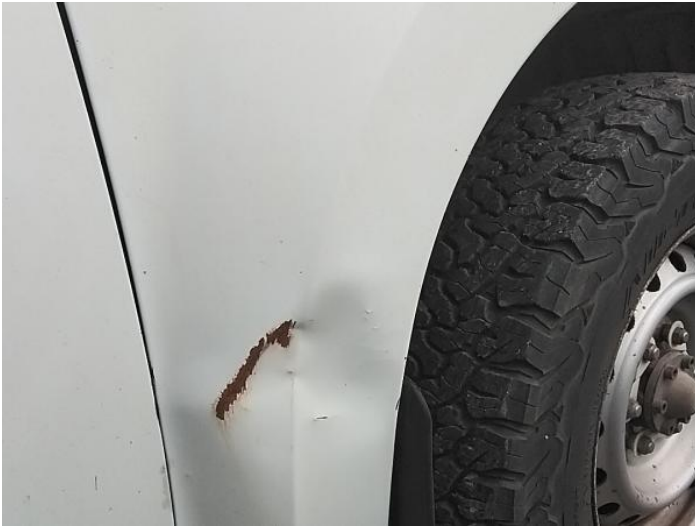
3: Wing osf
Dented
With Paint Damage

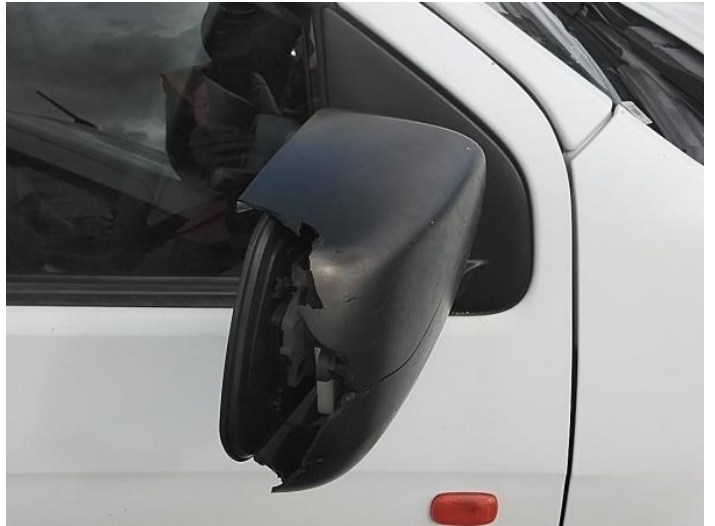
4: Door Mirror Assy osf
Broken
Replace

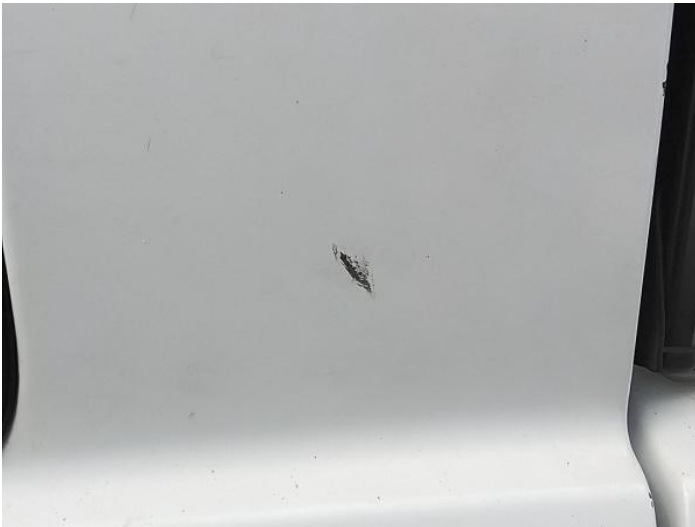
5: Door nsf
Scratched
UpTo 25mm Thru Paint

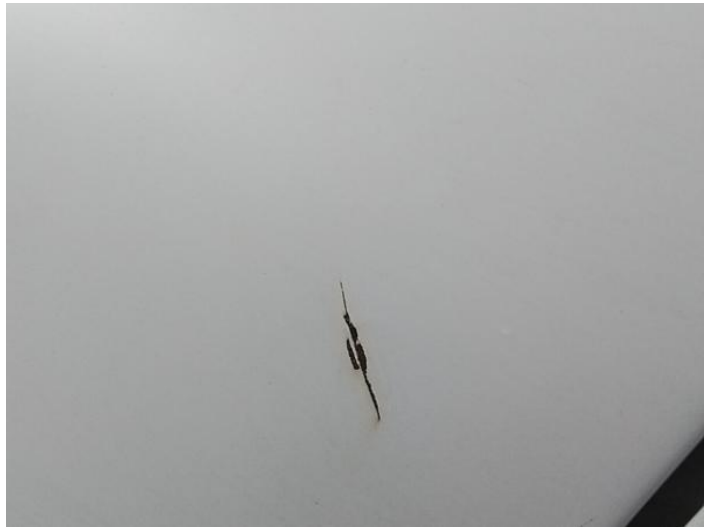
6: Wing nsf
Scratched
Rusted

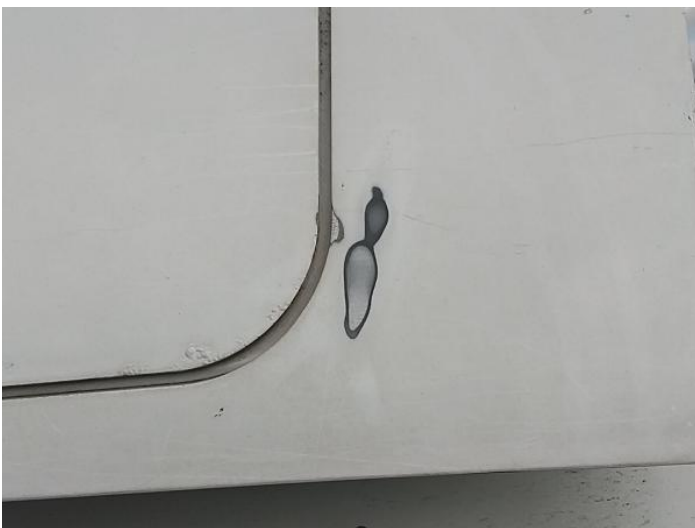
7: Roof
Scratched
Over 25mm Thru Paint
