VEHICLE INSPECTION REPORT

PF14TZV

Daf LF 120

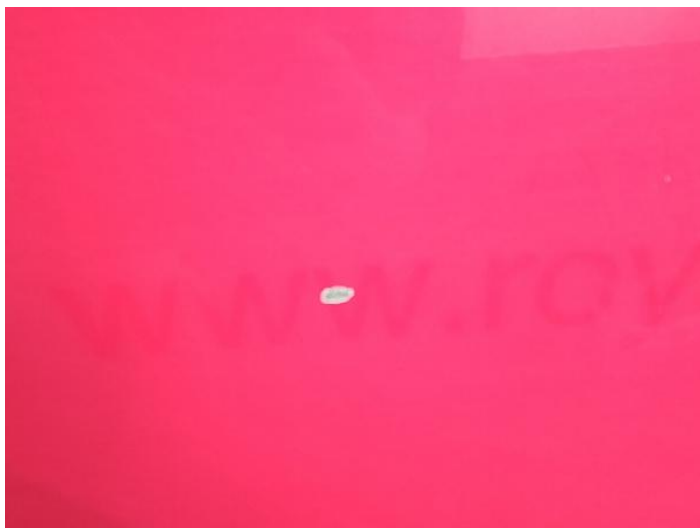
1: Door osf
Chipped
Over 5mm

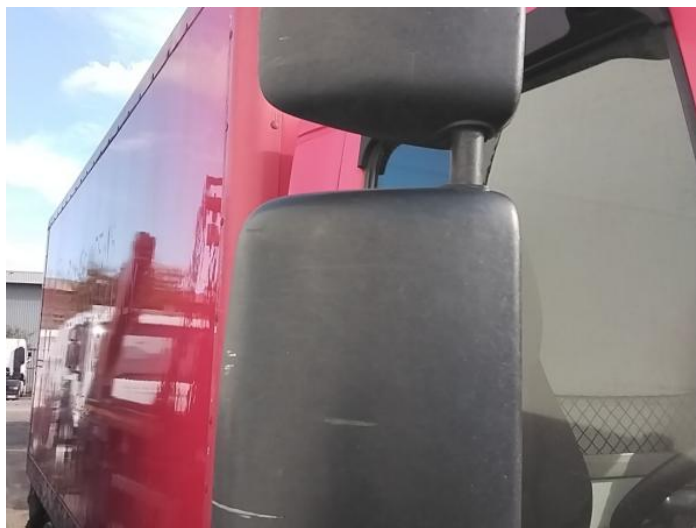
2: Door Mirror Assy osf
Scuffed (Unpainted)
Over 100mm

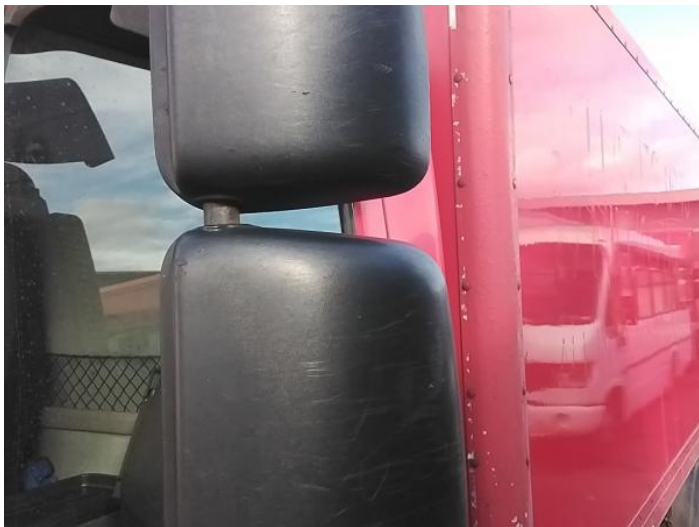
3: Door Mirror Assy nsf
Scuffed (Unpainted)
Over 100mm

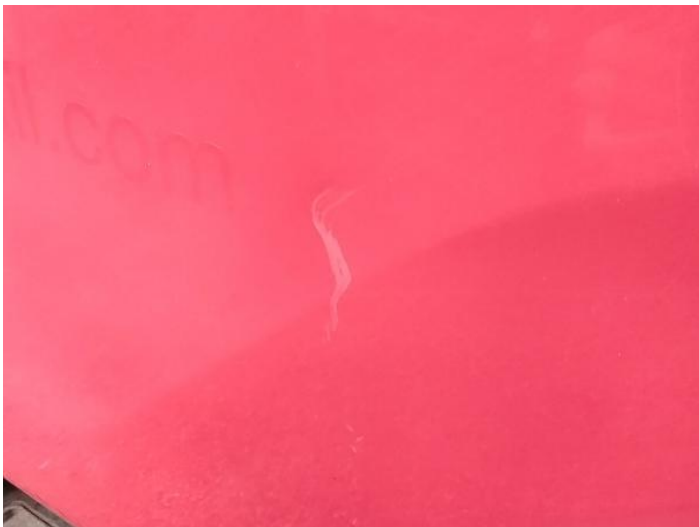
4: Door nsf
Dented
Over 30mm

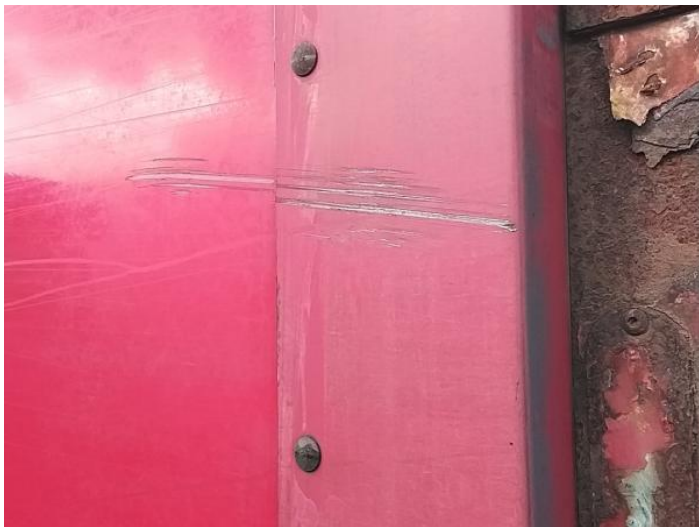
5: Panel Rear
Scratched
Over 25mm Not Thru Paint

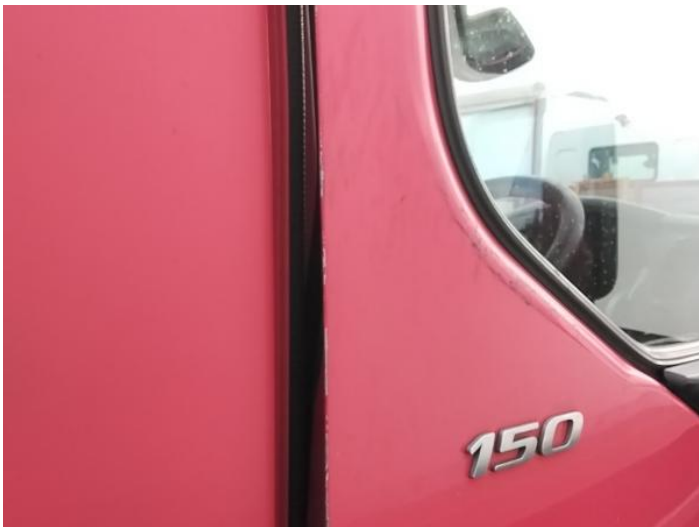
6: Door osf
Chipped
Multiple Chips
