VEHICLE INSPECTION REPORT

LR16YCE

Vauxhall Combo 2000 1.3 CDTI 16V

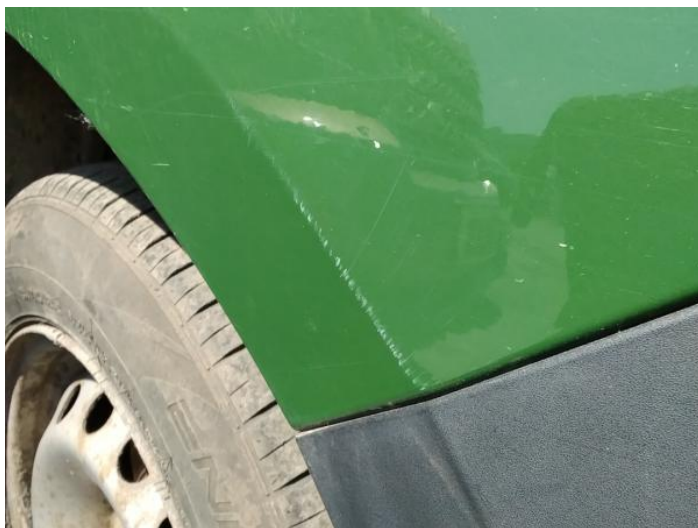
1: Moulding nsf Wing
Scratched (Painted)
Over 25mm Not Thru Paint

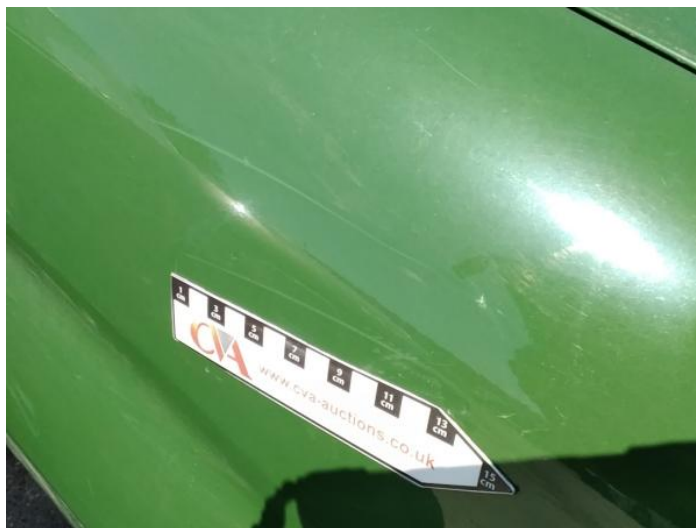
2: Moulding nsf Wing
Scuffed (Unpainted)
Over 100mm

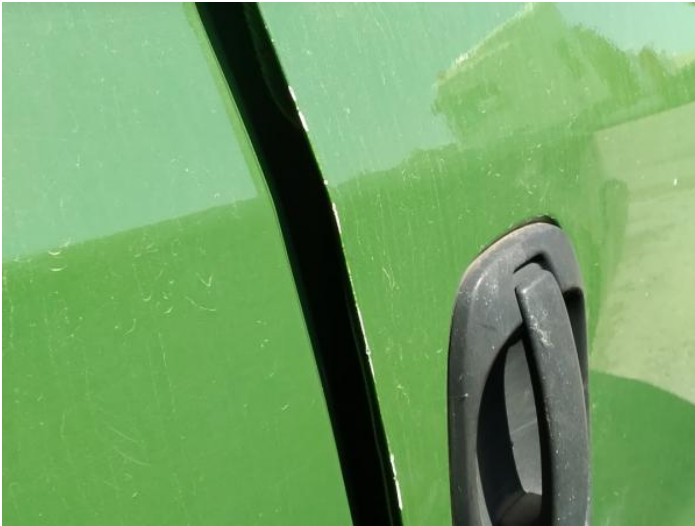
3: Door nsf
Chipped
Multiple Chips

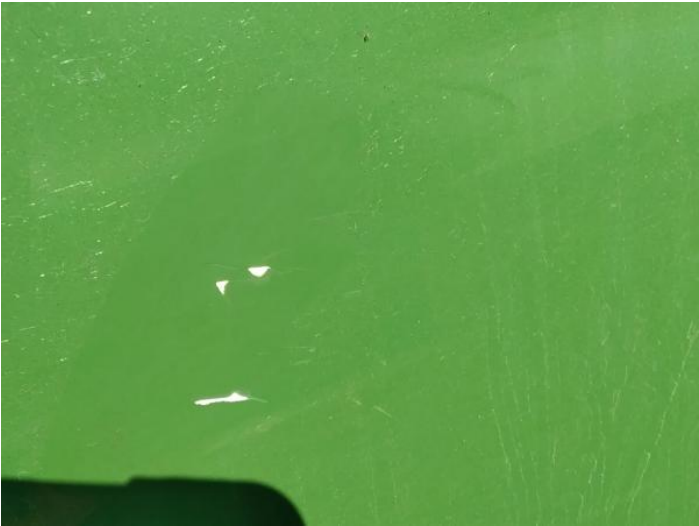
4: Panel Front
Chipped
Multiple Chips

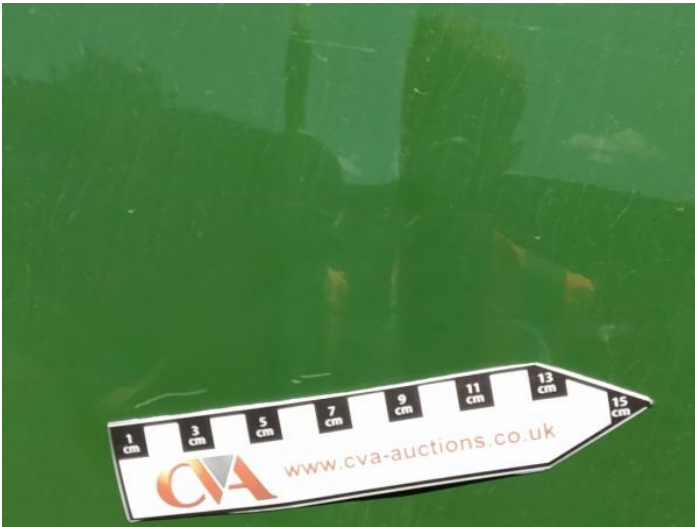
5: Panel Rear
Scratched
Over 25mm Not Thru Paint

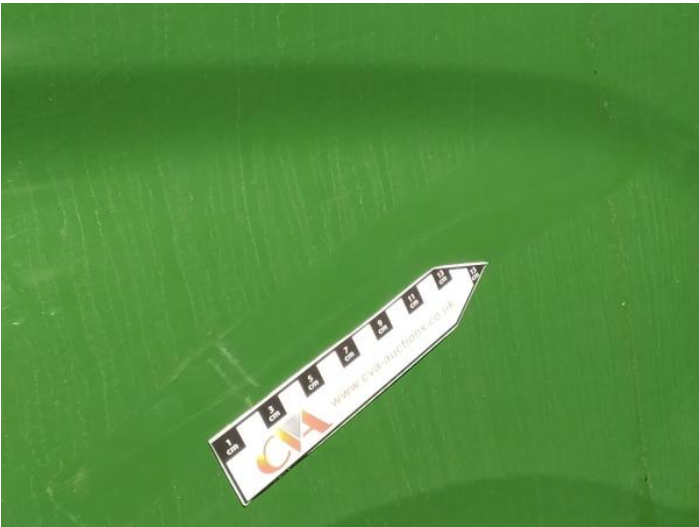
6: Panel Rear
Scratched
Over 25mm Not Thru Paint

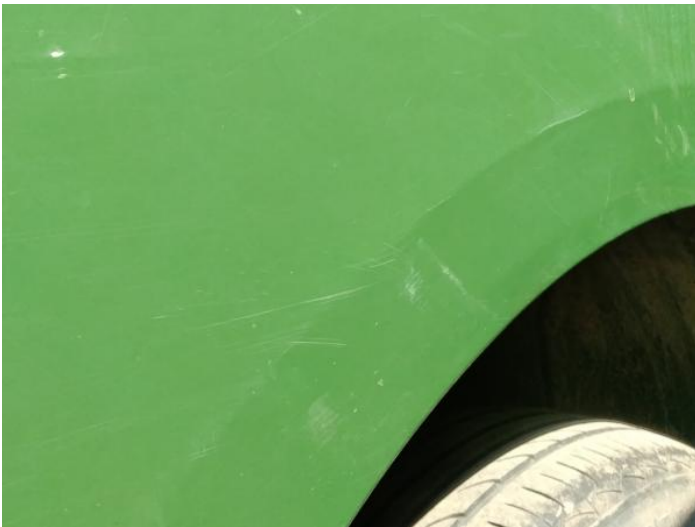
7: Panel Rear
Scratched
Over 25mm Not Thru Paint

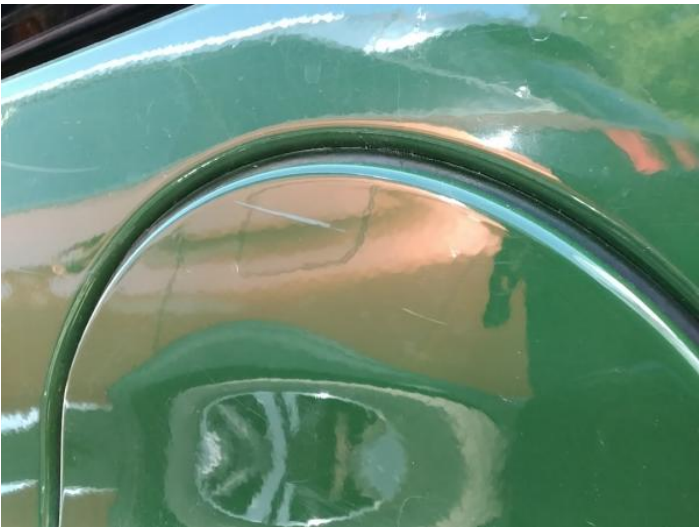
8: Fuel Flap
Scratched
Over 25mm Not Thru Paint

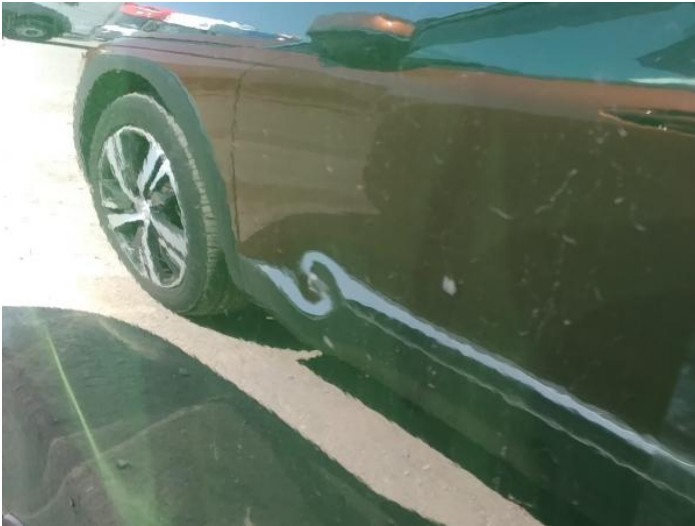
9: Door osf
Dented
With Paint Damage

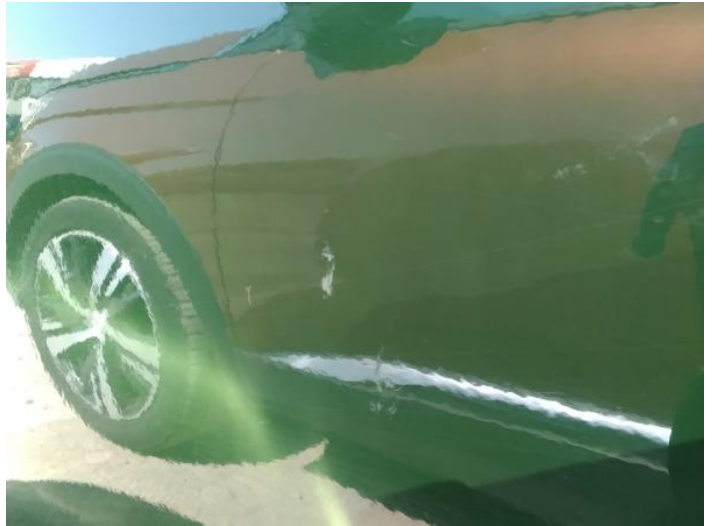
10: Door osf
Scratched
Over 25mm Not Thru Paint

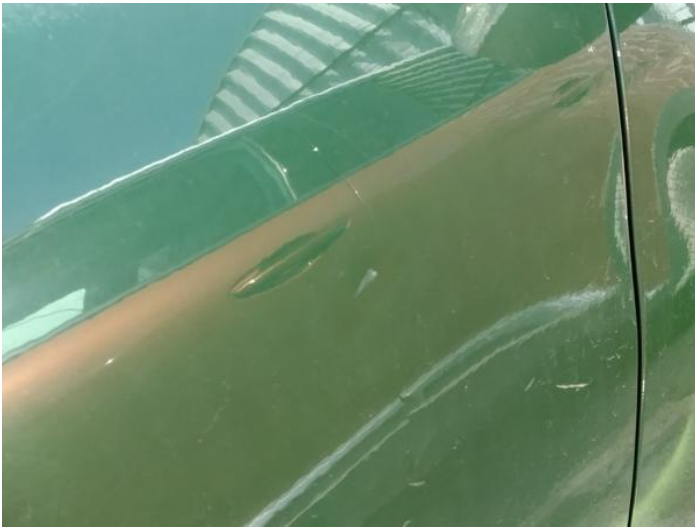
11: Wing osf
Dented
With Paint Damage

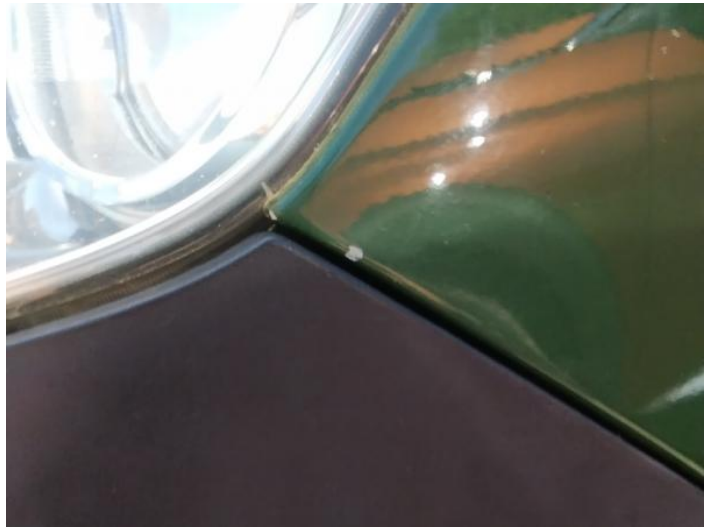
12: Wing osf
Chipped
Edge Chip

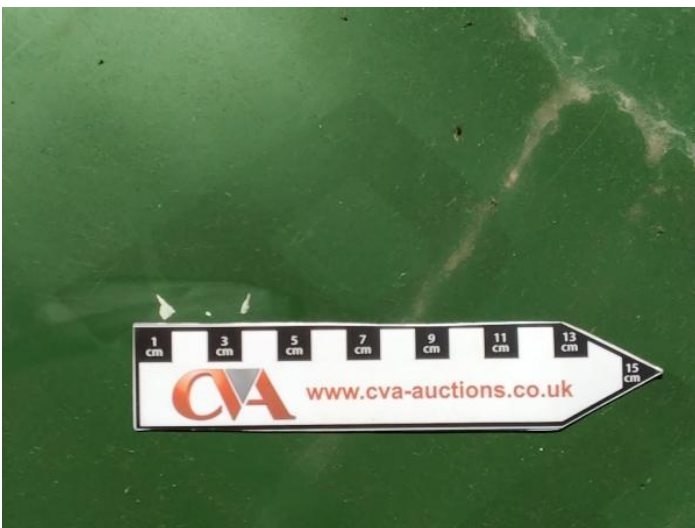
13: Bonnet
Scratched
UpTo 25mm Thru Paint

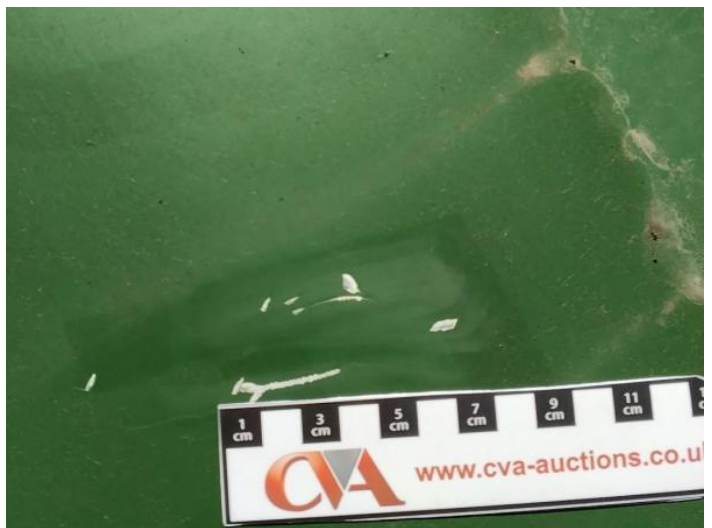
14: Bonnet
Scratched
Over 25mm Thru Paint

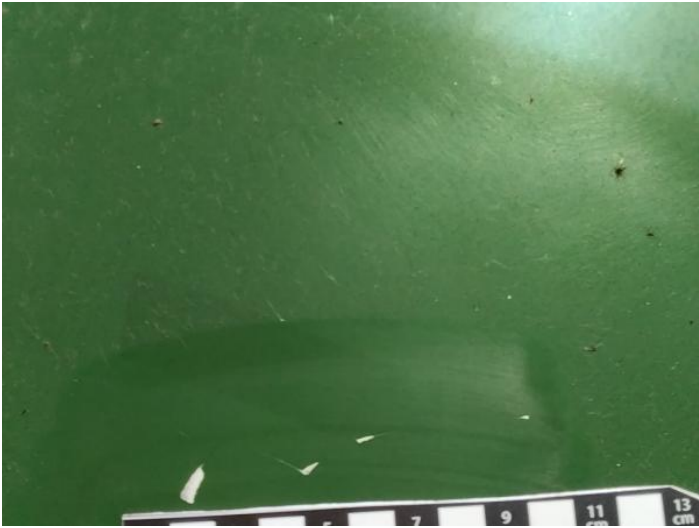
15: Bonnet
 Scratched
 UpTo 25mm Thru Paint

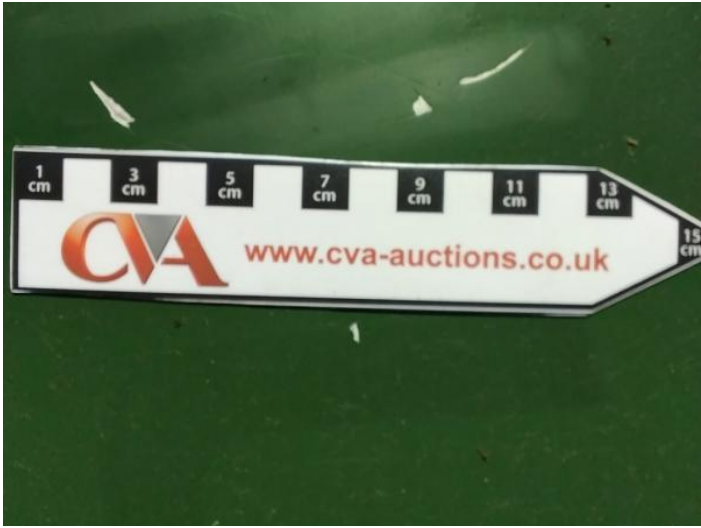
16: Bonnet
 Scratched
 UpTo 25mm Thru Paint

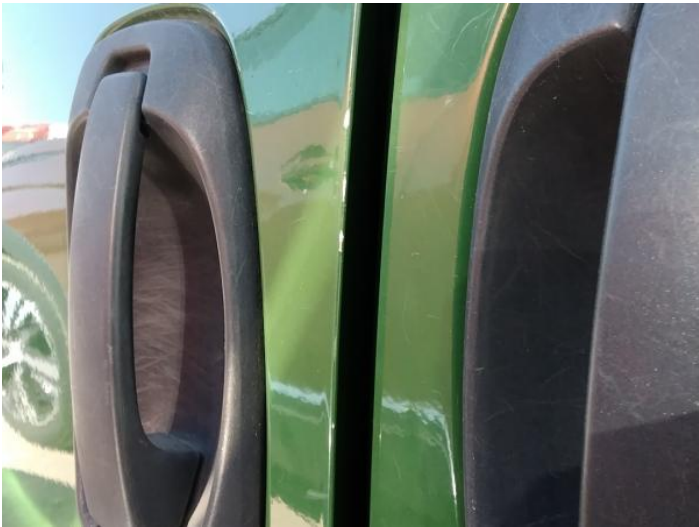
17: Door osf
 Chipped
 Edge Chip

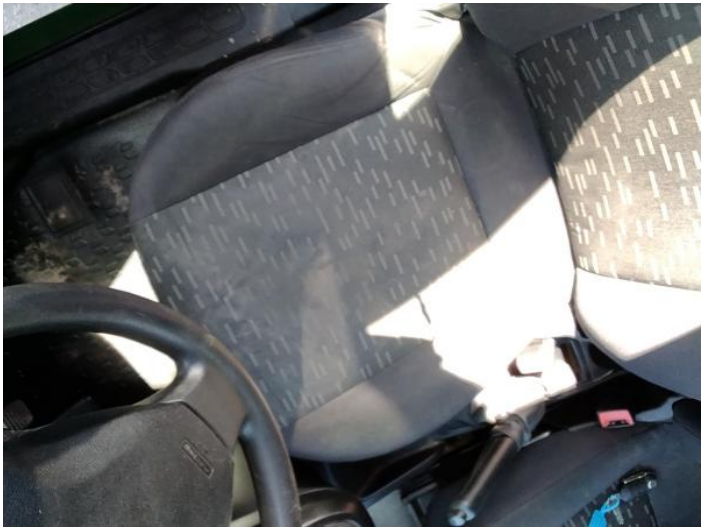
18: Seat Base Cover nsf
 Soiled
 Light
