VEHICLE INSPECTION REPORT

LR16YCF

Vauxhall Combo 2000 1.3 CDTI 16V

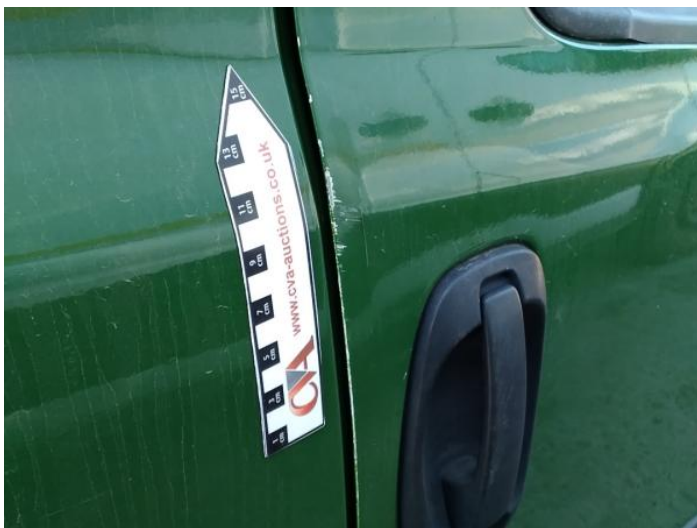
1: Door nsf
Chipped
Multiple Chips

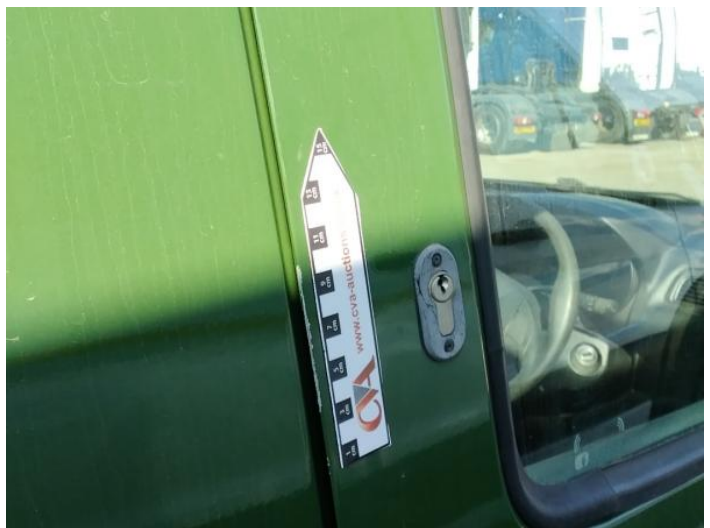
2: Door nsf
Scratched
Over 25mm Thru Paint

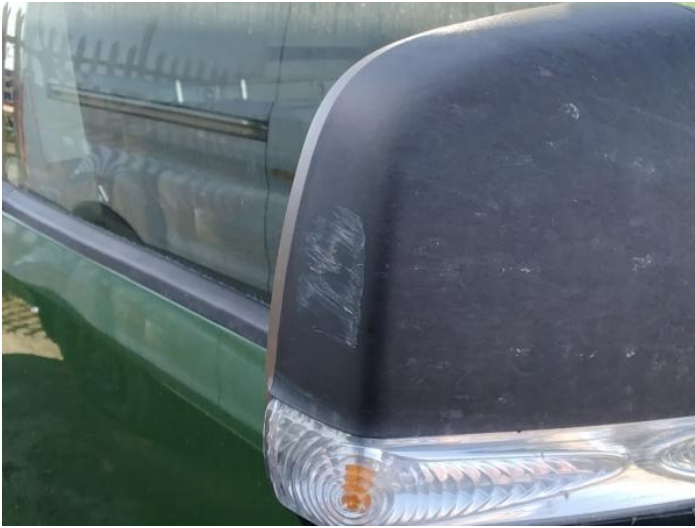
3: Door Mirror Assy nsf
Scuffed (Unpainted)
Over 100mm

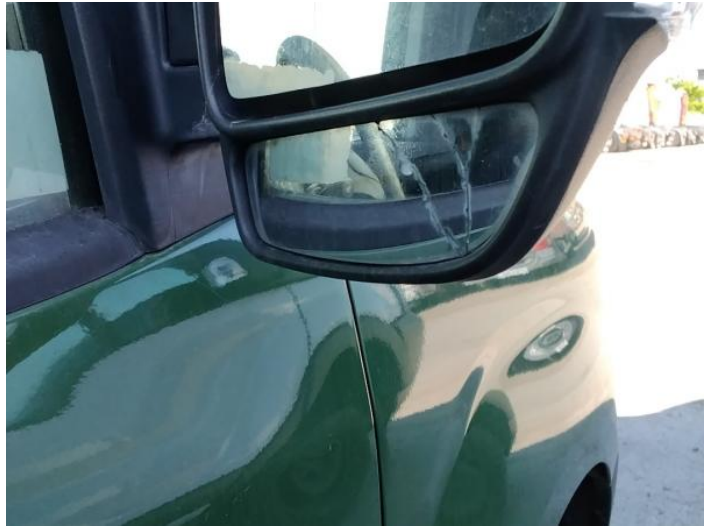
4: Door Mirror Glass ns
Broken
Replace

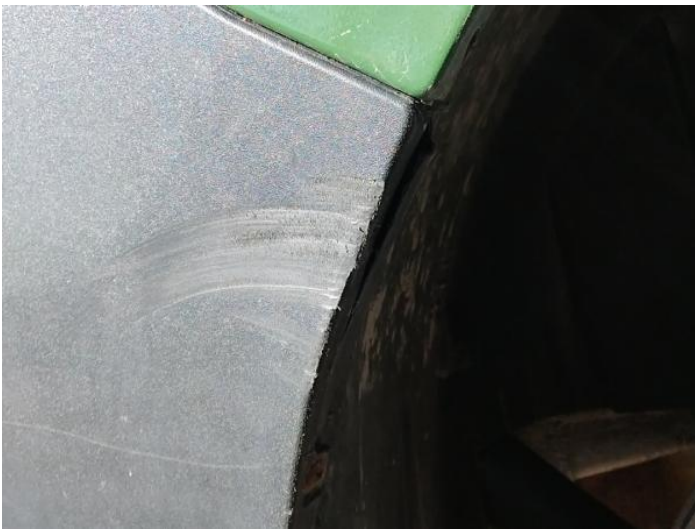
5: Bumper Rear
Scratched
Over 25mm Not Thru Paint

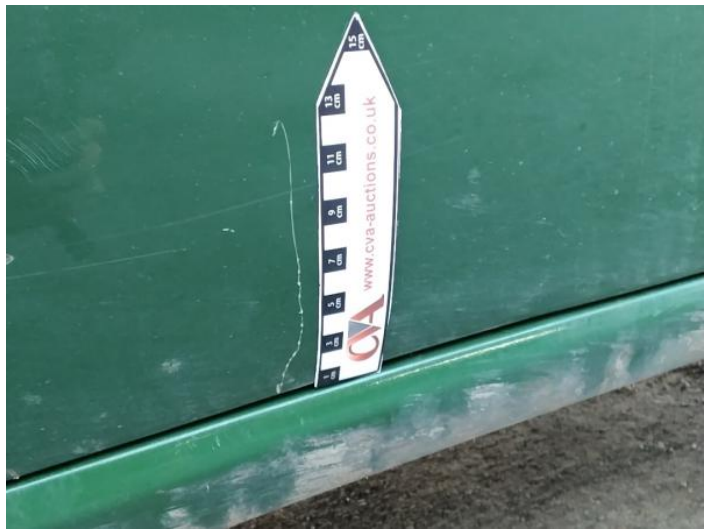
6: Door nsf
Scratched
Over 25mm Thru Paint

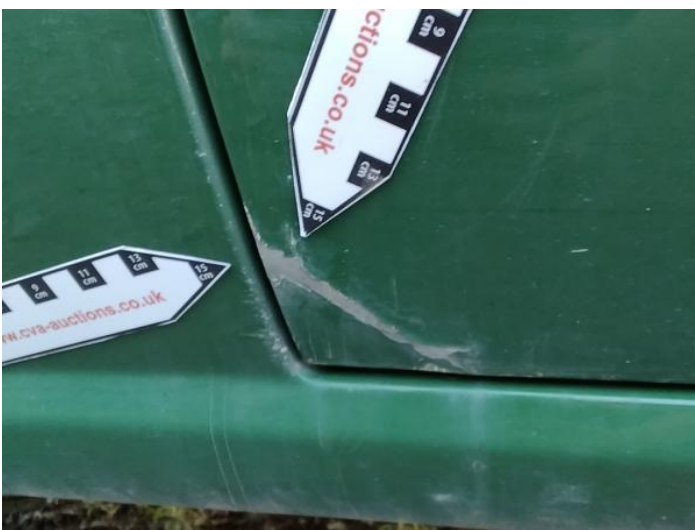
7: Door nsf
Scratched
Over 25mm Thru Paint

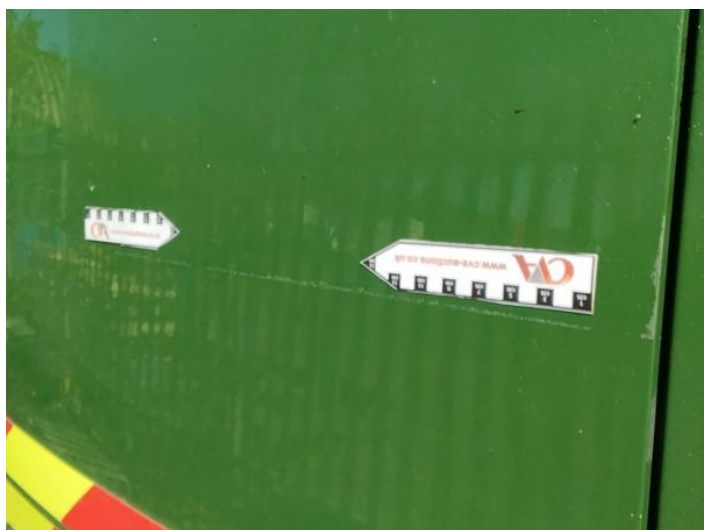
8: Panel Rear
Scratched
Over 25mm Not Thru Paint

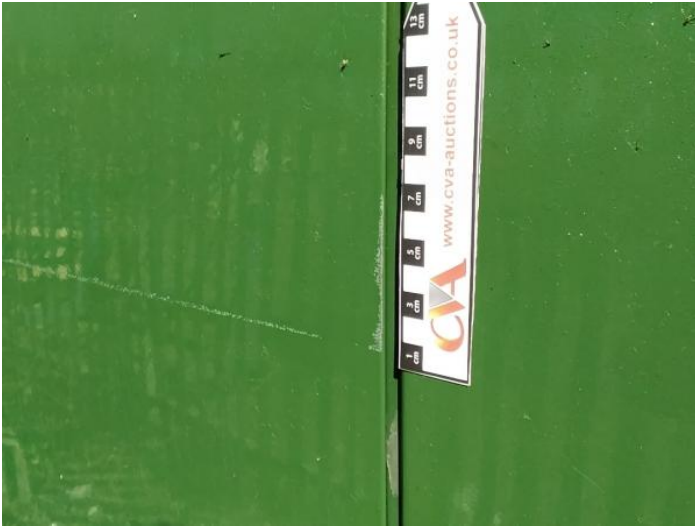
9: Panel Rear
Scratched
Over 25mm Not Thru Paint

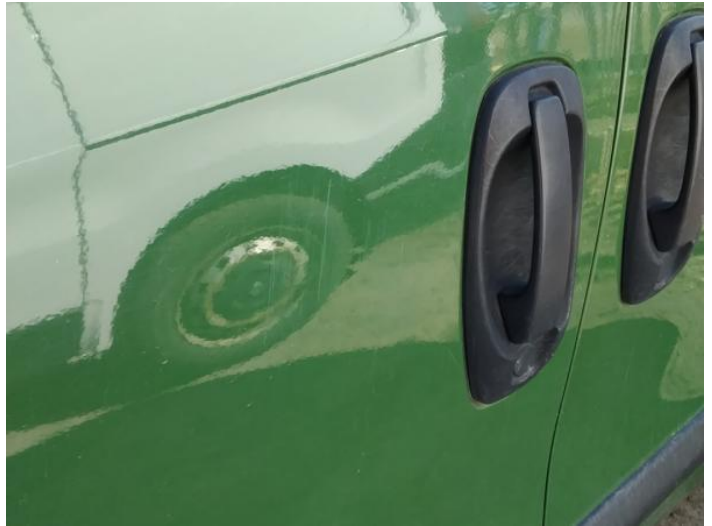
10: Door osf
Scratched
Over 25mm Not Thru Paint

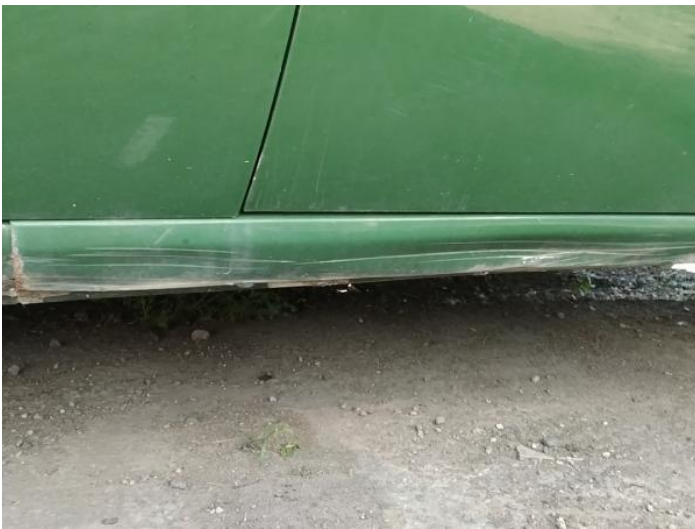
11: Sill os
Dented
With Paint Damage

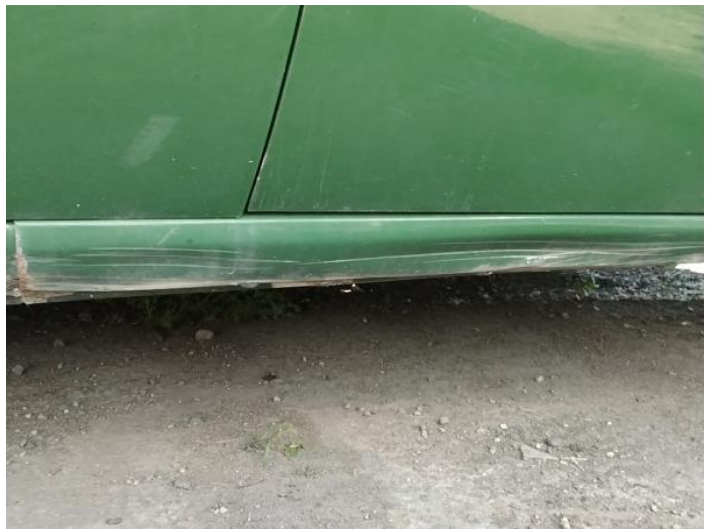
12: Sill os
Dented
With Paint Damage

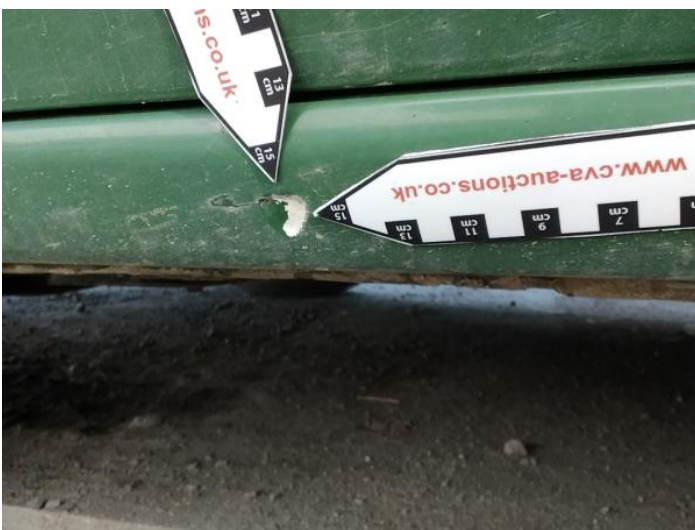
13: Sill os
Dented
With Paint Damage

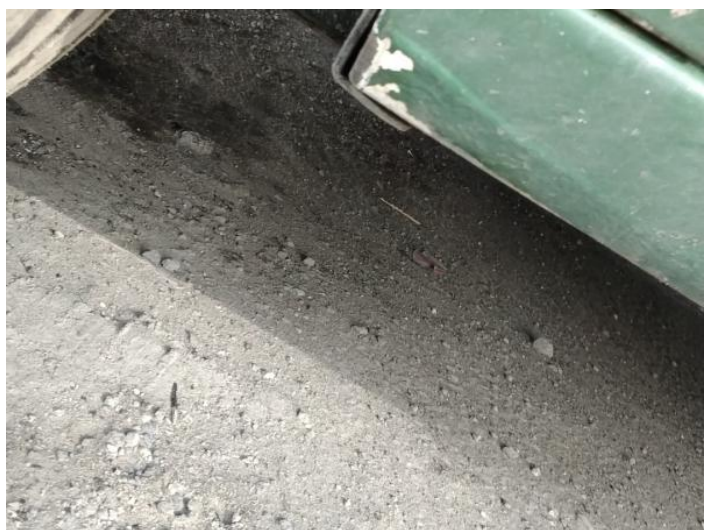
14: Sill os
Chipped
Multiple Chips

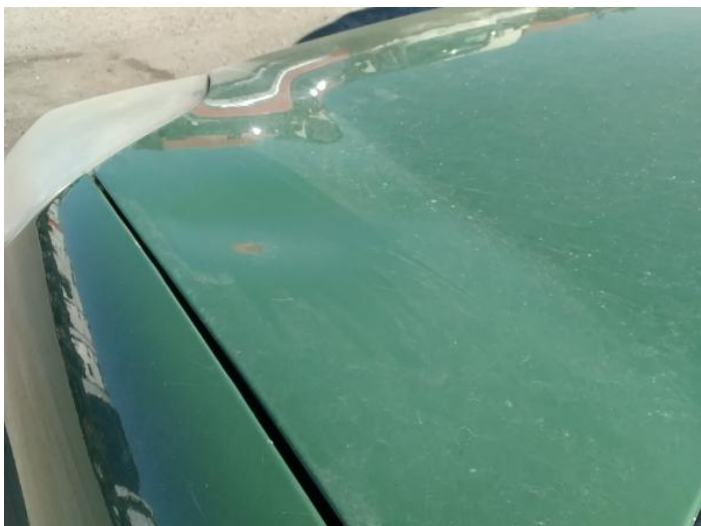
15: Bonnet
Dented
Over 30mm

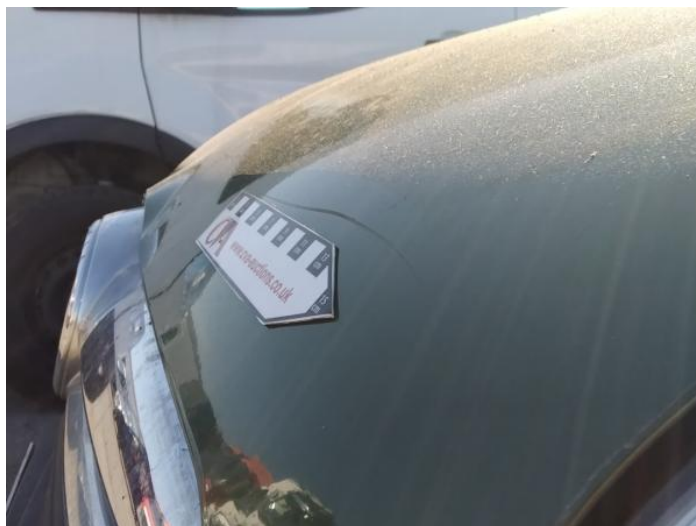
16: Bonnet
Scratched
Over 25mm Not Thru Paint

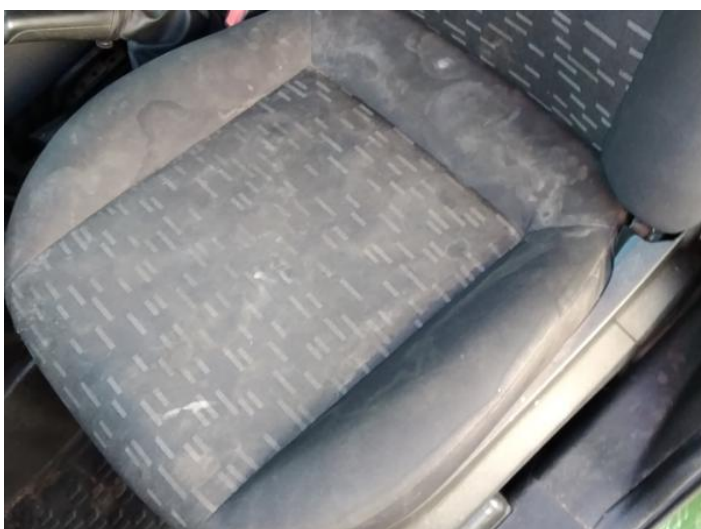
17: Seat Base Cover osf
Soiled
Light

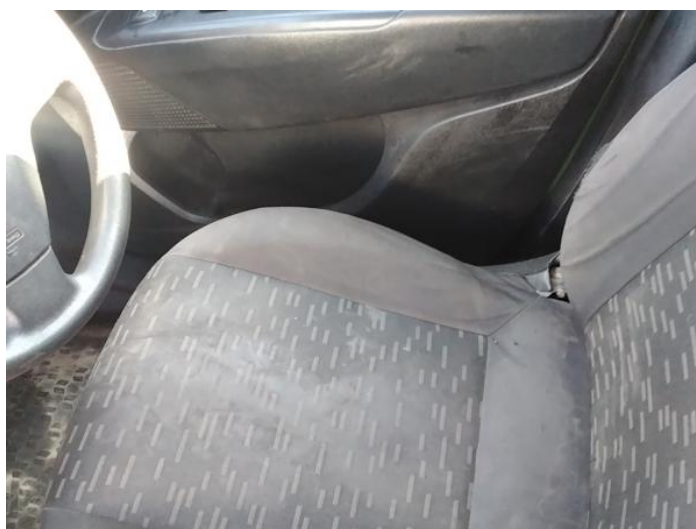
18: Seat Base Cover nsf
Soiled
Light

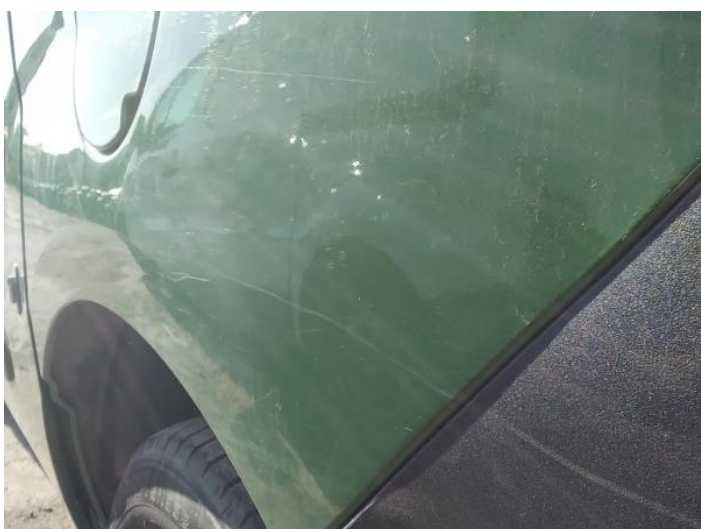
19: Panel Rear
Scratched
Over 25mm Not Thru Paint

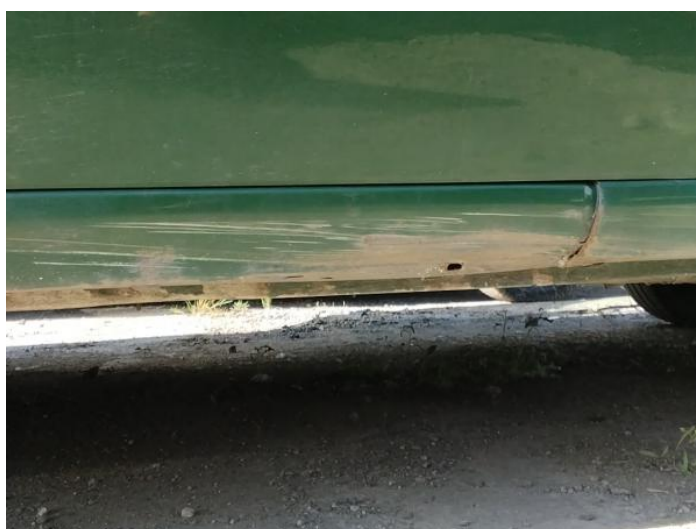
20: Sill os
Dented
With Paint Damage

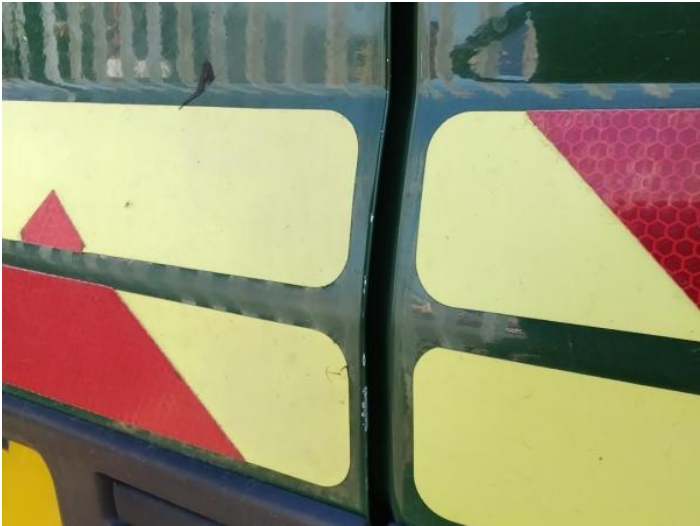
21: Panel Rear
Chipped
Edge Chip
