VEHICLE INSPECTION REPORT

VN18UZU

VOLKSWAGEN AMAROK HIGHLINE 3.0 TDI V6 224PS

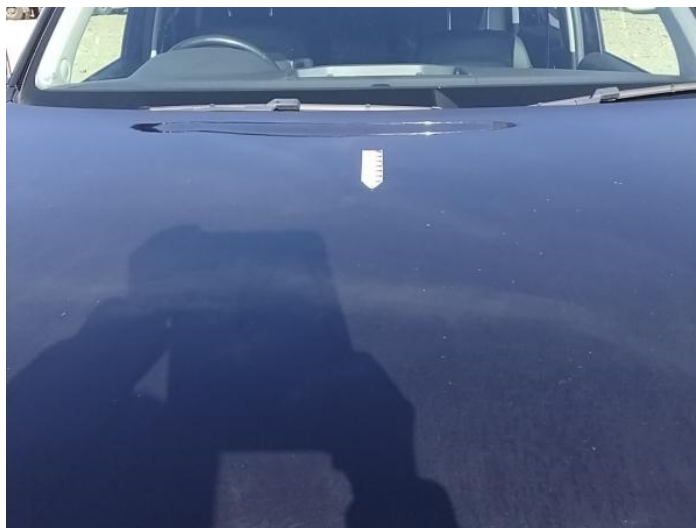
2: Bonnet
Chipped
Multiple Chips

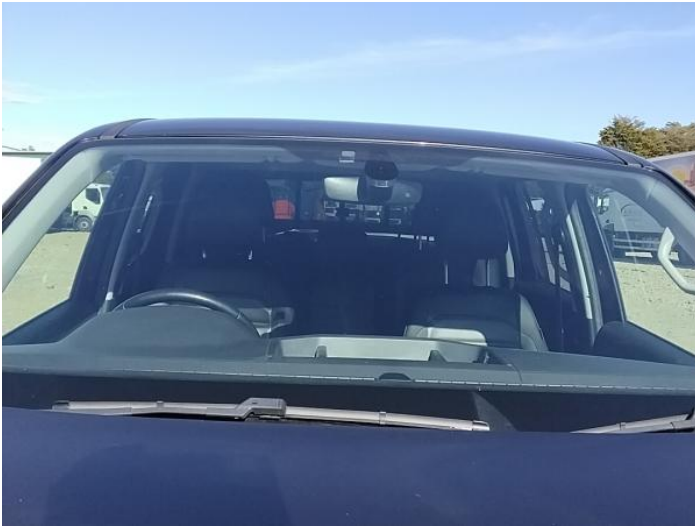
3: Screen Front
Chipped
UpTo 10mm

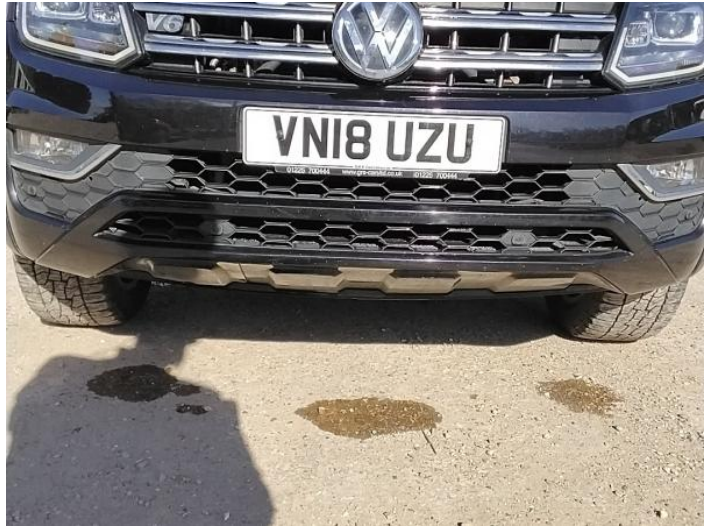
4: Bumper Front
Chipped
Multiple Chips

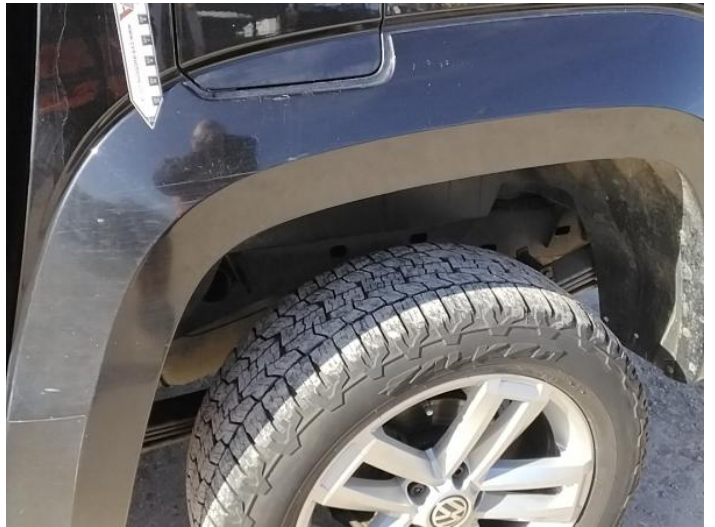
6: Qtr Panel Arch Extension ns
Scratched (Painted)
Over 25mm Not Thru Paint

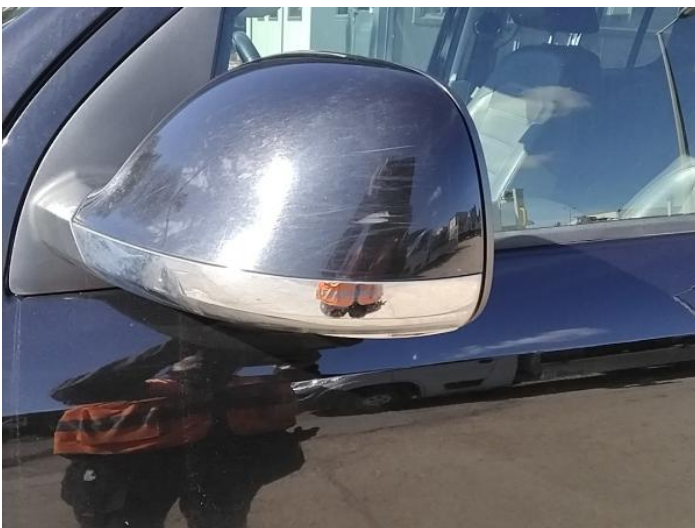
7: Door Mirror Assy nsf
Scratched (Painted)
UpTo 25mm Not Thru Paint

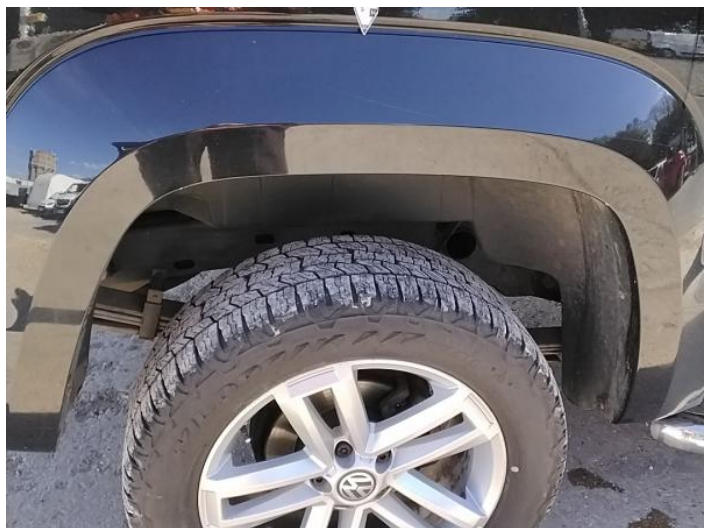
8: Qtr Panel Arch Extension os
Scratched (Painted)
UpTo 25mm Not Thru Paint

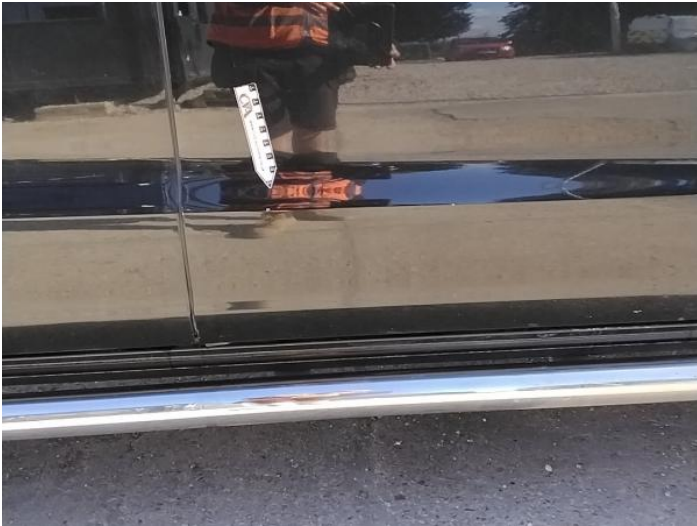
9: Door osf
Chipped
1 To 5

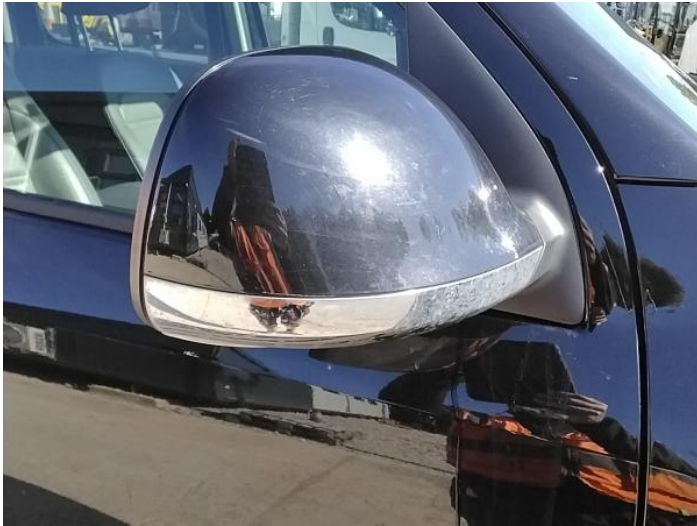
10: Door Mirror Assy osf
Scratched (Painted)
UpTo 25mm Not Thru Paint
