VEHICLE INSPECTION REPORT

YK69MGY

Volvo FH 500

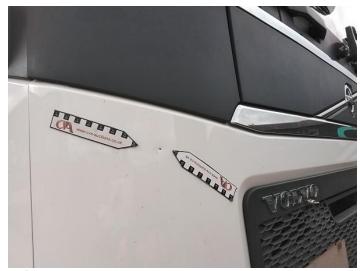
1: Bonnet Dented With Paint Damage

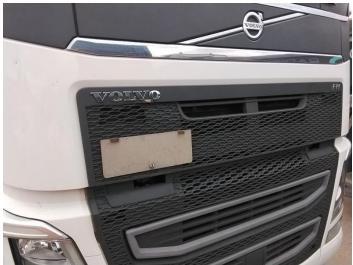
2: Bonnet Chipped Multiple Chips

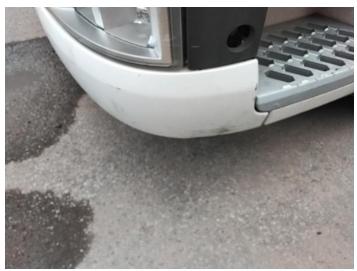
3: Bumper Front Scratched Over 100mm Thru Paint

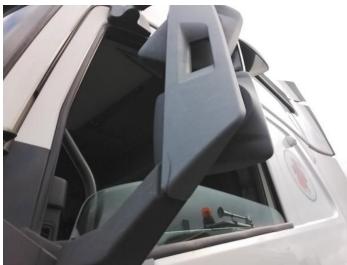
4: Door Mirror Assy nsf Broken Replace

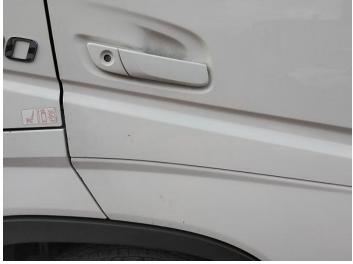
5: Door osf Chipped Multiple Chips
