# **VEHICLE INSPECTION REPORT**

PE17HPN

### Daf CF 440

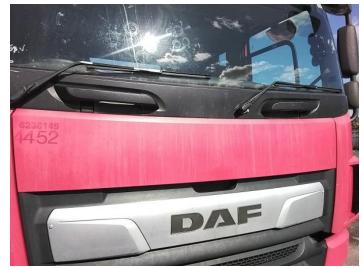
1: Bonnet Chipped Multiple Chips

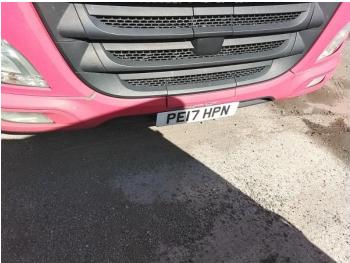
2: Bumper Front Scratched Over 100mm Thru Paint

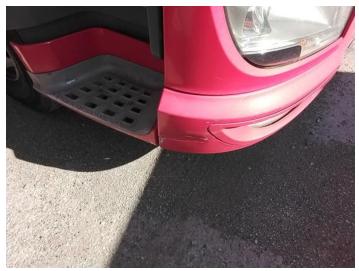
3: Bumper Front Dented With Paint Damage

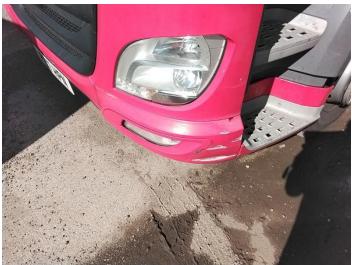
4: Bumper Front Dented With Paint Damage

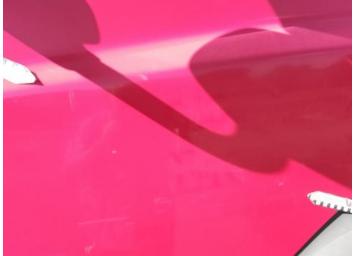
5: Door nsf Scratched Over 25mm Thru Paint

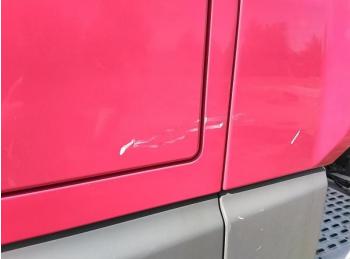
6: Qtr Panel nsr Scratched Over 25mm Thru Paint

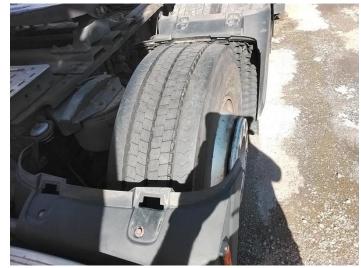
7: Qtr Panel Moulding ns Missing Replace

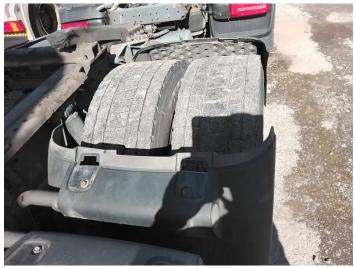
8: Qtr Panel Moulding ns Missing Replace

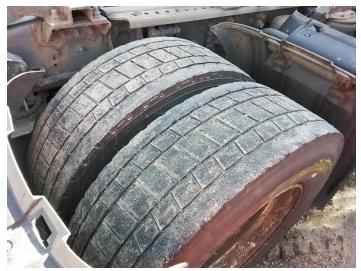
9: Qtr Panel Moulding os Missing Replace

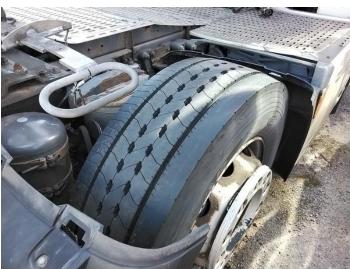
10: Qtr Panel Moulding os Missing Replace

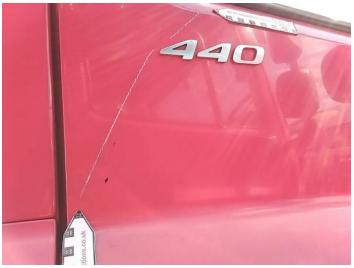
11: Door osf Scratched Over 25mm Thru Paint

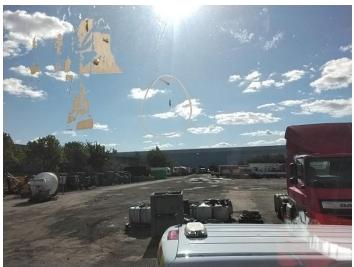
12: Screen Front Chipped Over 10mm

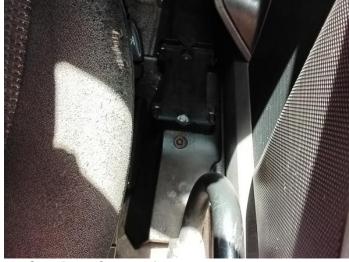
13: Seat Base Cover osf Torn Over 3mm
