# VEHICLE INSPECTION REPORT

**LM66ZZH**

## Mercedes-Benz Sprinter 314 CDI

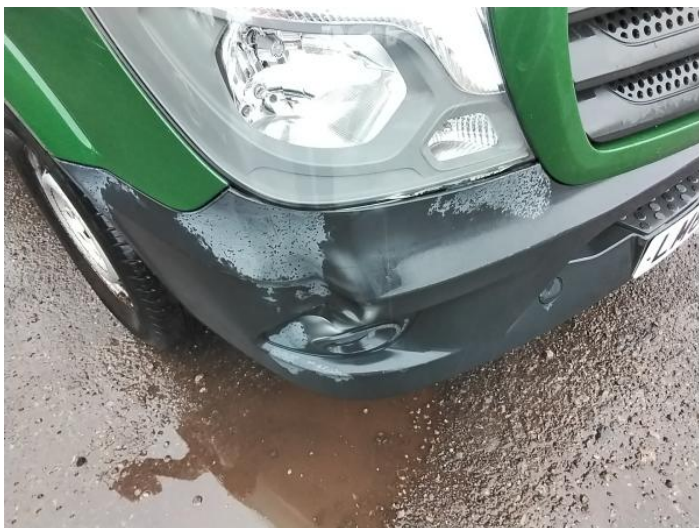
1: Bumper Front  
Dented  
Over 30mm

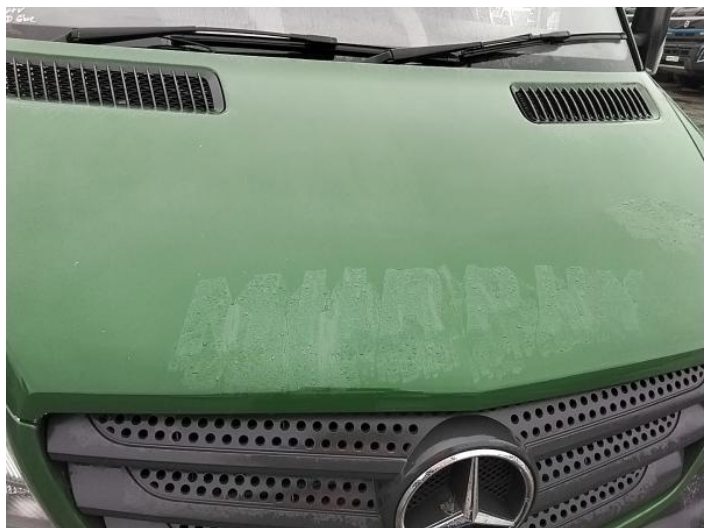
2: Bonnet  
Chipped  
Multiple Chips

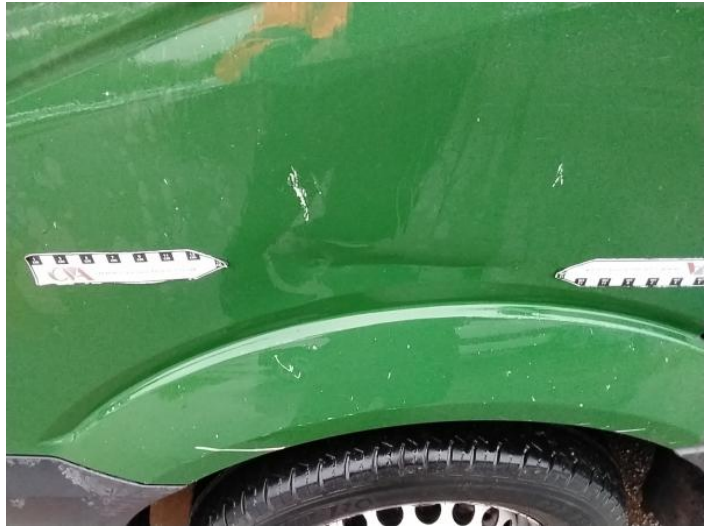
4: Wing nsf  
Dented  
Over 30mm

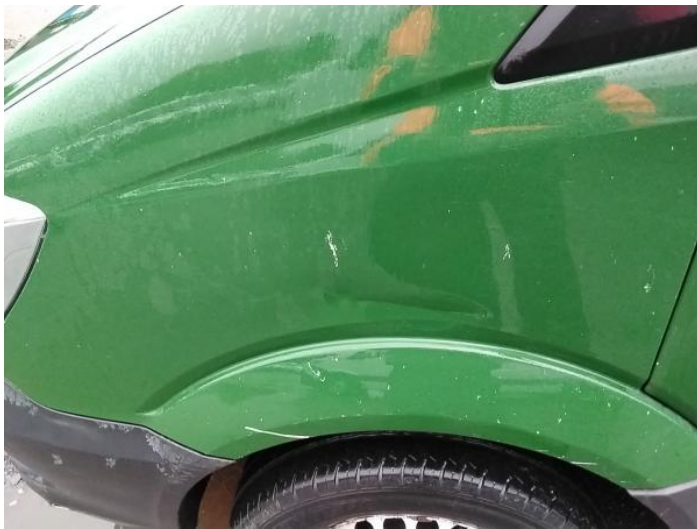
5: Wing nsf  
Chipped  
Multiple Chips

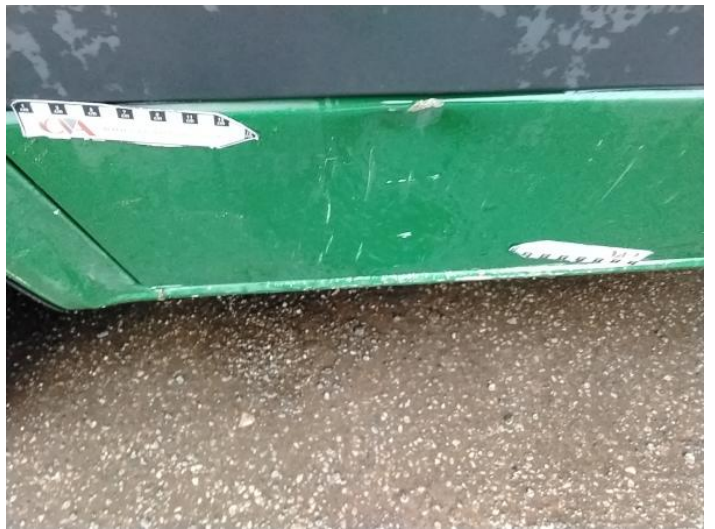
6: Door nsf  
Dented  
With Paint Damage

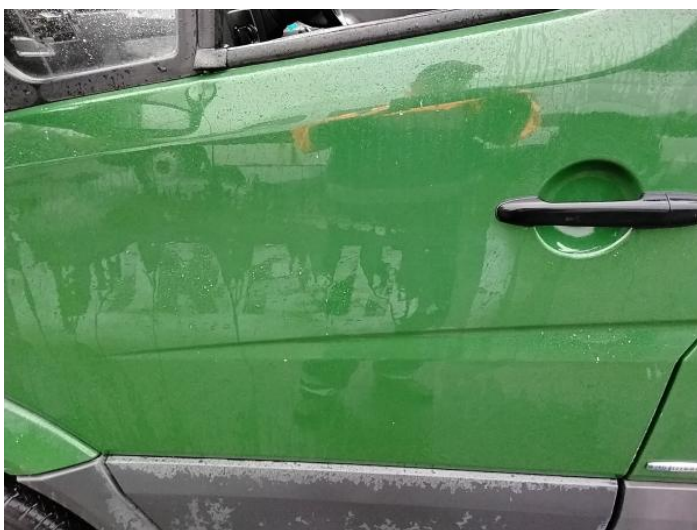
7: Door nsf  
Chipped  
Multiple Chips

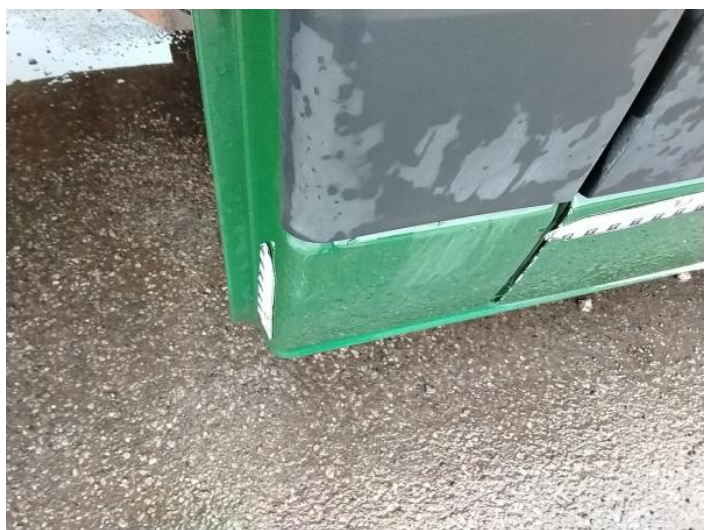
8: B Post os  
Scratched  
Over 25mm Thru Paint

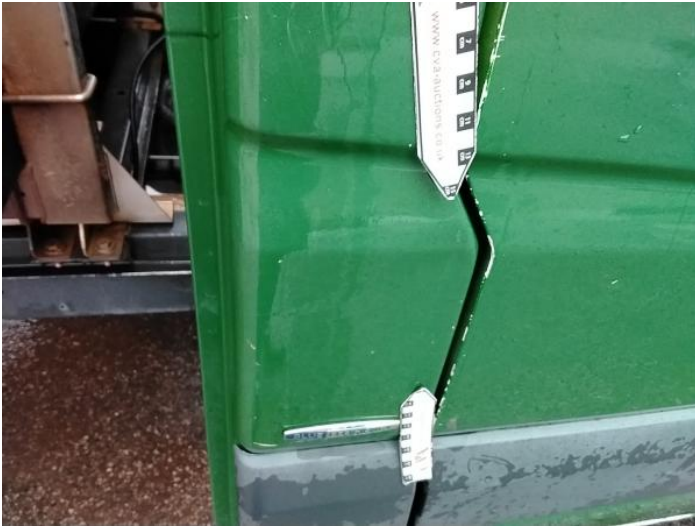
9: B Post osf  
Dented  
Over 30mm

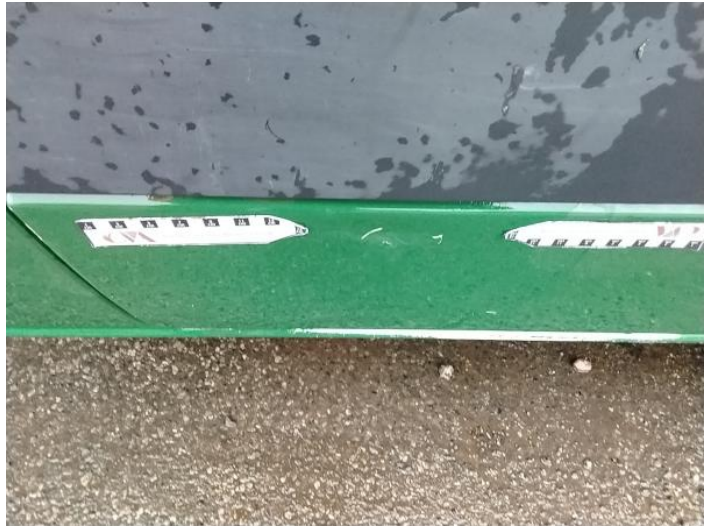
10: Door osf  
Dented  
With Paint Damage

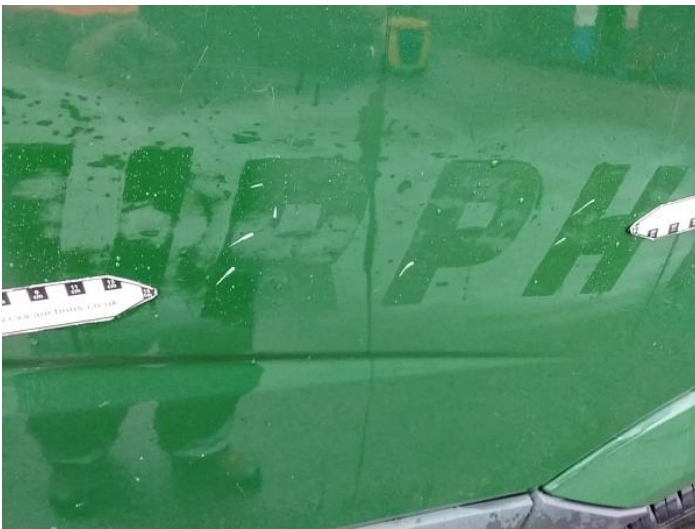
11: Door osf  
Scratched  
Over 25mm Thru Paint

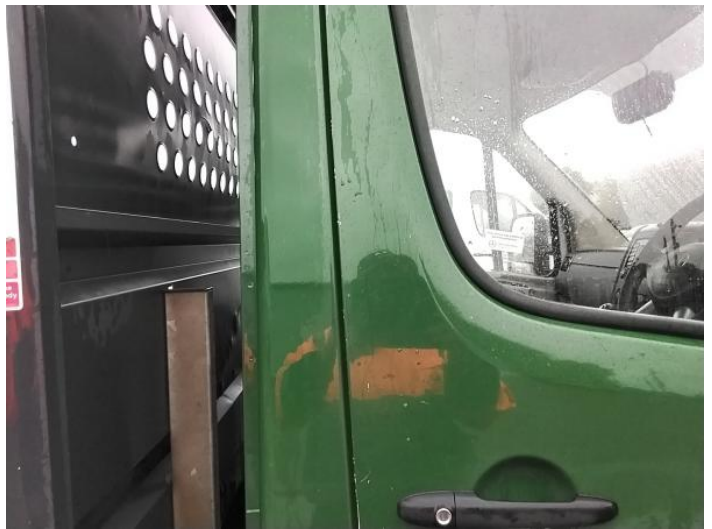
12: Door osf  
Chipped  
Multiple Chips

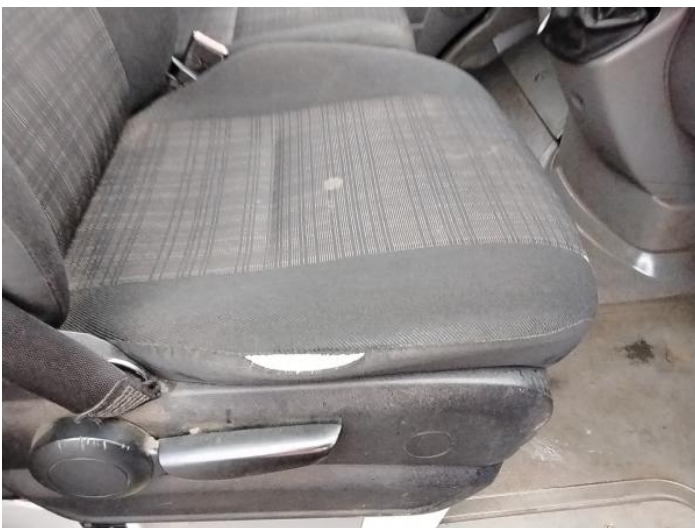
13: Seat Base Cover osf  
Holed  
Over 3mm

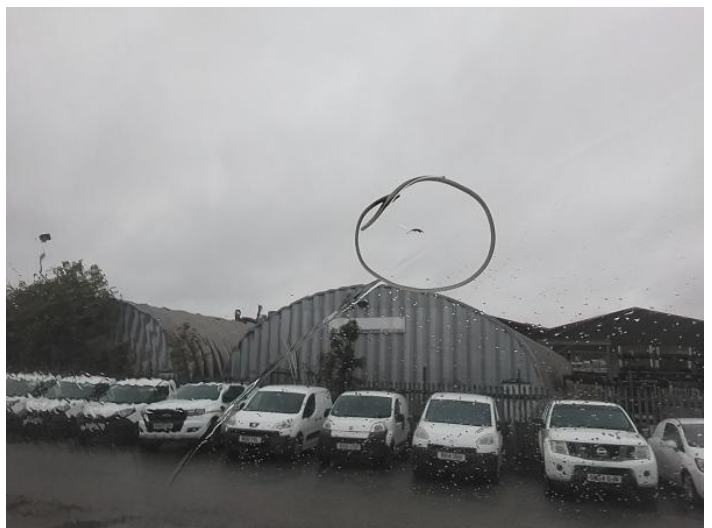
14: Screen Front  
Cracked  
Replace
