VEHICLE INSPECTION REPORT

PE65UZD

Daf LF 220

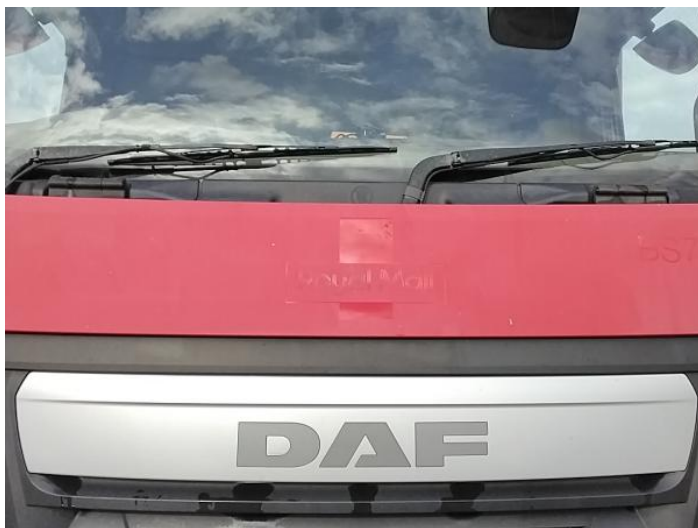
1: Bonnet
Chipped
Multiple Chips

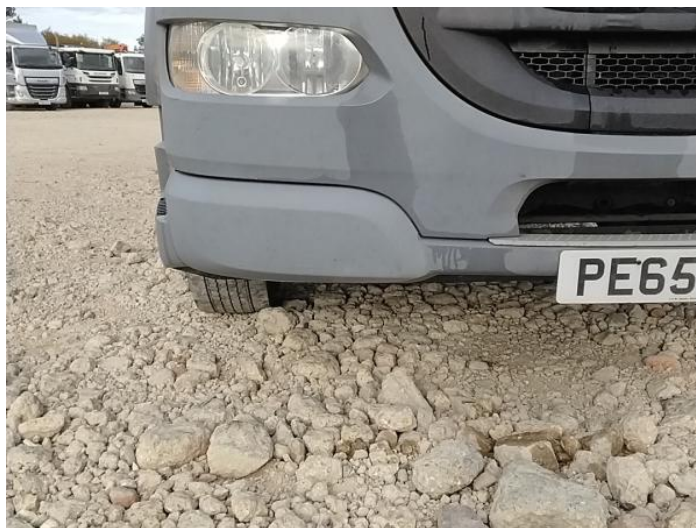
2: Bumper Front
Chipped
Multiple Chips

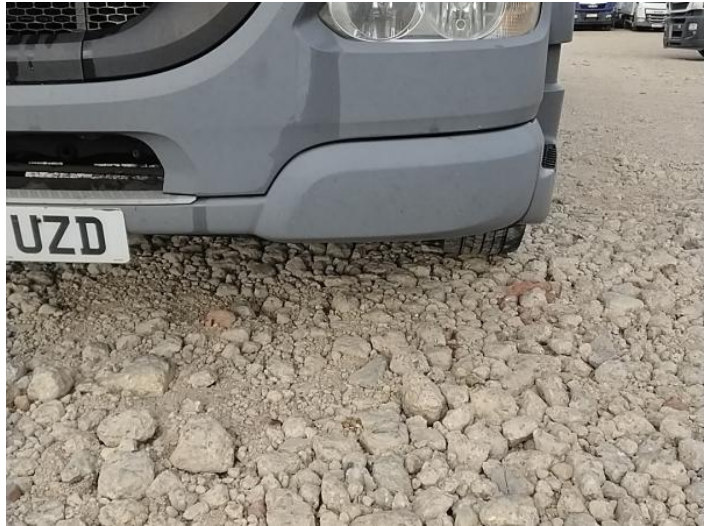
4: Bumper Front
Chipped
Multiple Chips

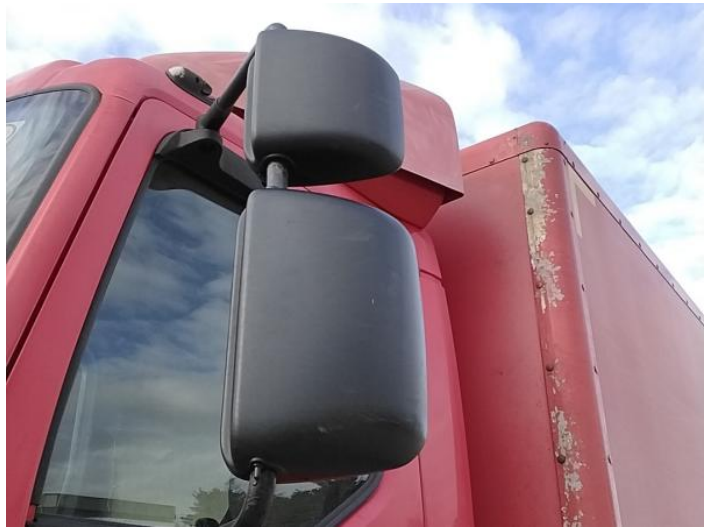
6: Door Mirror Assy nsf
Scuffed (Unpainted)
UpTo 100mm

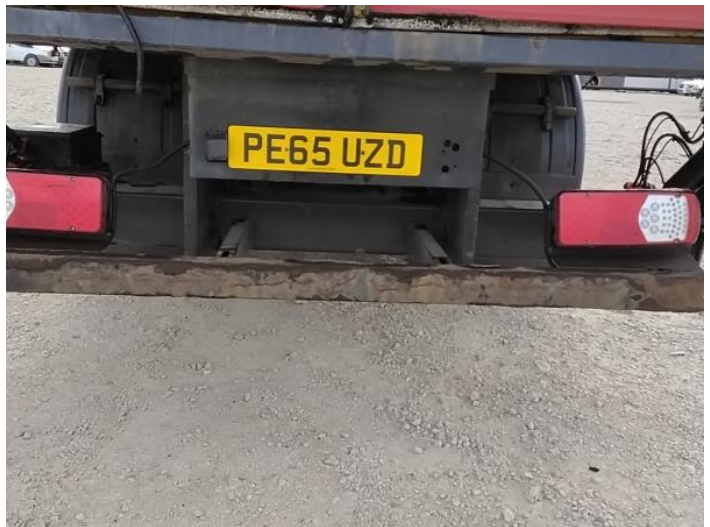
10: Bumper Rear
Rusted
Over 5mm

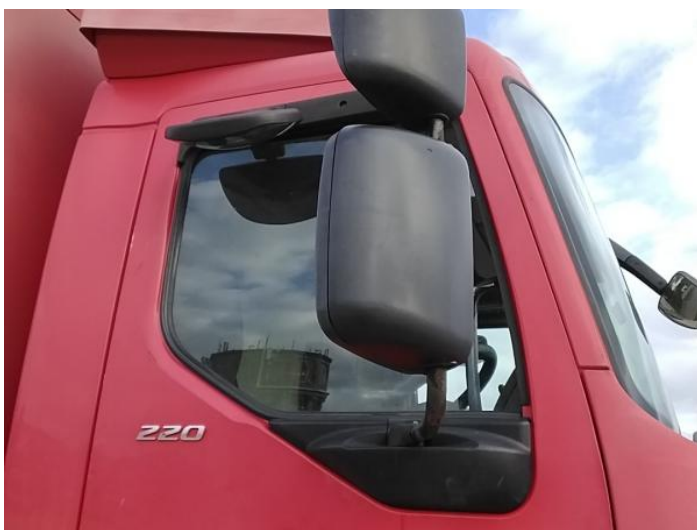
13: Door Mirror Assy osf
Scuffed (Unpainted)
UpTo 100mm

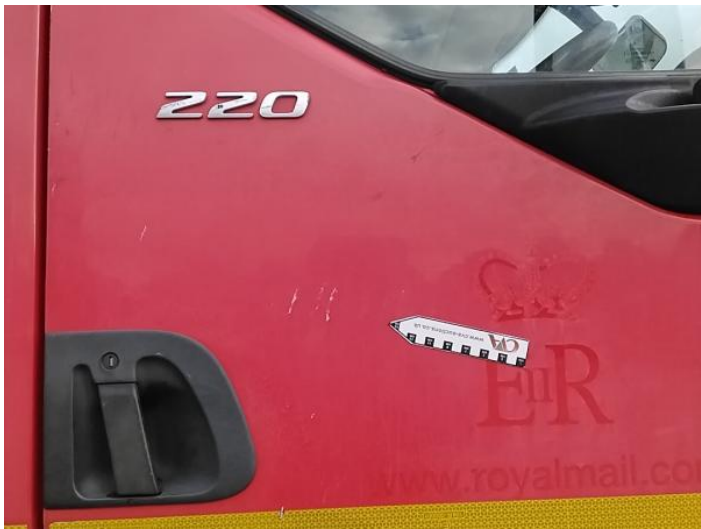
15: Door osf
 Scratched
 UpTo 25mm Thru Paint
