VEHICLE INSPECTION REPORT

BL70CVN

Nissan E-Nv200 80kW Acenta Van Auto 40kWh

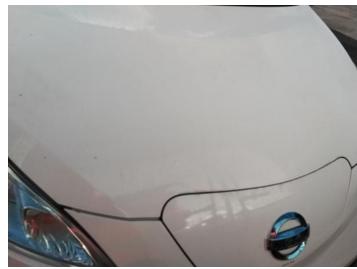
1: Bonnet Chipped Multiple Chips

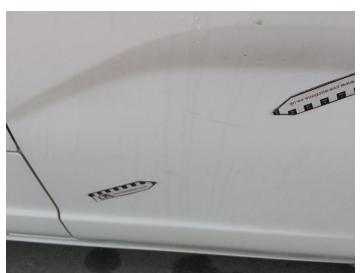
2: Qtr Panel nsr Scratched Over 25mm Thru Paint

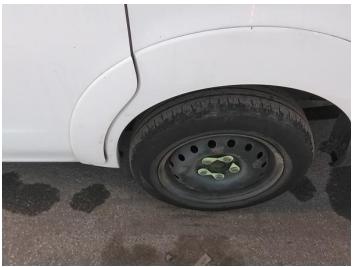
3: Qtr Panel Moulding ns Scuffed (Unpainted) Over 100mm

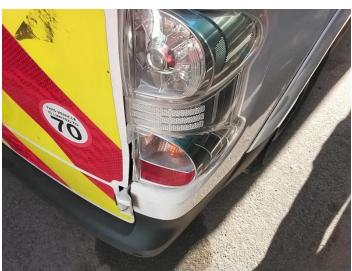
4: Lamp osr Broken Replace

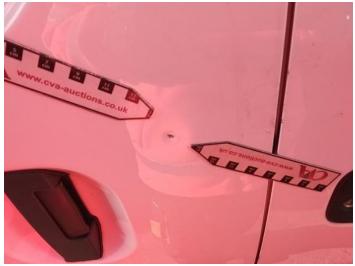
5: Qtr Panel osr Dented With Paint Damage

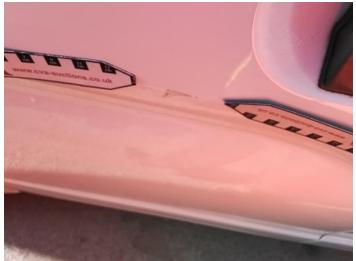
6: Qtr Panel osr Dented With Paint Damage

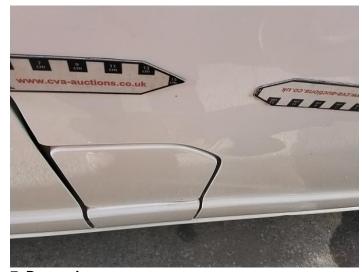
7: Door osf Dented Over 30mm

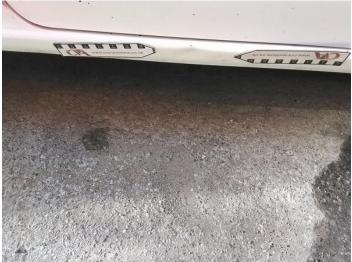
8: Sill os Dented Over 30mm

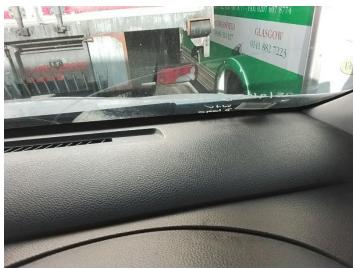
9: Screen Front Scratched Over 30mm

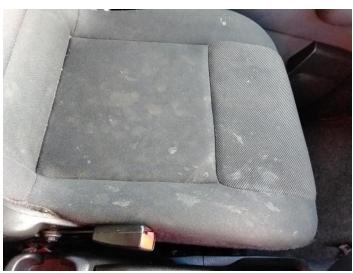
10: Seat Base Cover nsf Soiled Heavy

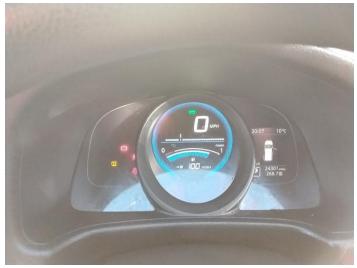
11: Dash Warning Lights Displayed No Action
