# **VEHICLE INSPECTION REPORT**

**WX17KFP**

## Isuzu D-Max 2.5 TD

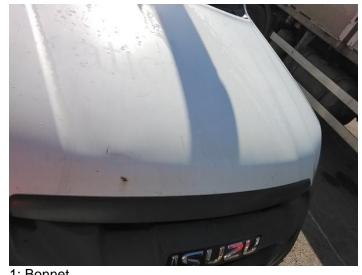
1: Bonnet Chipped Multiple Chips

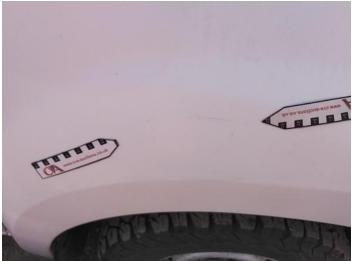
2: Wing osf Scratched Over 25mm Thru Paint

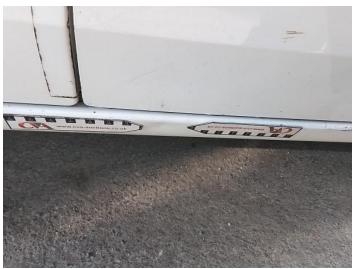
3: Sill os Dented Over 30mm

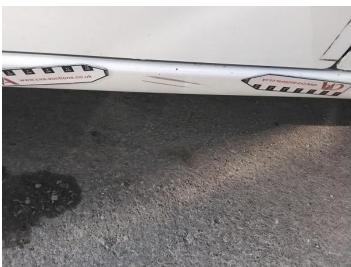
4: Sill os Dented With Paint Damage

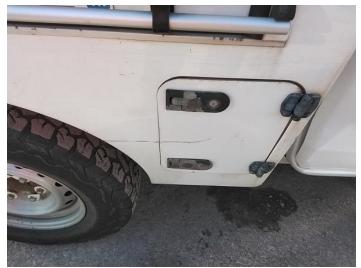
5: Qtr Panel osr Scratched Over 25mm Thru Paint

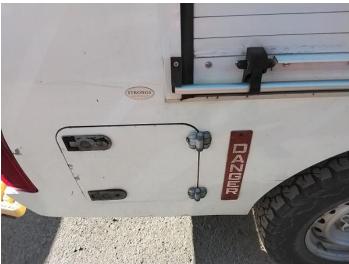
6: Qtr Panel osr Scratched Over 25mm Thru Paint

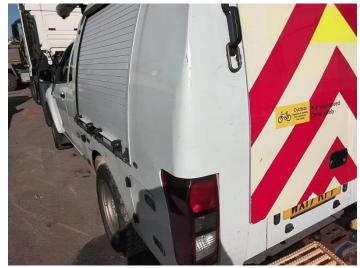
7: Panel Rear Chipped Multiple Chips

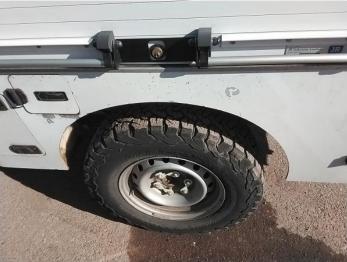
8: Qtr Panel nsr Scratched Over 25mm Thru Paint

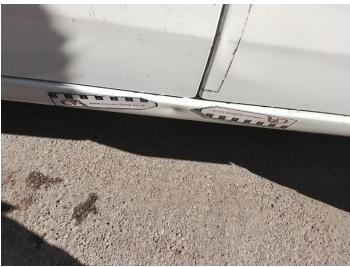
10: Sill ns Dented Over 30mm

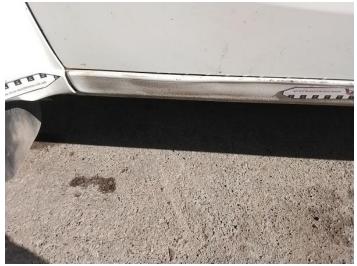
11: Sill ns Dented Over 30mm

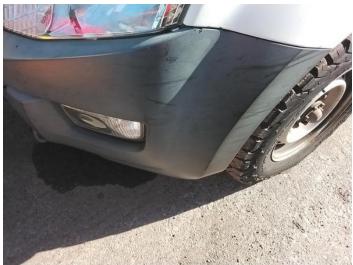
12: Bumper Front Scratched Over 100mm Thru Paint

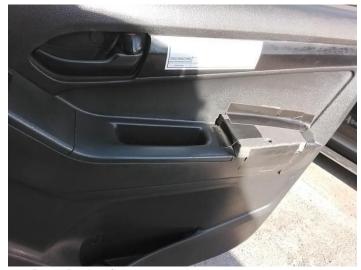
13: Door Pad osf Broken Replace

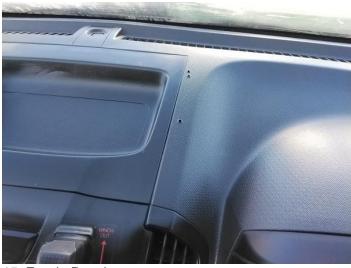
15: Fascia Panel Holed Over 3mm
