VEHICLE INSPECTION REPORT

WD65UCW

Isuzu D-Max 2.5 TD TURBO

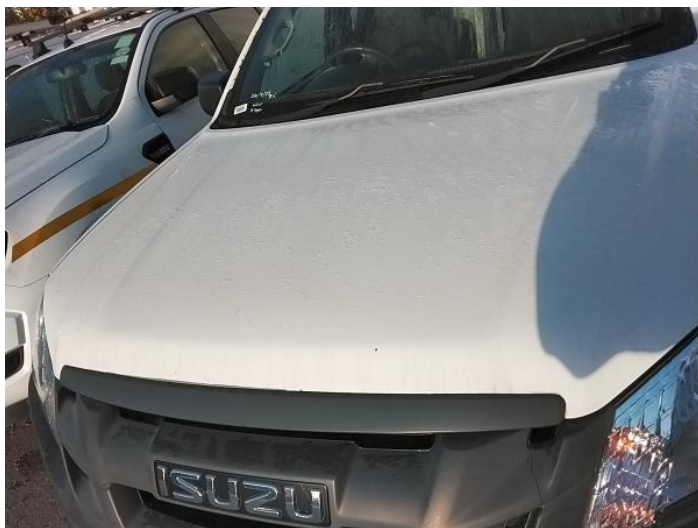
1: Bonnet
Chipped
Multiple Chips

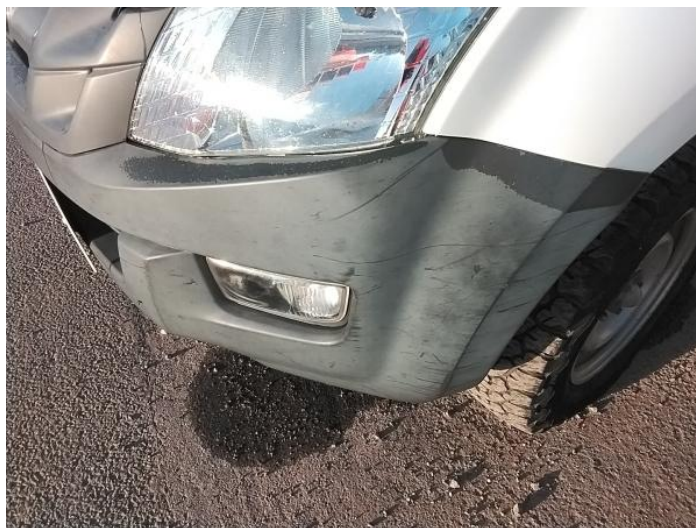
2: Bumper Front
Scratched
Over 100mm Thru Paint

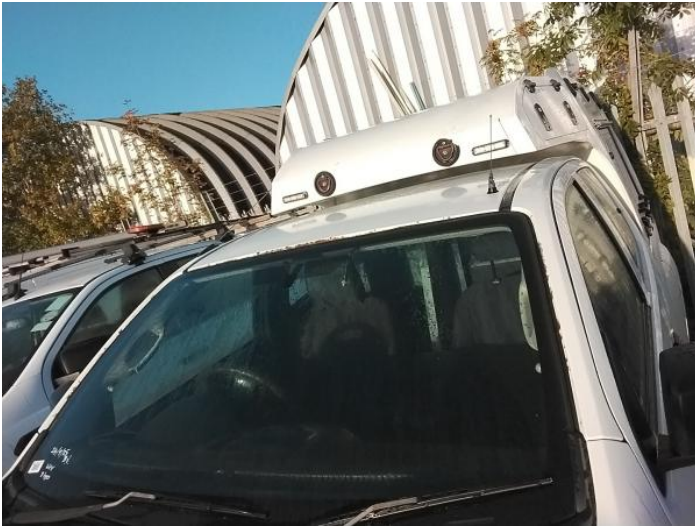
3: Roof
Chipped
Multiple Chips

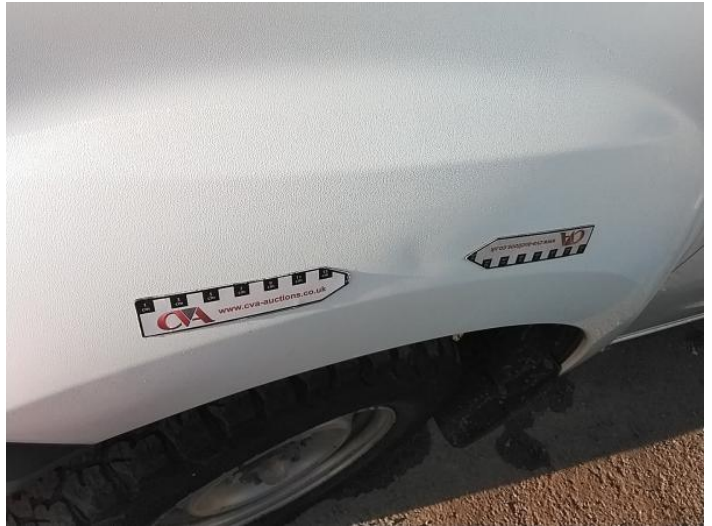
4: Wing nsf
Dented
Over 30mm

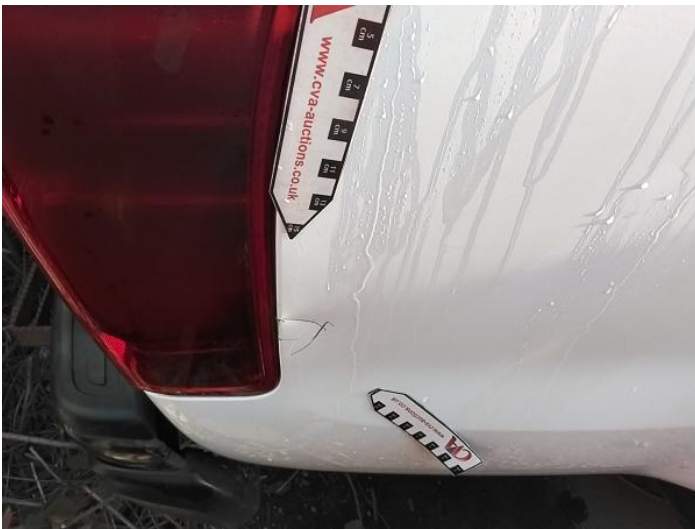
5: Qtr Panel osr
Dented
With Paint Damage

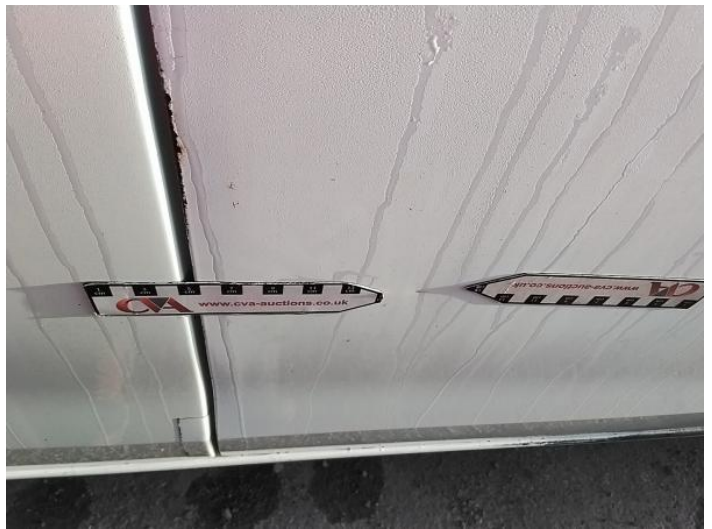
6: Door osf
Dented
With Paint Damage

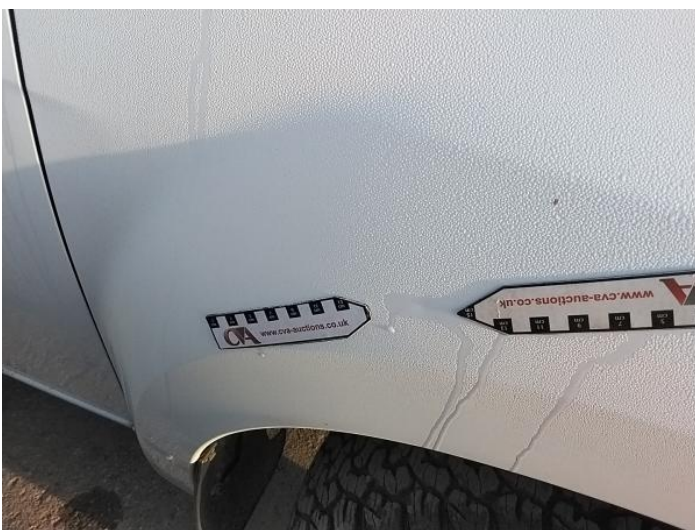
7: Wing osf
Dented
Over 30mm

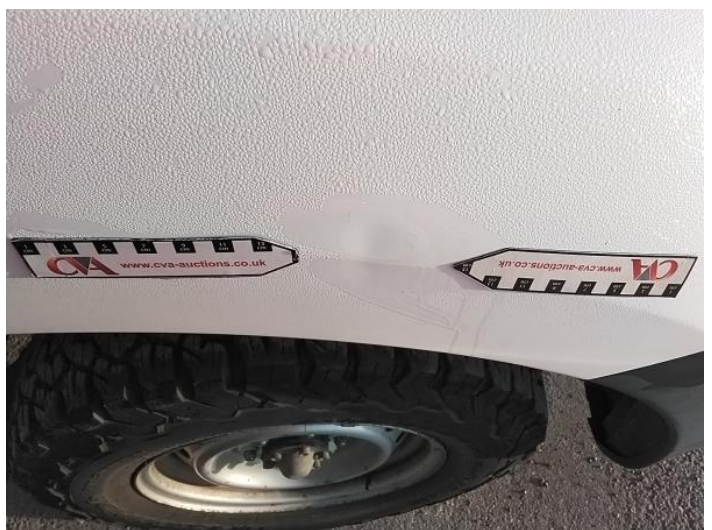
8: Wing osf
Dented
Over 30mm

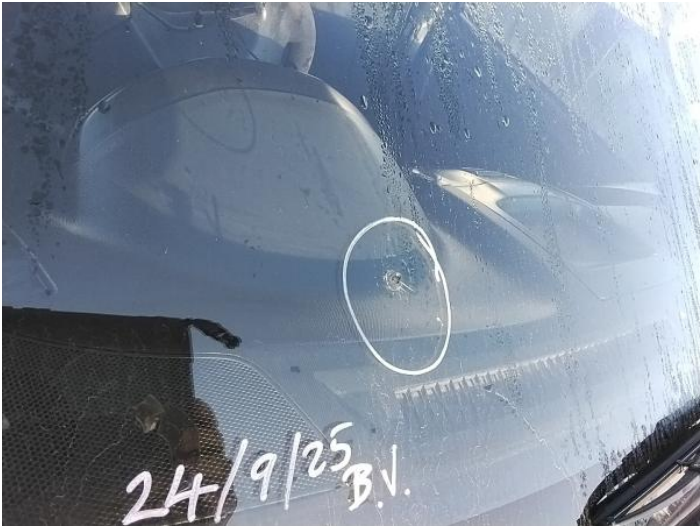
9: Screen Front
Cracked
Replace

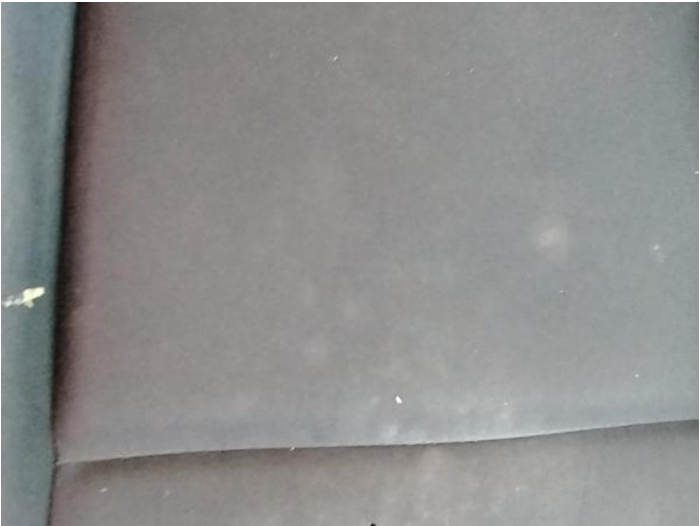
10: Seat Base Cover osf
Burn
Over 3mm

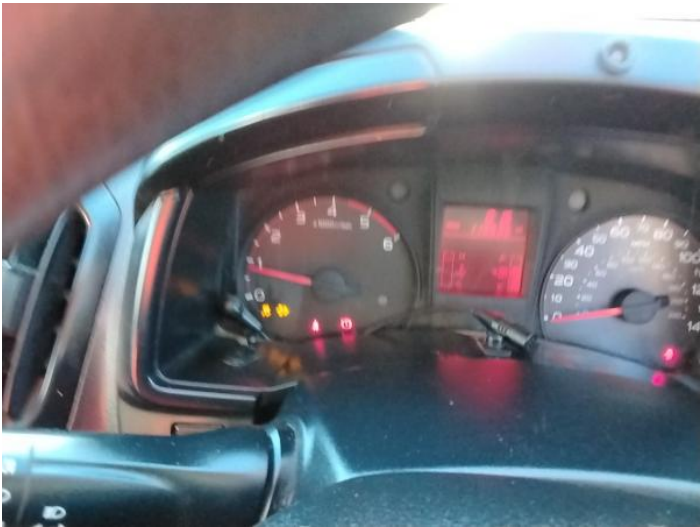
11: Dash Warning Lights
Displayed
No Action

Carpet Condition	OK	Upholstery Condition	OK
Seat Condition	Poor	Odour	No
Engine Runs	OK	No Excessive Smoking	OK
EML light illuminated	OK	DPF light illuminated	Fault
ABS light illuminated	OK
