VEHICLE INSPECTION REPORT

KU61ECC

Volvo FMX 380

Inspection

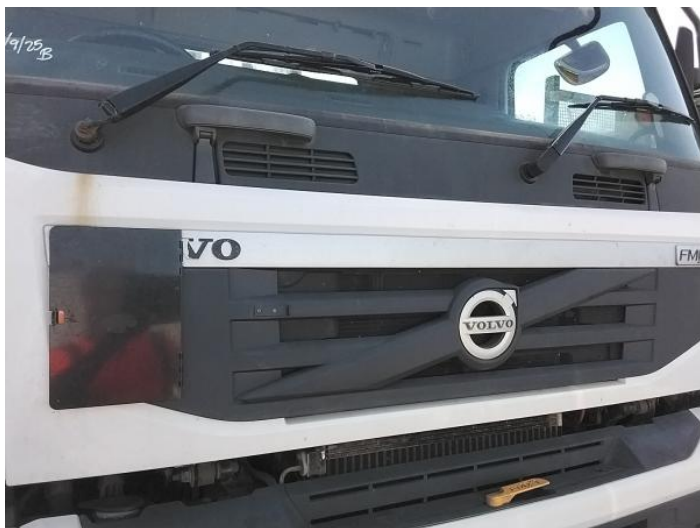
1: Bonnet
Chipped
Multiple Chips

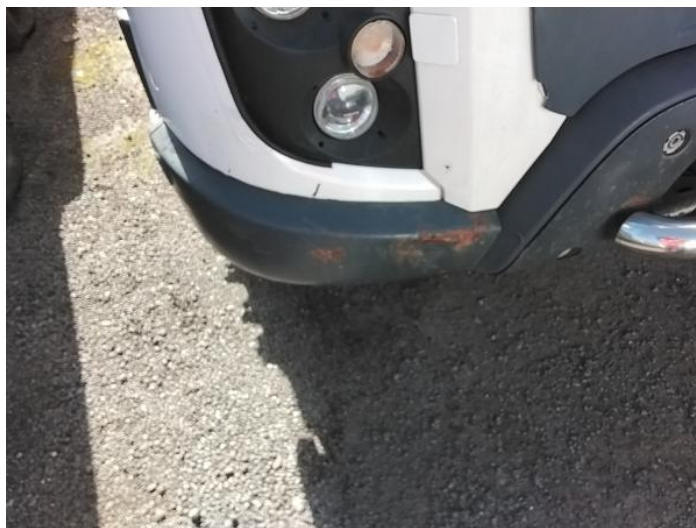
2: Bumper Front
Rusted
Over 5mm

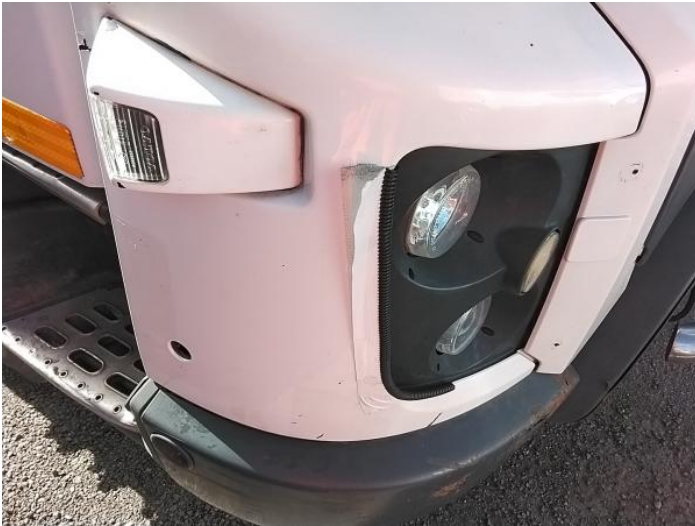
3: Panel Front
Cracked
Replace

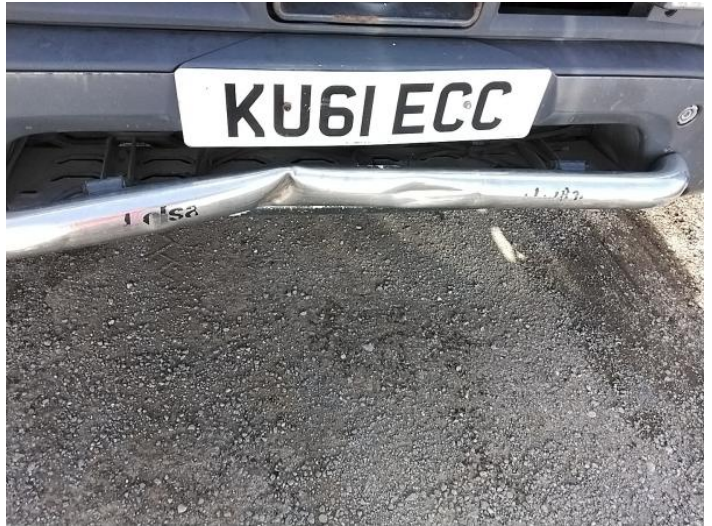
4: Bumper Front Moulding
Broken
Replace

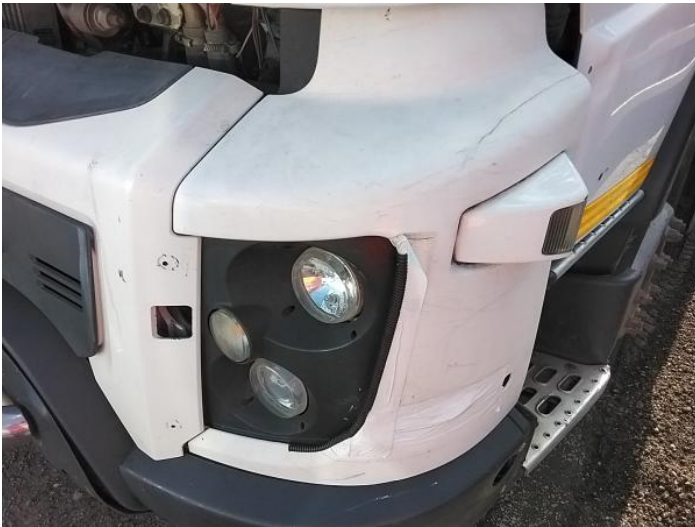
5: Panel Front
Cracked
Replace

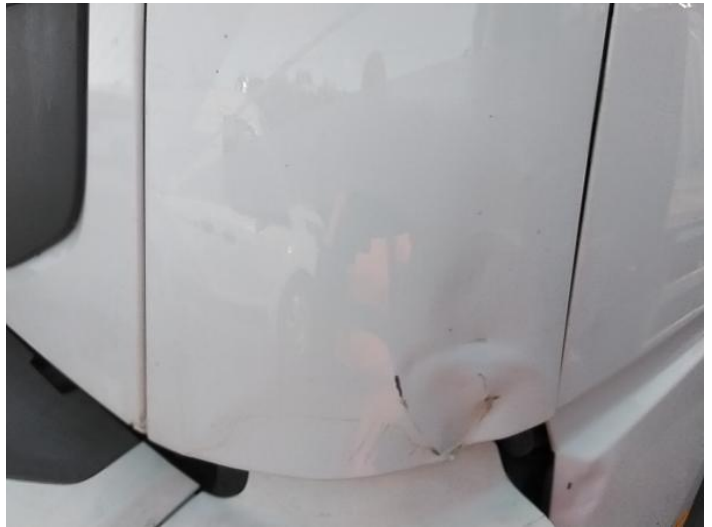
6: Panel Front
Dented
With Paint Damage

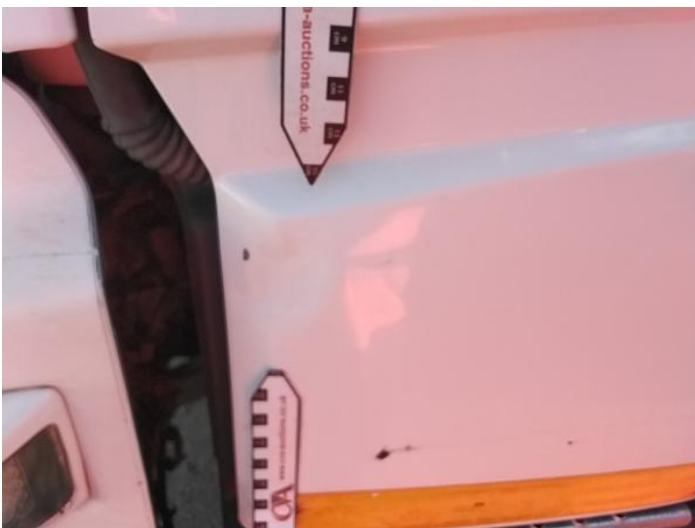
7: Door nsf
Dented
Over 30mm

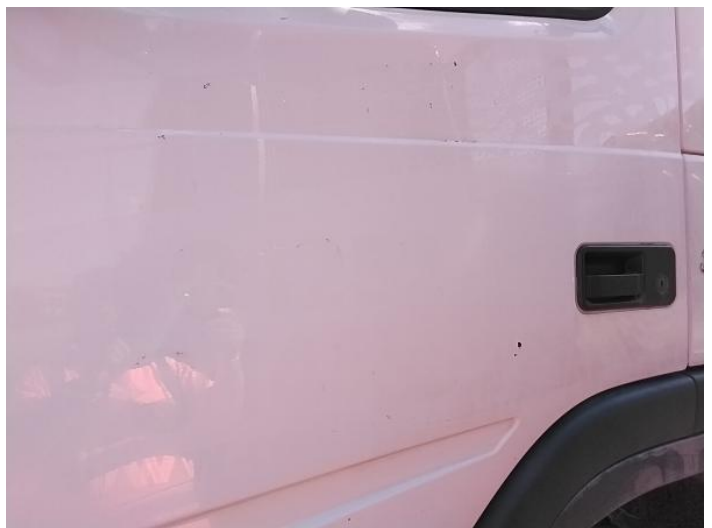
8: Door nsf
Chipped
Multiple Chips

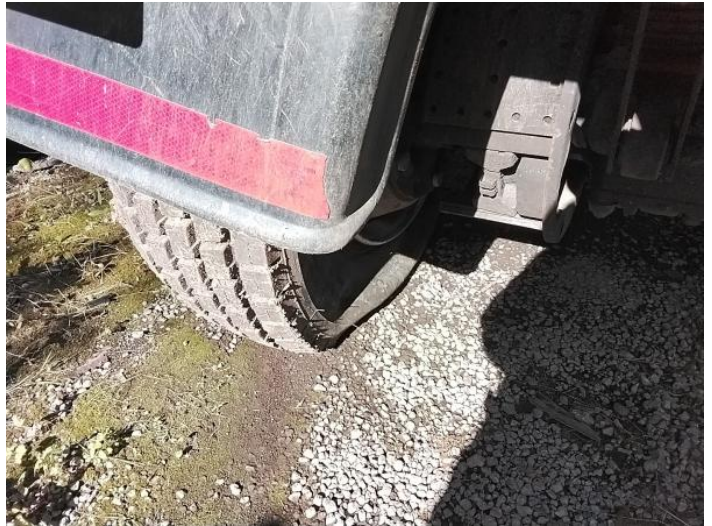
10: Wheel nsr
Missing
Replace

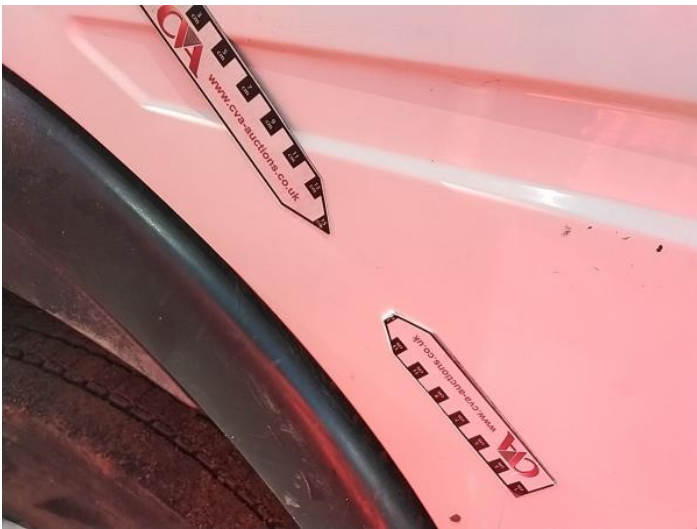
11: Door osf
Dented
With Paint Damage

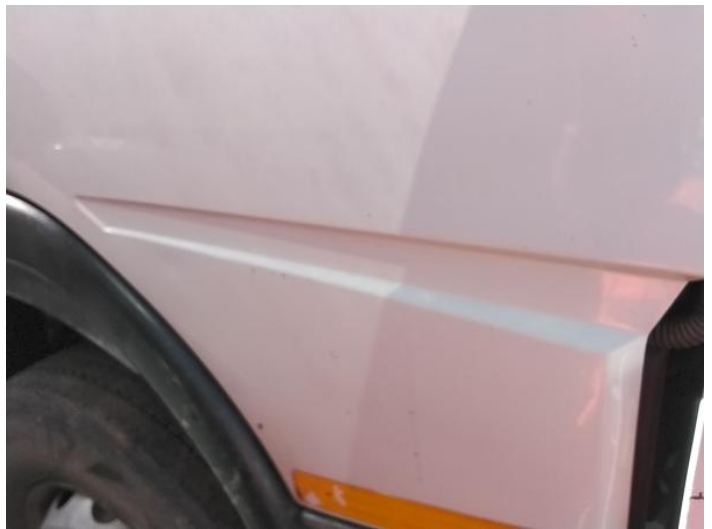
12: Door osf
Chipped
Multiple Chips

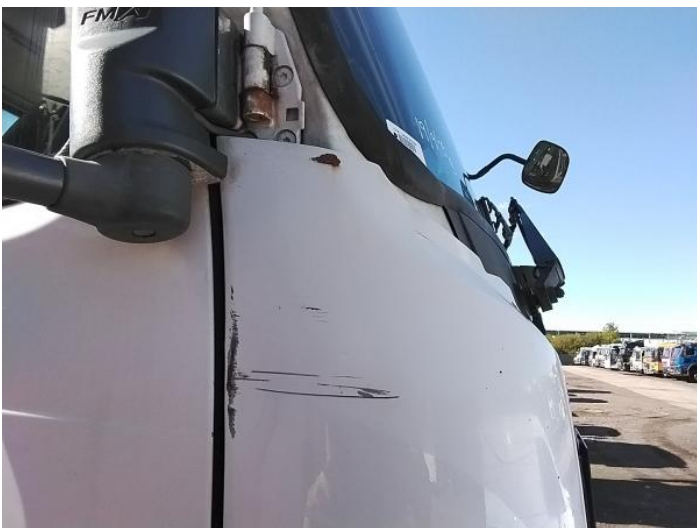
13: Panel Front
Dented
With Paint Damage
