VEHICLE INSPECTION REPORT

PO70YAX

Fiat Ducato 35 2.3 Multijet 140PS

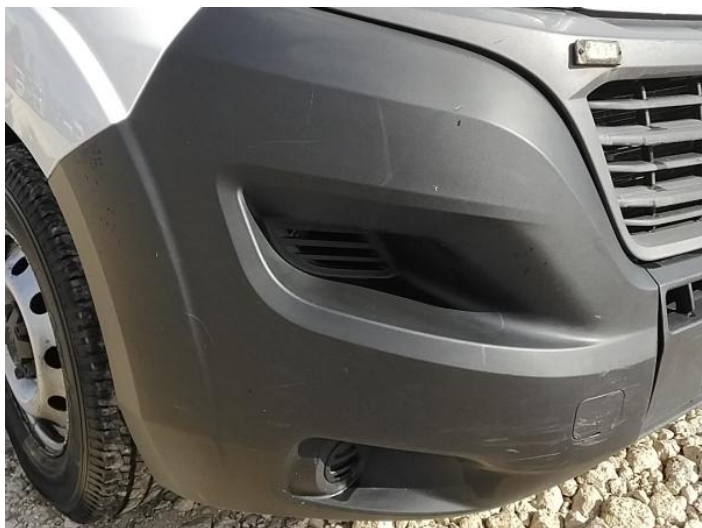
1: Bumper Front Moulding
Scuffed (Unpainted)
UpTo 100mm

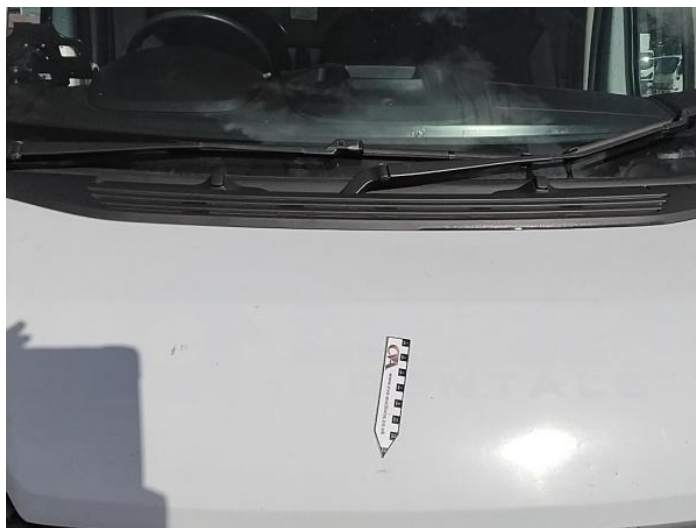
2: Bonnet
Dented
With Paint Damage

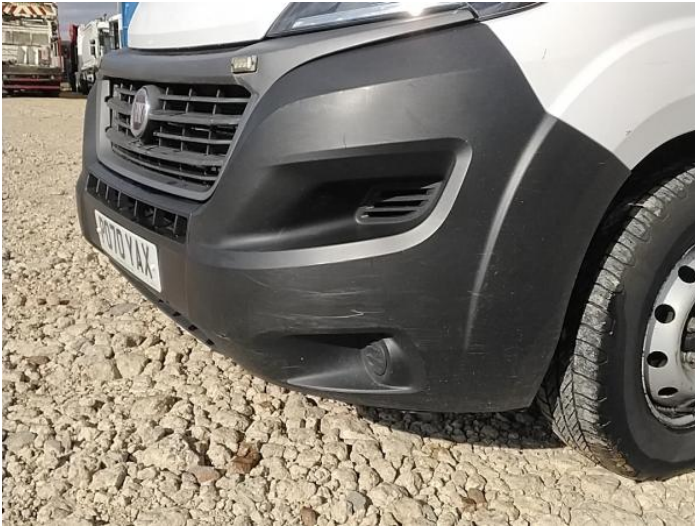
3: Bumper Front Moulding
Scuffed (Unpainted)
UpTo 100mm

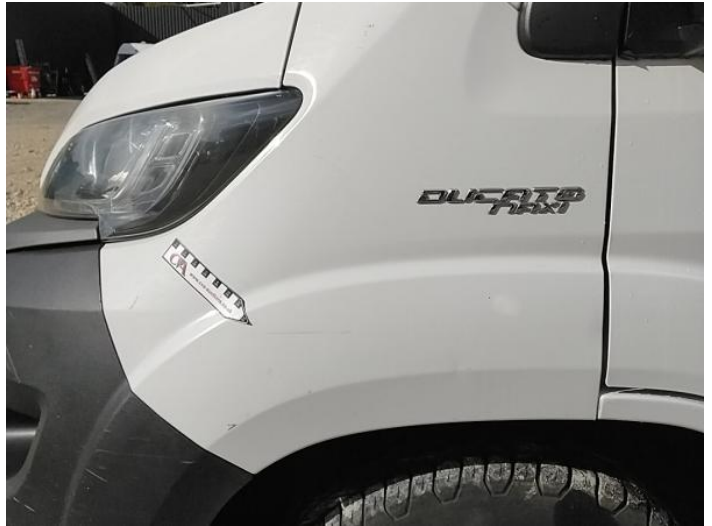
4: Wing nsf
Scratched
Over 25mm Thru Paint

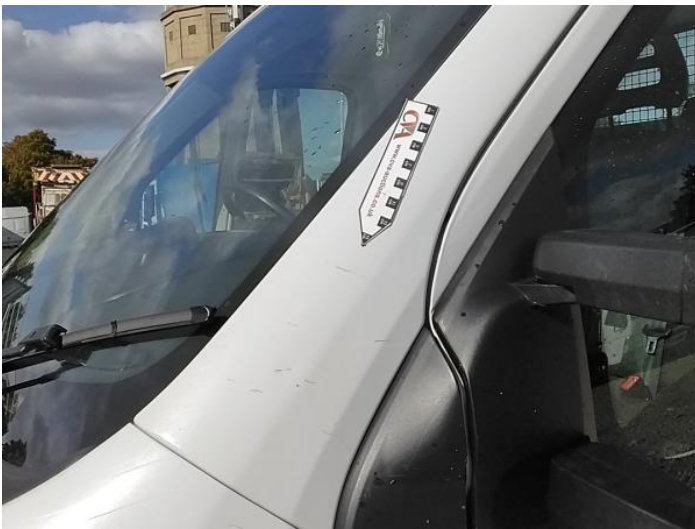
5: A Post ns
Scratched
Over 25mm Thru Paint

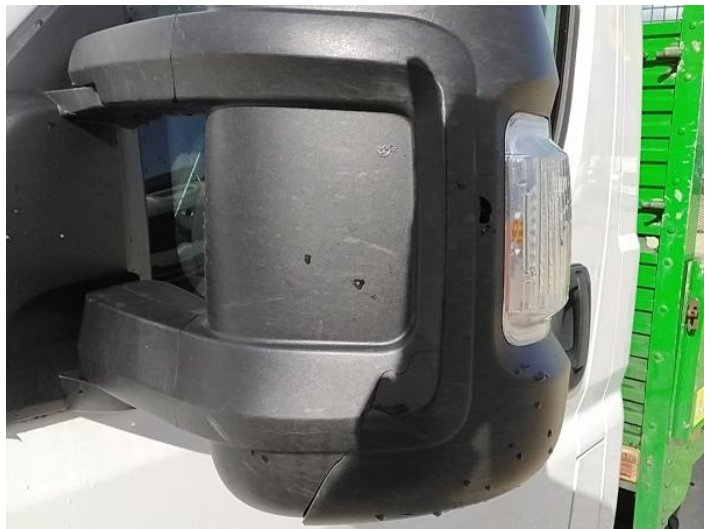
6: Door Mirror Assy nsf
Broken
Replace

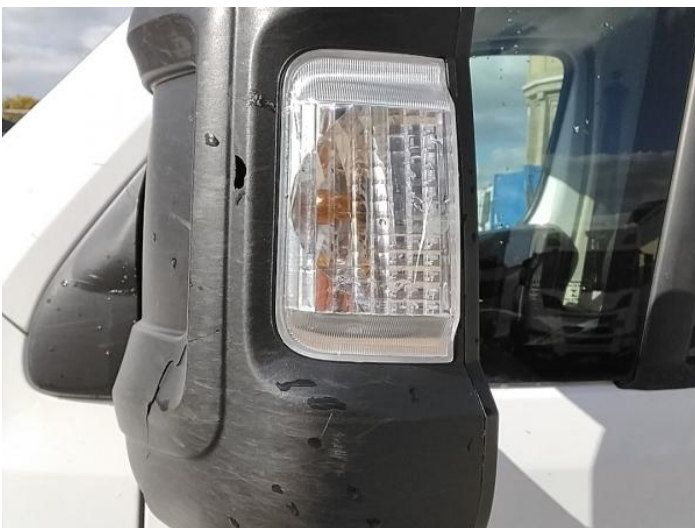
7: Flasher Side Repeater ns
Broken
Replace

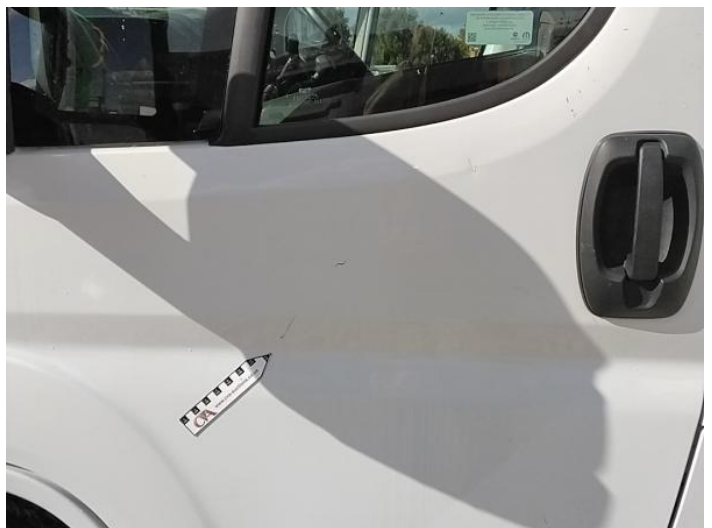
8: Door nsf
Scratched
UpTo 25mm Thru Paint

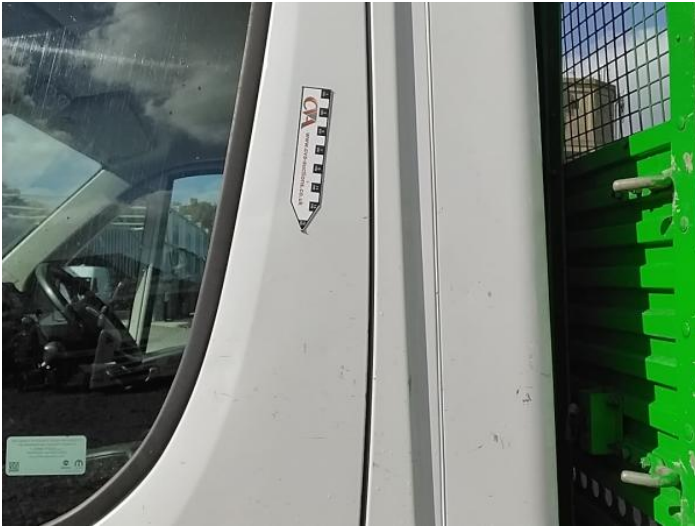
9: Door nsf
Scratched
Over 25mm Thru Paint

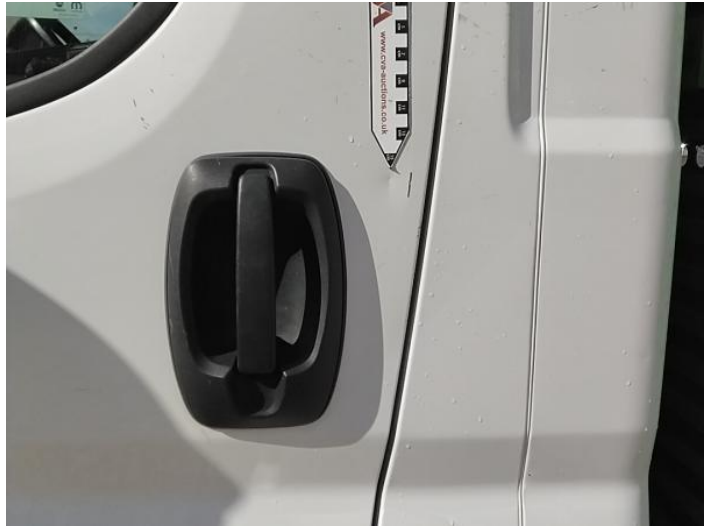
10: Door nsf
Dented
2 Or Less UpTo 10mm

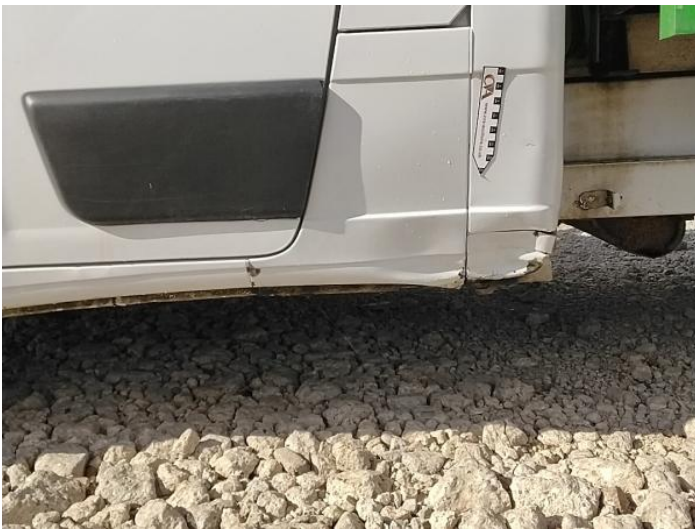
11: Sill ns
Dented
With Paint Damage

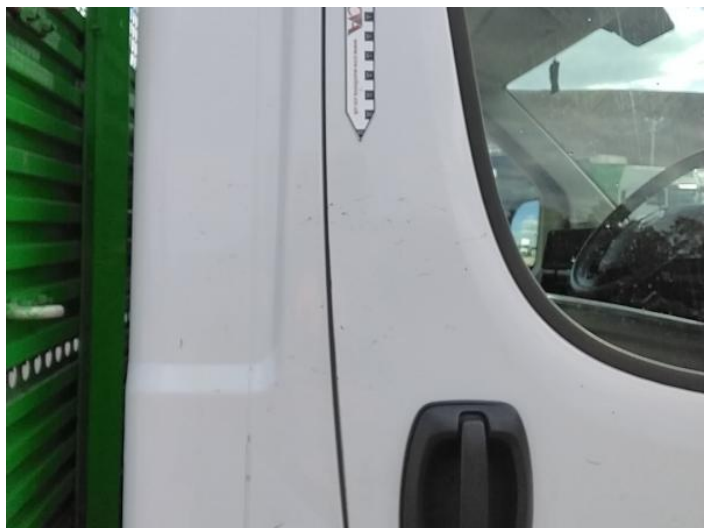
14: Door osf
Scratched
Over 25mm Thru Paint

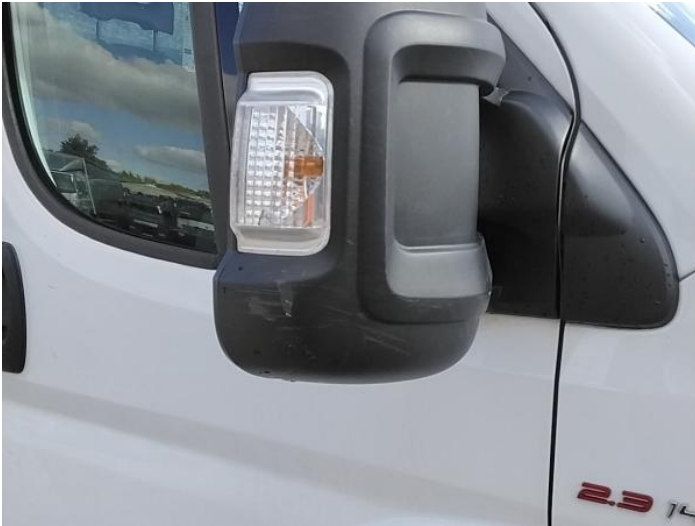
15: Door Mirror Assy osf
Scuffed (Unpainted)
UpTo 100mm

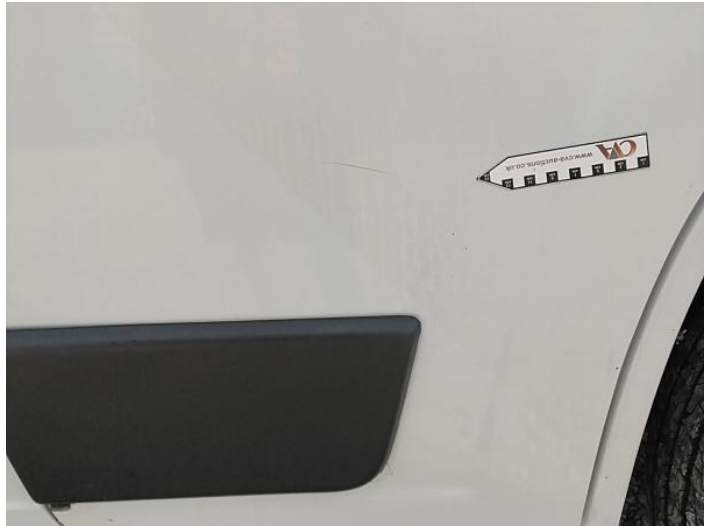
16: Door osf
Dented
2 Or Less UpTo 10mm

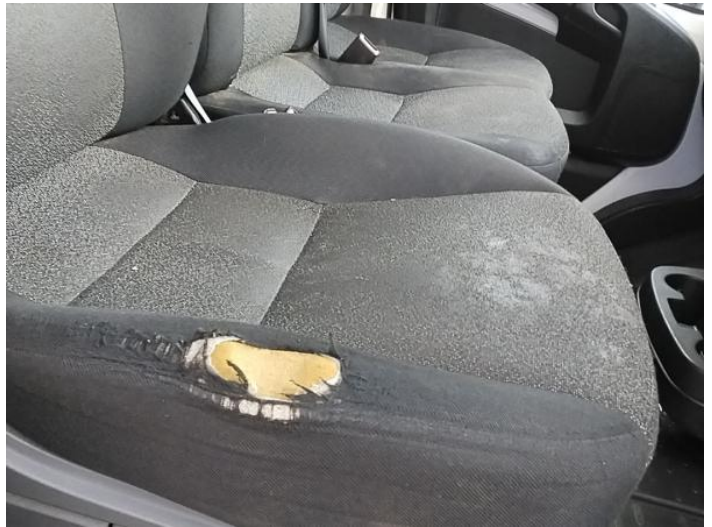
18: Seat Base Cover osf
Holed
Over 3mm
