VEHICLE INSPECTION REPORT

2635100

Iveco Eurocargo 75E16

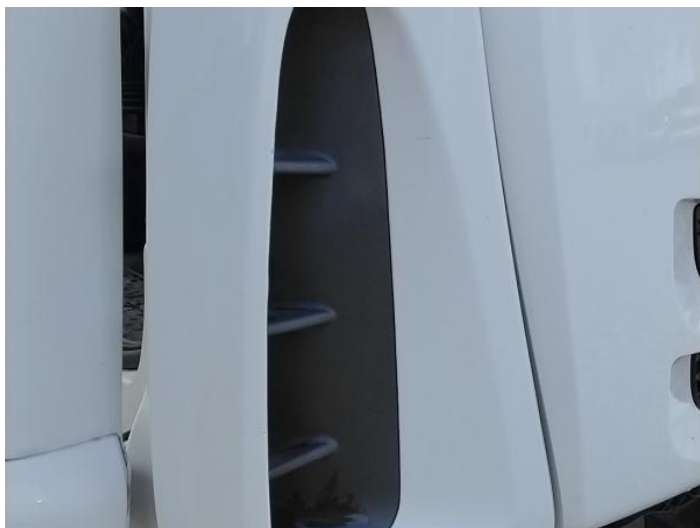
1: Wing osf
Scratched
UpTo 25mm Thru Paint

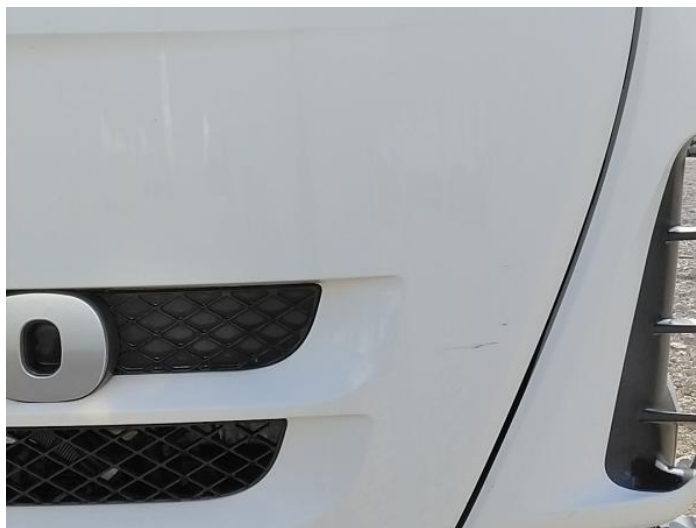
2: Bonnet
Scratched
UpTo 25mm Not Thru Paint

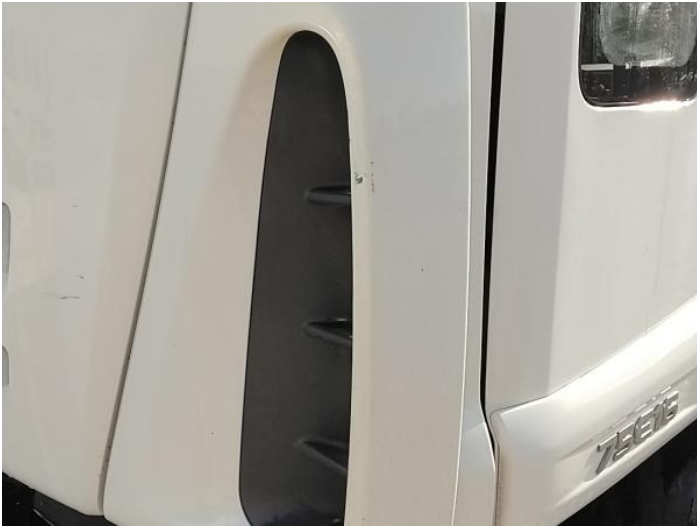
3: Wing nsf
Scratched
UpTo 25mm Not Thru Paint

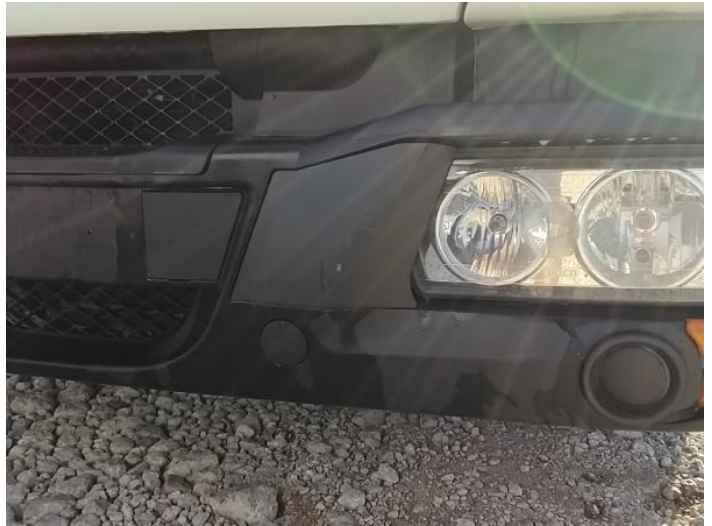
4: Bumper Front Moulding
Scuffed (Unpainted)
UpTo 100mm

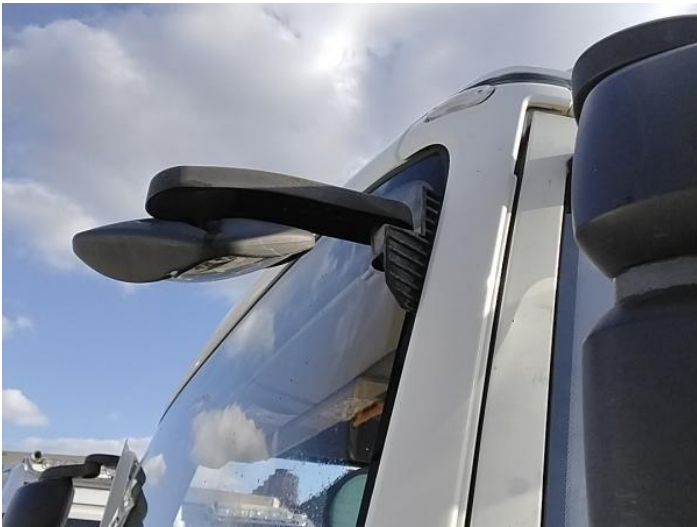
5: Door Mirror Assy nsf
Missing
Replace

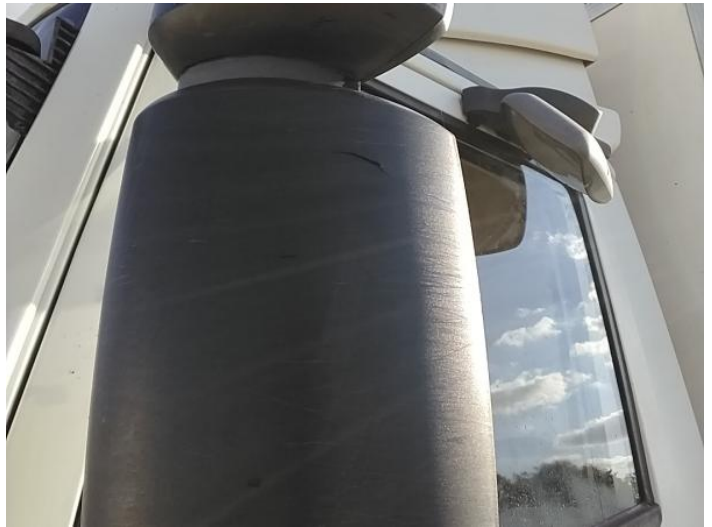
6: Door Mirror Assy nsf
Scuffed (Unpainted)
UpTo 100mm

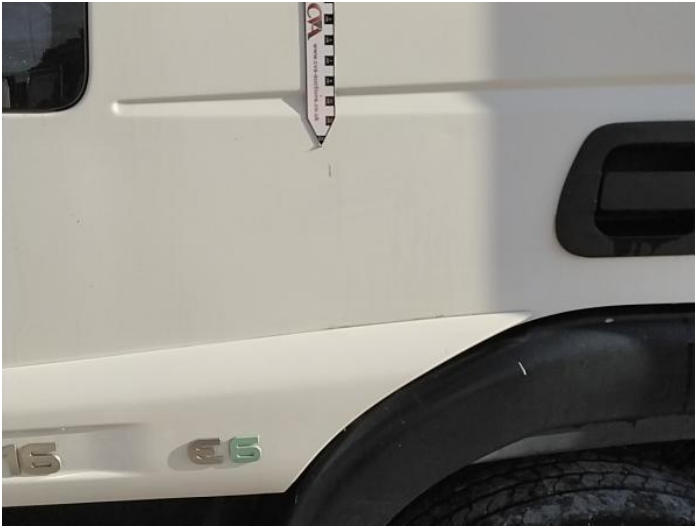
9: Door nsf
 Scratched
 UpTo 25mm Thru Paint

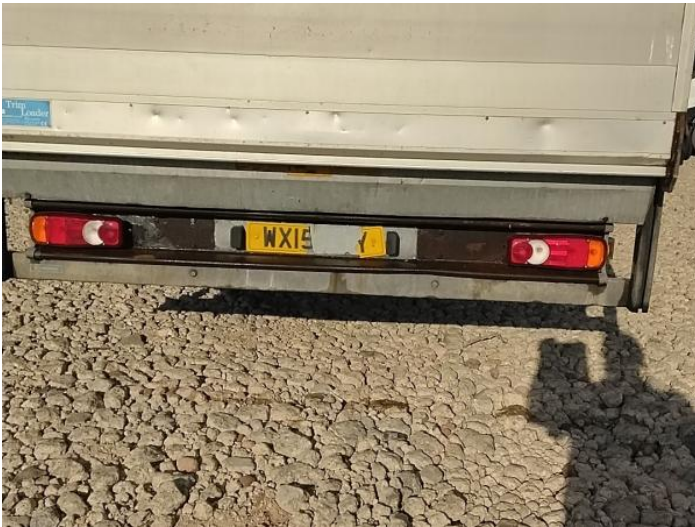
11: Bumper Rear
 Rusted
 Over 5mm

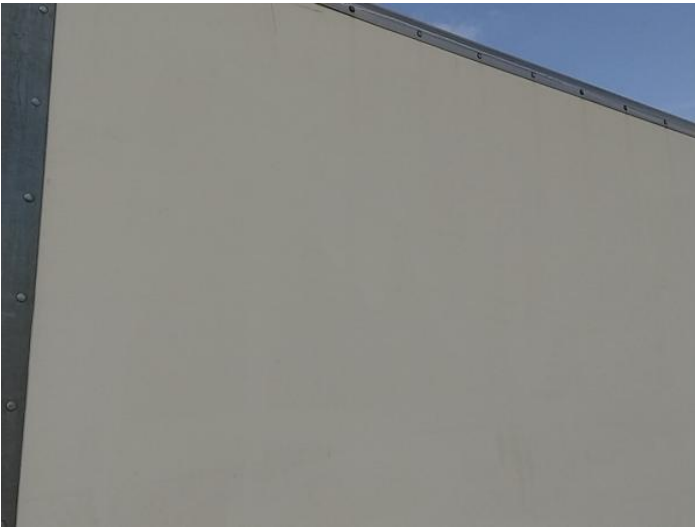
12: Qtr Panel nsr
 Scratched
 Over 25mm Thru Paint

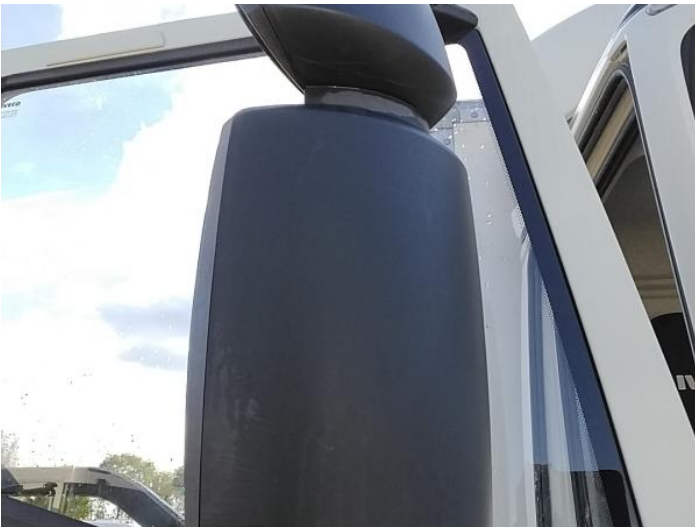
14: Door Mirror Assy osf
 Scuffed (Unpainted)
 UpTo 100mm

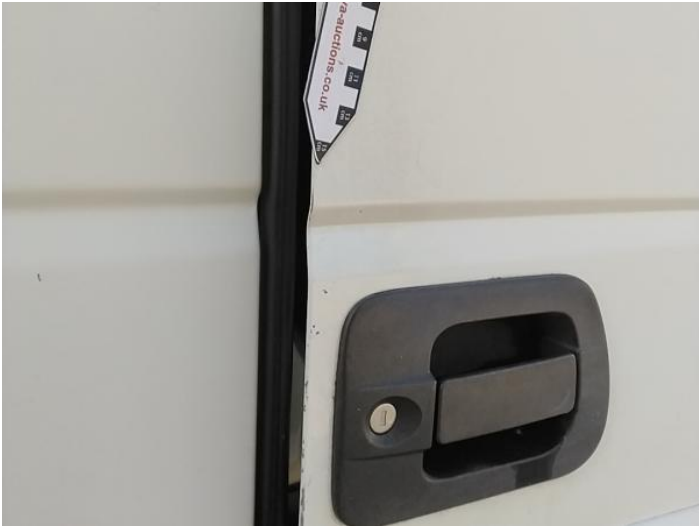
15: Door osf
Chipped
Edge Chip
