VEHICLE INSPECTION REPORT

PF16UAA

Daf CF 460

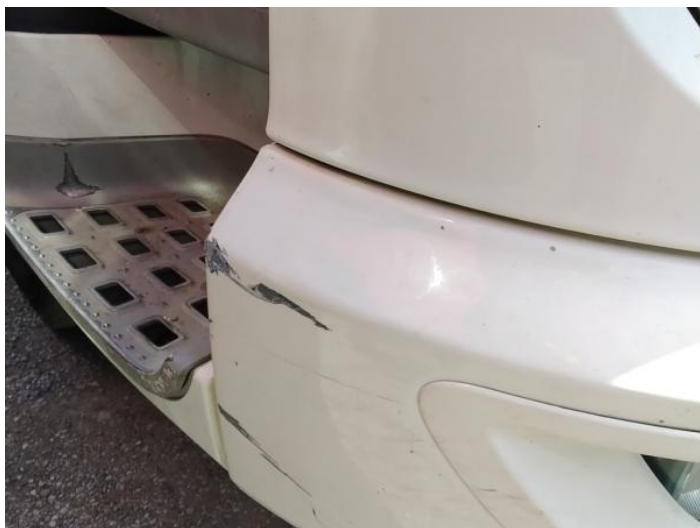
1: Bumper Front
Scratched
Over 100mm Thru Paint

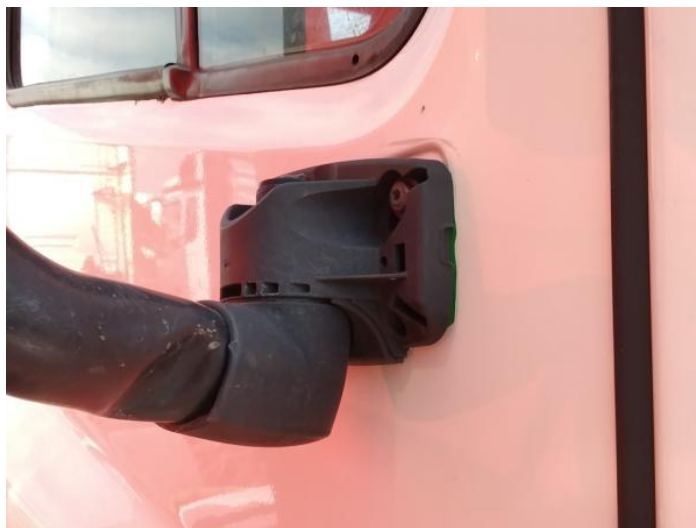
2: Door Mirror Assy nsf
Missing
Replace

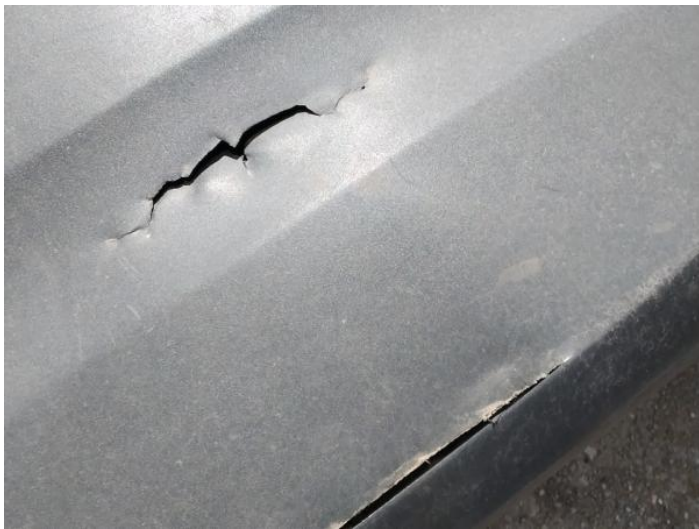
3: Qtr Panel nsr
Cracked
Replace
