VEHICLE INSPECTION REPORT

PF70UOS

Fiat Ducato 35 2.3 Multijet 140PS

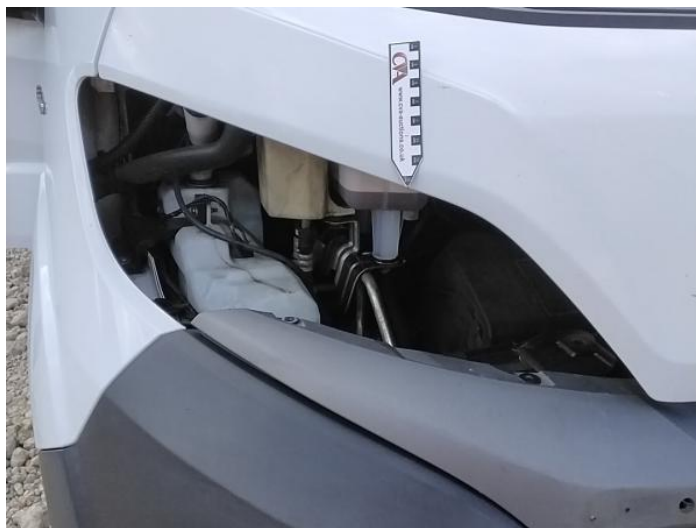
2: Headlamp os
Missing
Replace

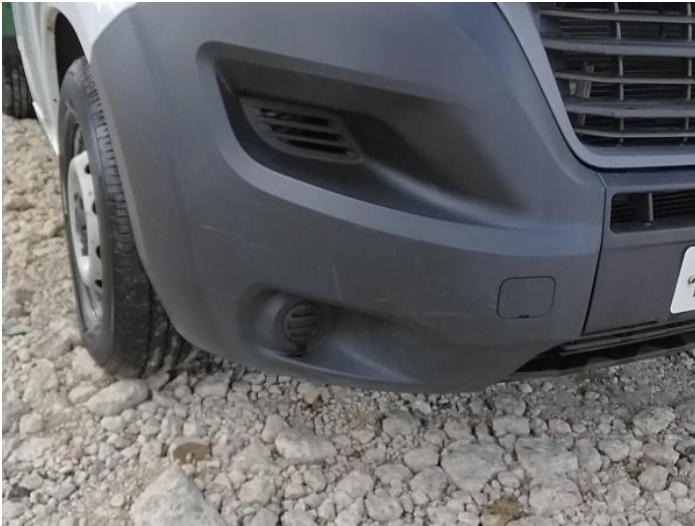
3: Bumper Front Moulding
Scuffed (Unpainted)
UpTo 100mm

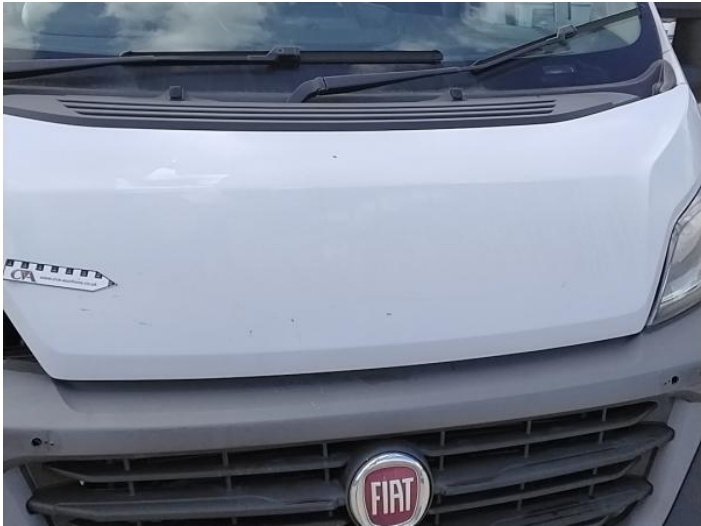
4: Bonnet
Scratched
Over 25mm Thru Paint

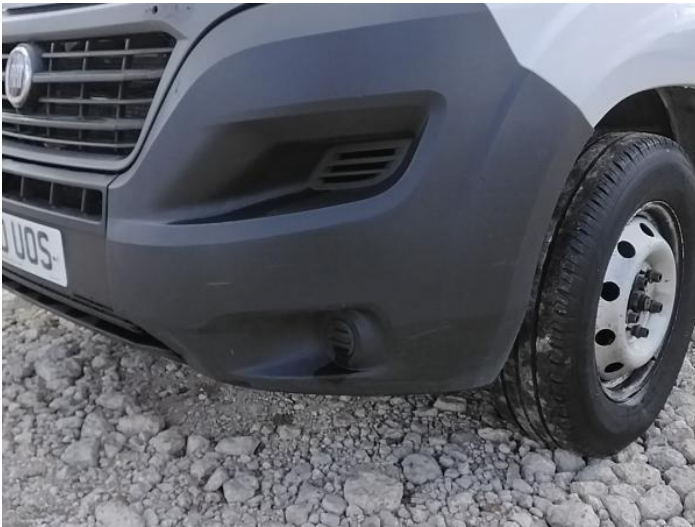
5: Bumper Front Moulding
Scuffed (Unpainted)
UpTo 100mm

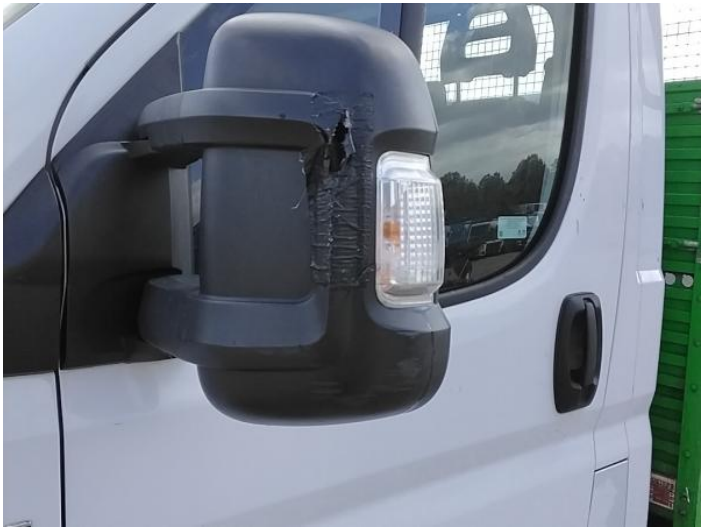
6: Door Mirror Assy nsf
Broken
Replace

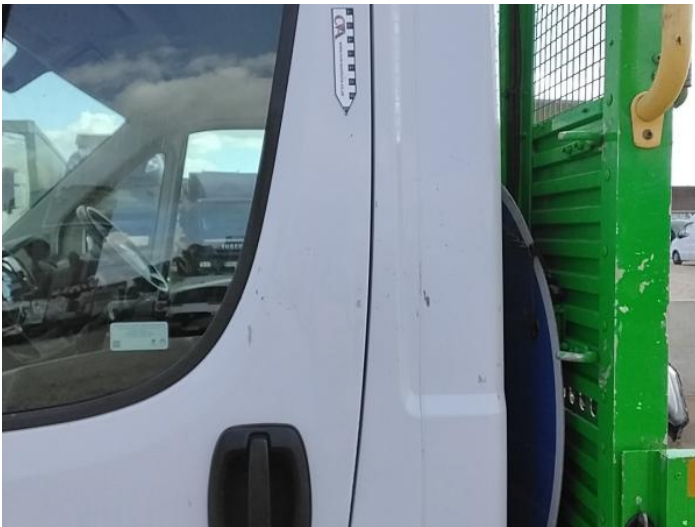
7: Door nsf
Scratched
Over 25mm Thru Paint

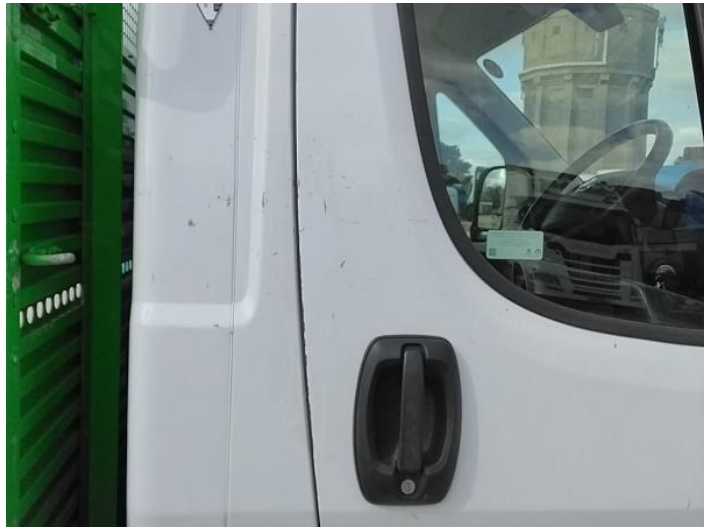
12: Door osf
Scratched
Over 25mm Thru Paint

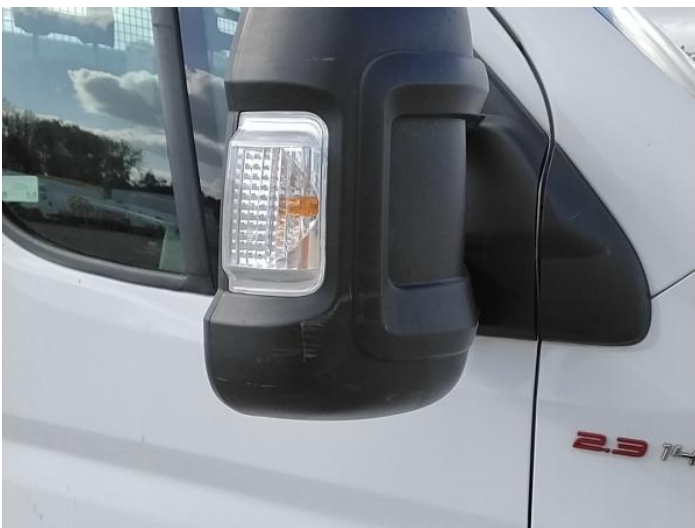
13: Door Mirror Assy osf
Scuffed (Unpainted)
UpTo 100mm

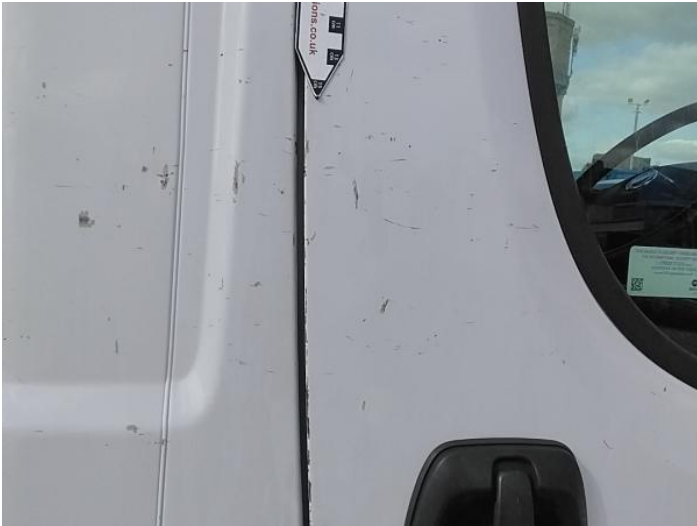
15: Door osf
Chipped
Edge Chip

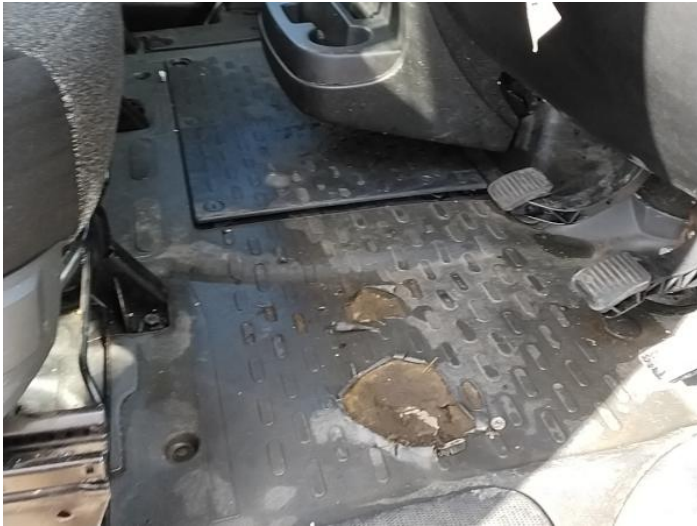
16: Carpets Front
Holed
Over 3mm
