VEHICLE INSPECTION REPORT

FN70AYB

Daf LF 180

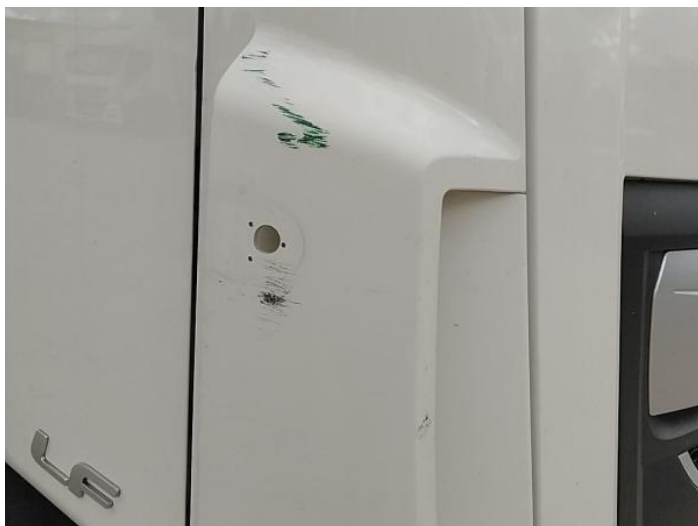
1: Wing of
Scratched
Over 25mm Not Thru Paint

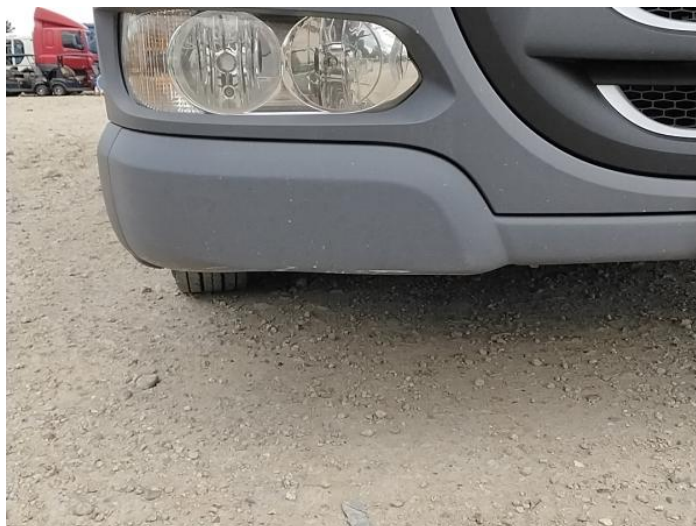
2: Bumper Front Moulding
Scuffed (Unpainted)
Up To 100mm

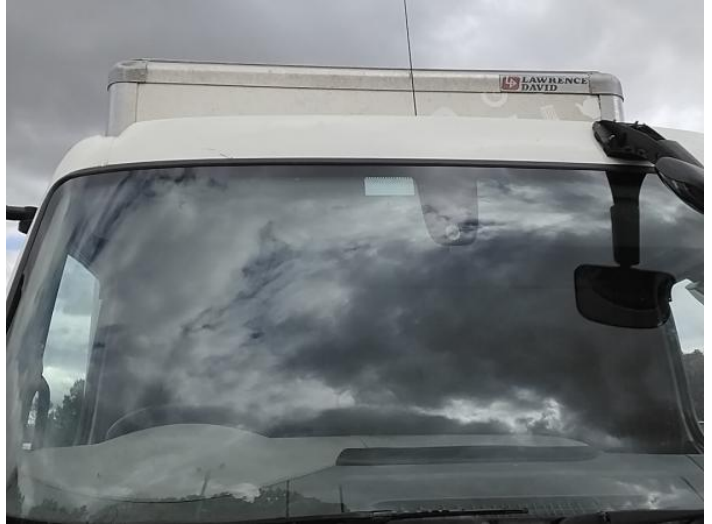
4: Screen Front
Chipped
Over 10mm

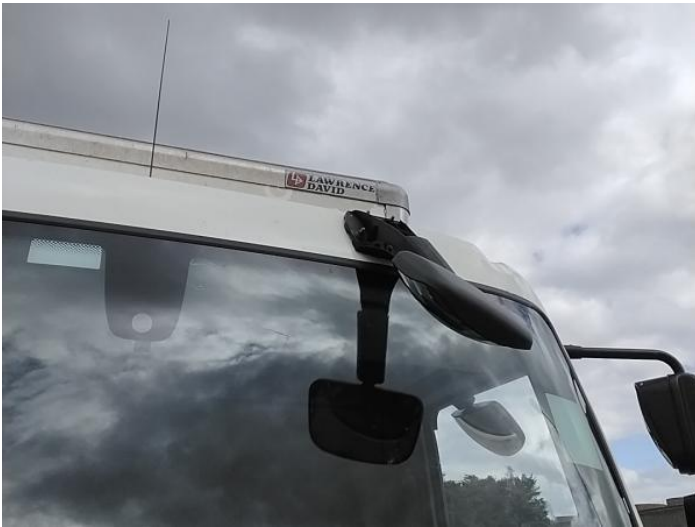
5: Door Mirror Assy nsf
Missing
Replace

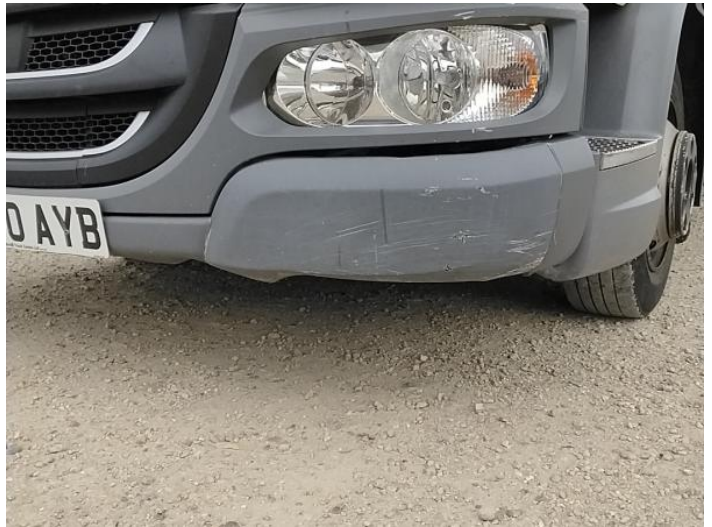
6: Bumper Front Moulding
Scuffed (Unpainted)
UpTo 100mm

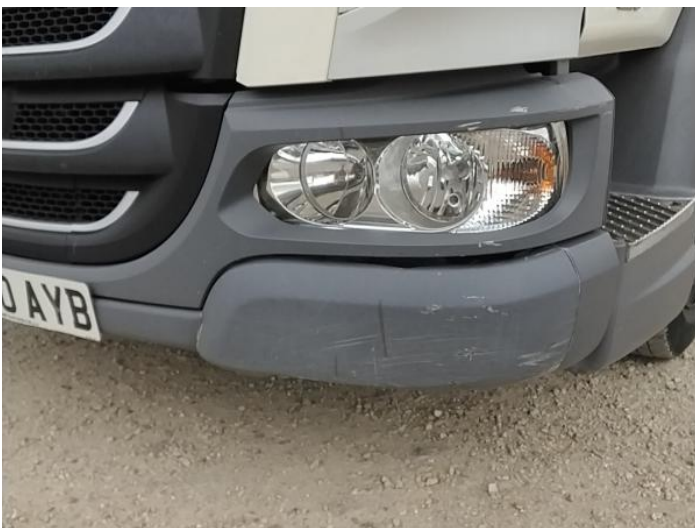
7: Fog Lamp Surround nsf
Scuffed (Unpainted)
UpTo 100mm

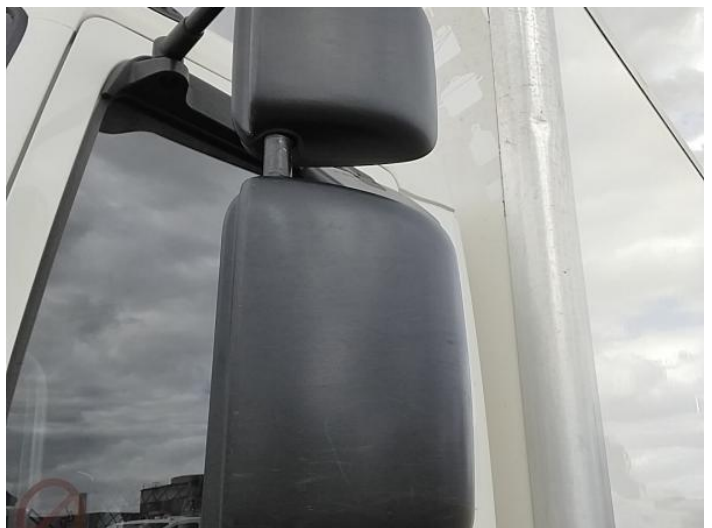
8: Door Mirror Assy nsf
Scuffed (Unpainted)
UpTo 100mm

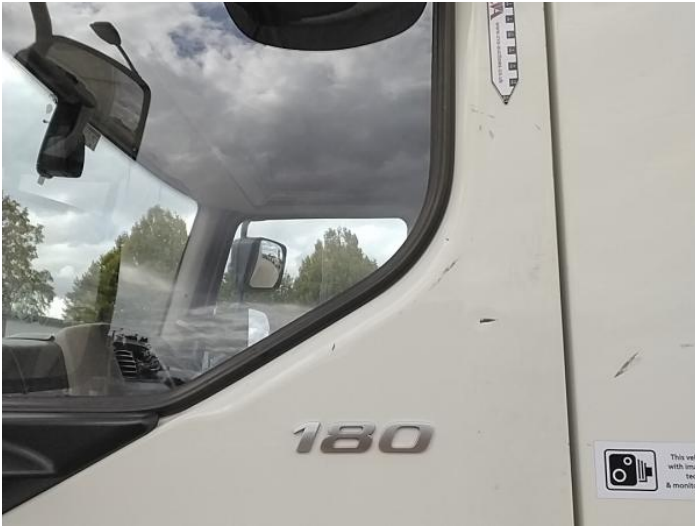
9: Door nsf
Scratched
Over 25mm Not Thru Paint

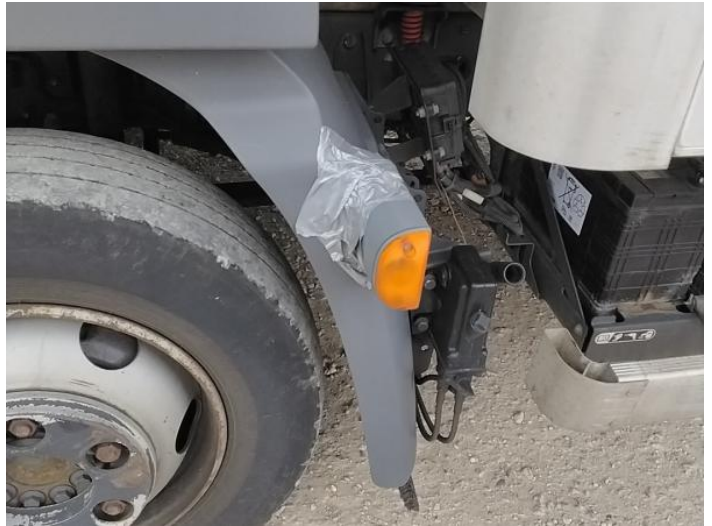
10: Flasher Side Repeater ns
Broken
Replace

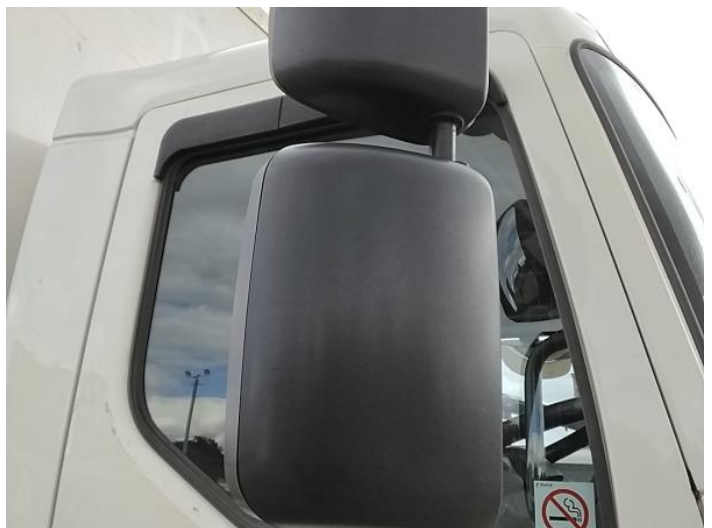
14: Door Mirror Assy osf
Scuffed (Unpainted)
UpTo 100mm

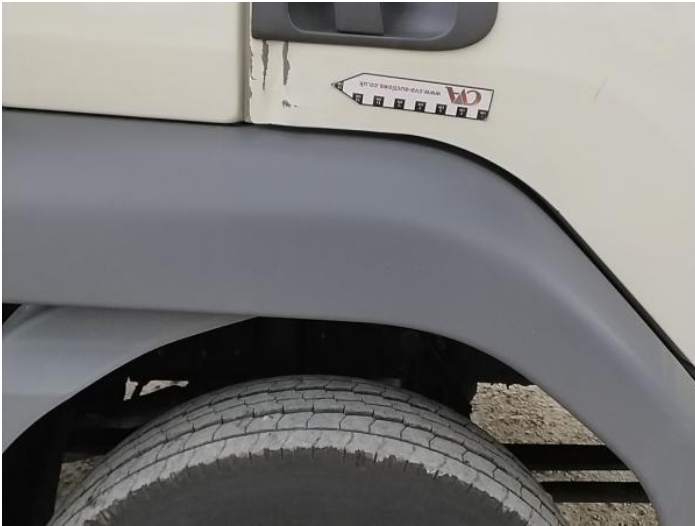
15: Door osf
Dented
With Paint Damage

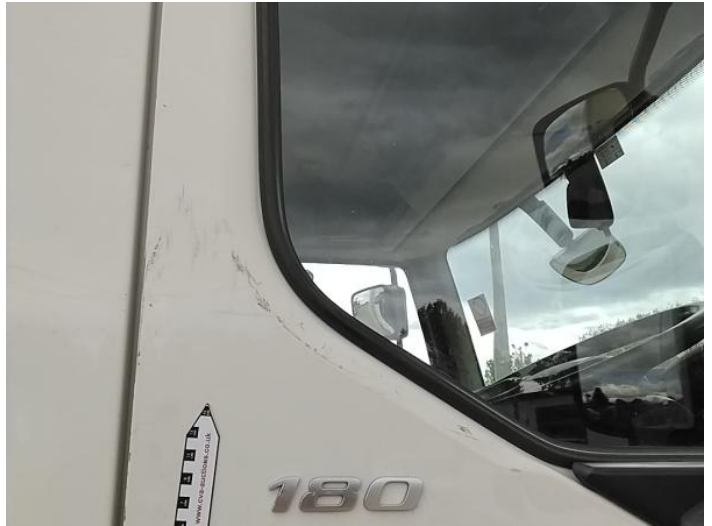
16: Door osf
Scratched
Over 25mm Not Thru Paint

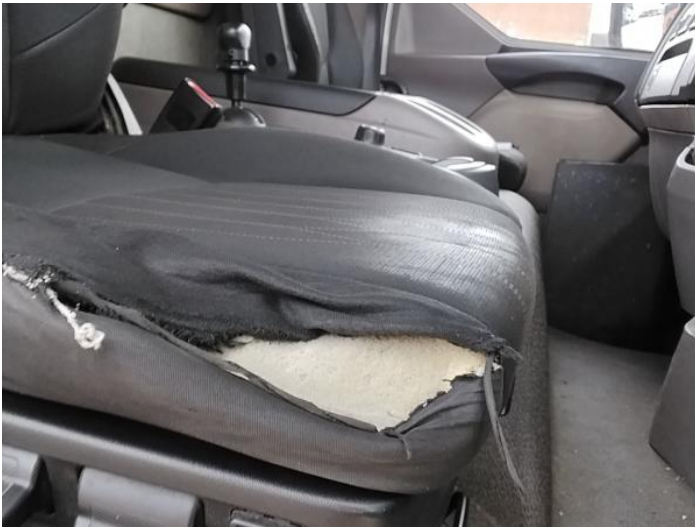
17: Seat Base Cover osf
Holed
Over 3mm

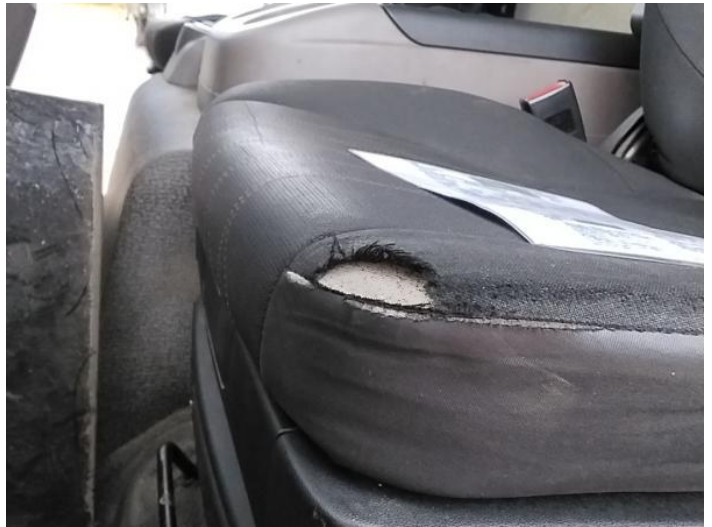
18: Seat Base Cover nsf
Holed
Over 3mm
