VEHICLE INSPECTION REPORT

BT68LVM

Iveco Eurocargo 120-210

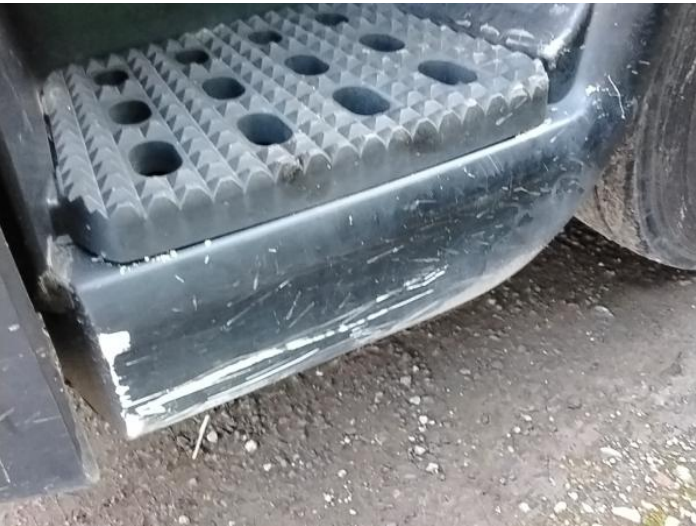
1: Panel Front
Scratched
Over 25mm Not Thru Paint

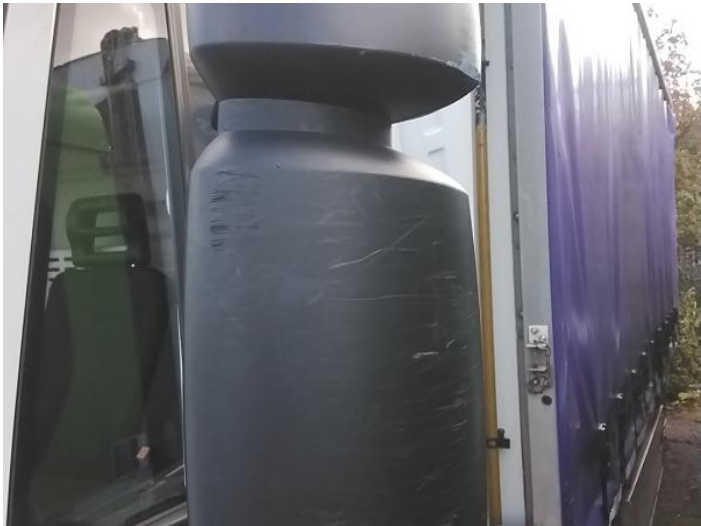
2: Door Mirror Assy nsf
Scuffed (Unpainted)
Over 100mm
