# VEHICLE INSPECTION REPORT

**DG67OTM**

## Man TGM 18.250

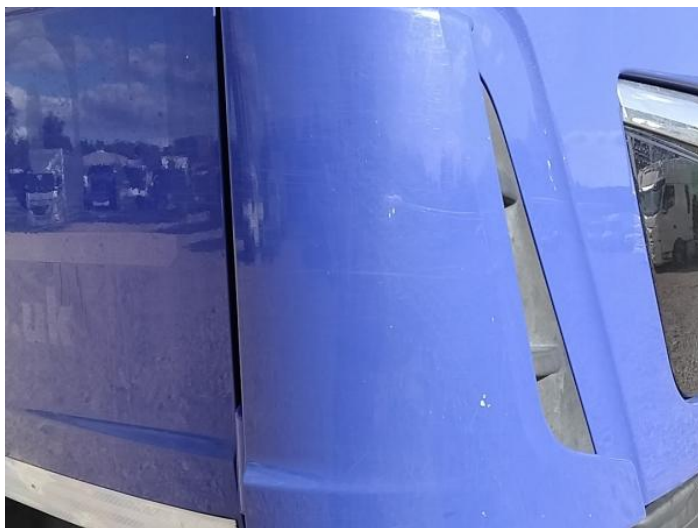
1: Wing osf  
Chipped  
Multiple Chips

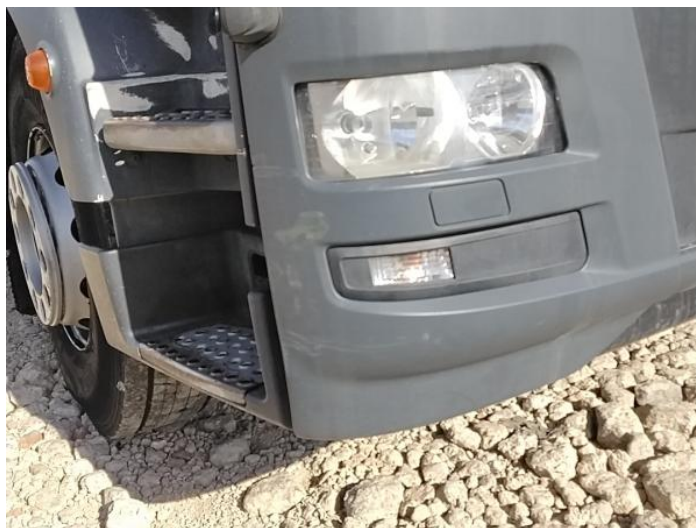
2: Fog Lamp Surround os  
Scuffed (Unpainted)  
UpTo 100mm

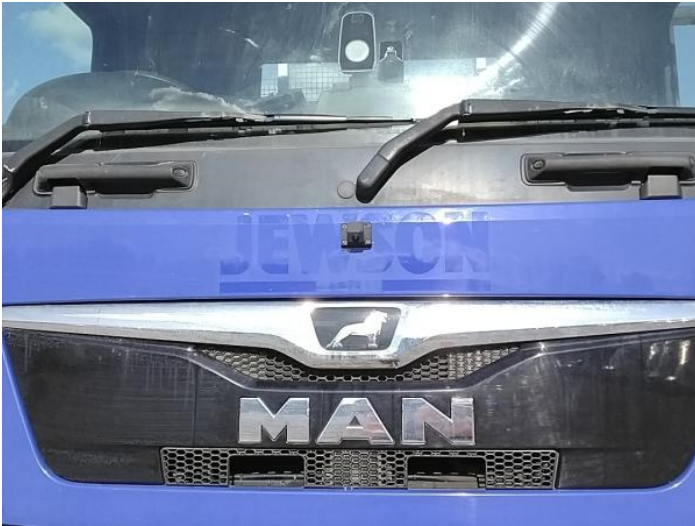
3: Bonnet  
Chipped  
Multiple Chips

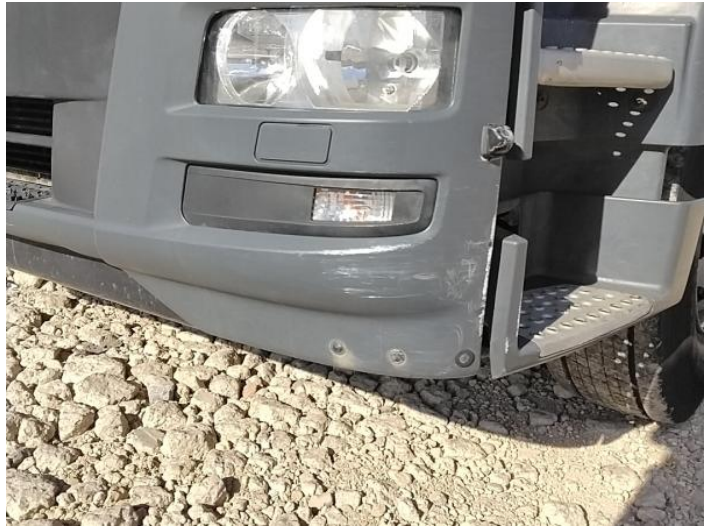
4: Fog Lamp Surround ns  
Scuffed (Unpainted)  
UpTo 100mm

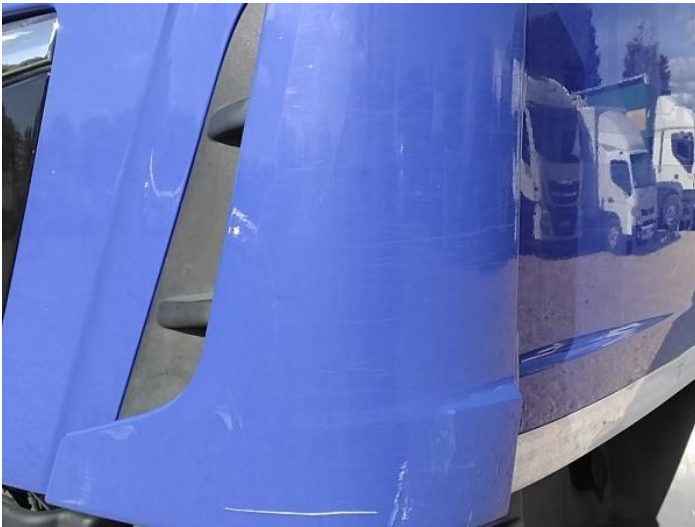
5: Wing nsf  
Scratched  
UpTo 25mm Thru Paint

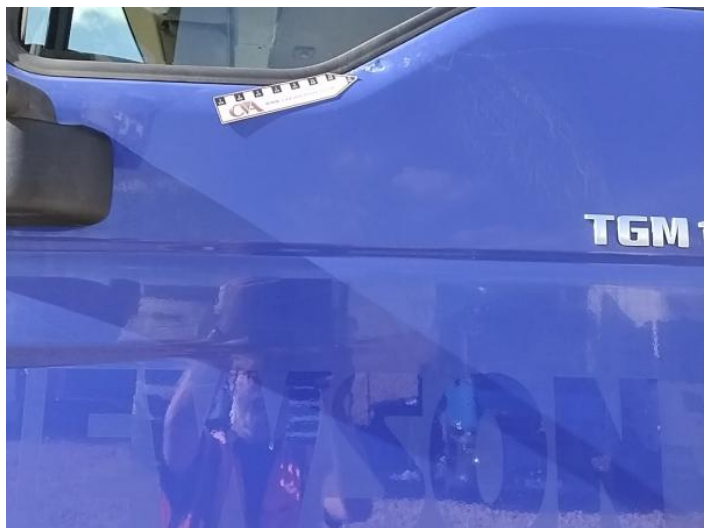
8: Door nsf  
Dented  
Between 10mm + 30mm

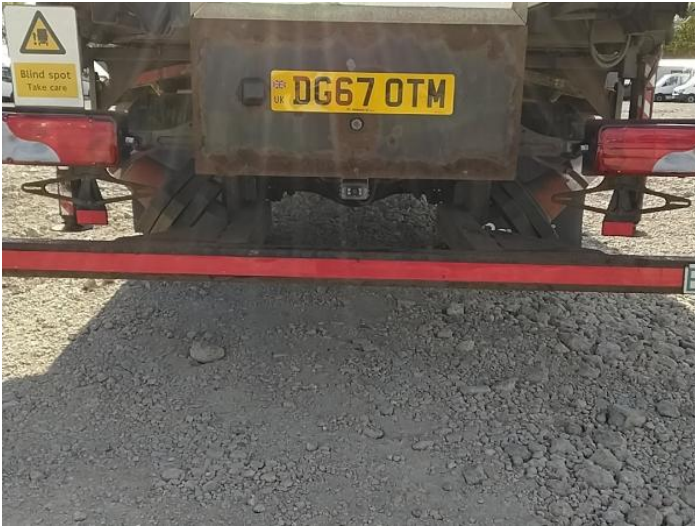
9: Bumper Rear  
Rusted  
Over 5mm

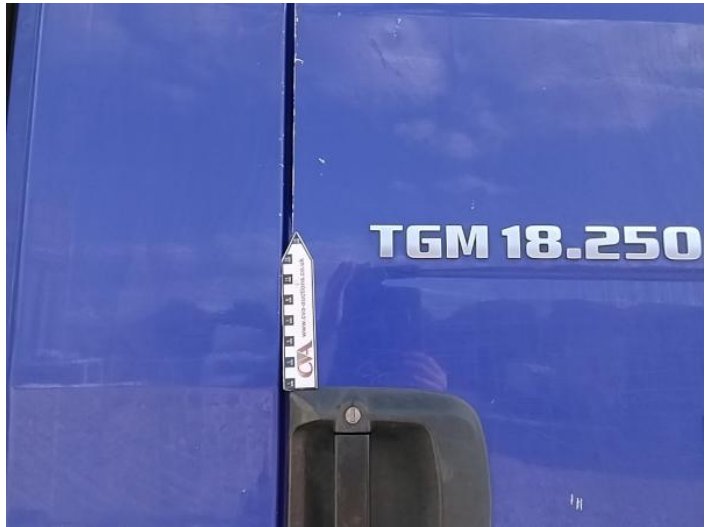
12: Door osf  
Chipped  
Edge Chip

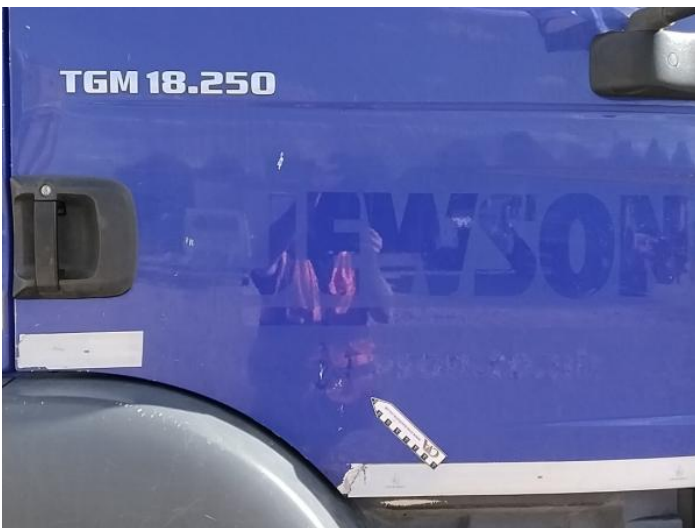
13: Door osf  
Scratched  
UpTo 25mm Thru Paint

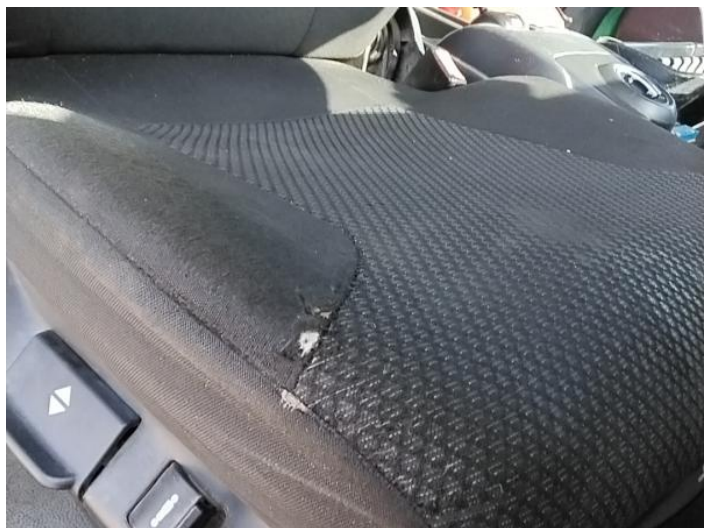
14: Seat Base Cover osf  
Holed  
Over 3mm

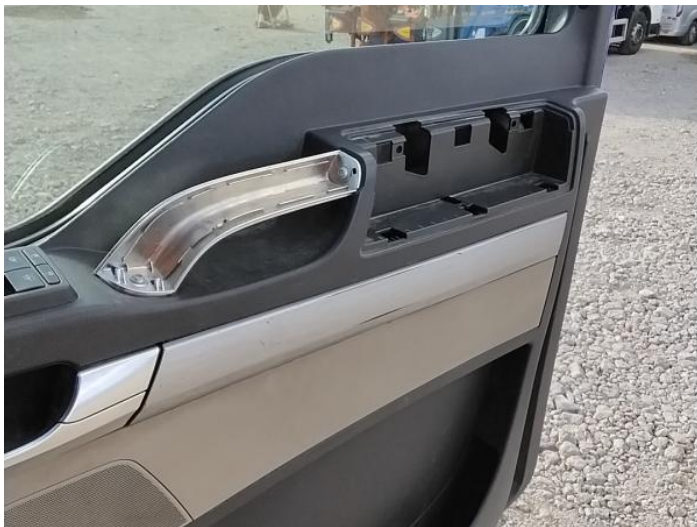
15: Handle Inner osf  
Damaged  
Replace

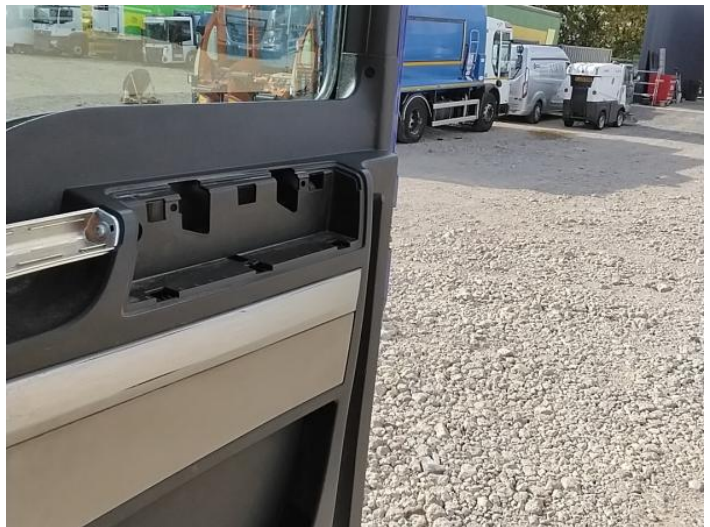
16: Door Pad osf  
Missing  
Replace
