# VEHICLE INSPECTION REPORT

**KX17MLV**

## Daf LF 230

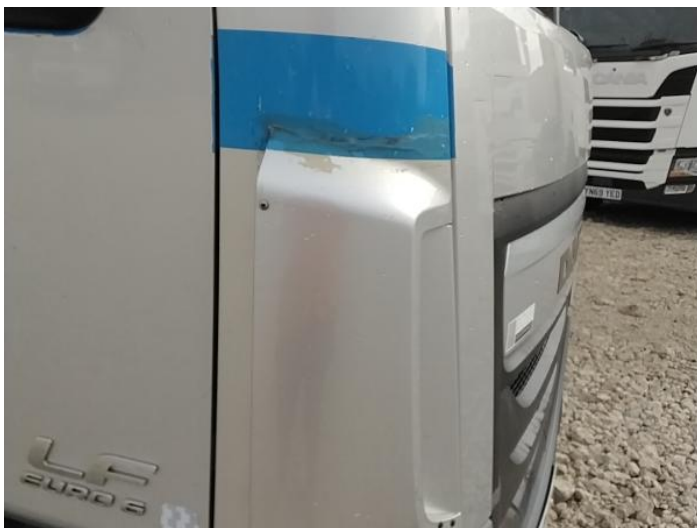
1: Wing of  
Cracked  
Replace

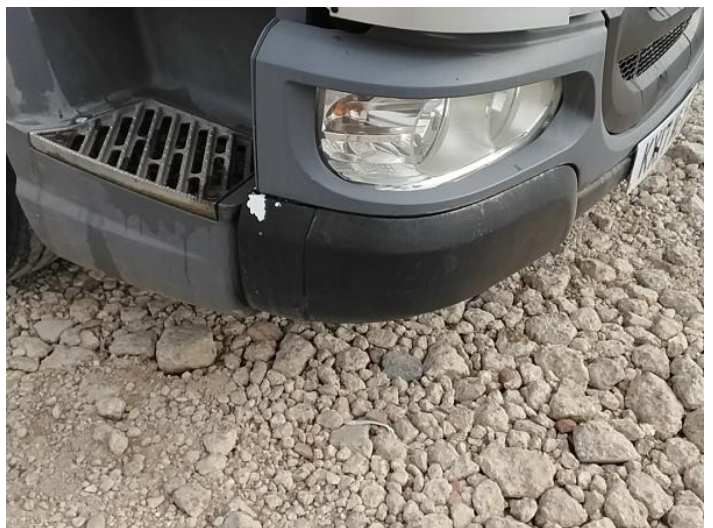
2: Bumper Front Moulding  
Scratched (Painted)  
Up To 25mm Thru Paint

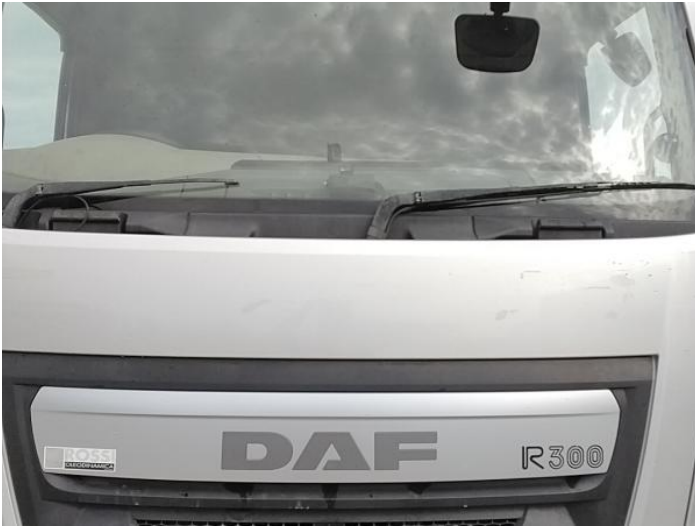
3: Bonnet  
Scratched  
Over 25mm Not Thru Paint

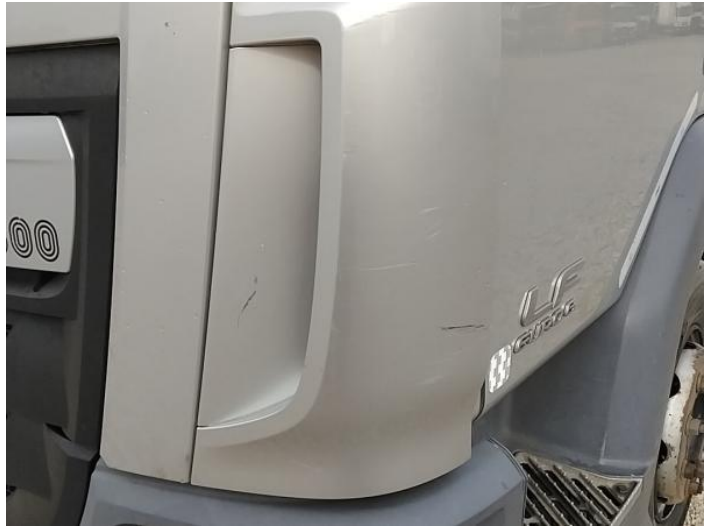
4: Wing nsf  
Scratched  
Over 25mm Not Thru Paint

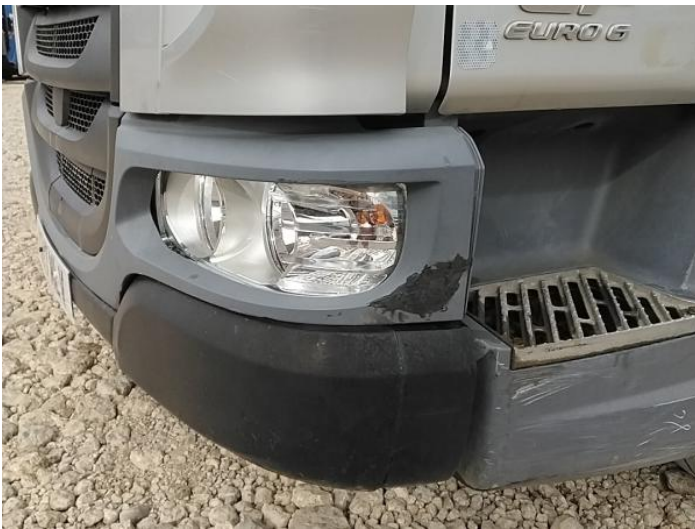
5: Fog Lamp Surround ns  
Scuffed (Unpainted)  
UpTo 100mm

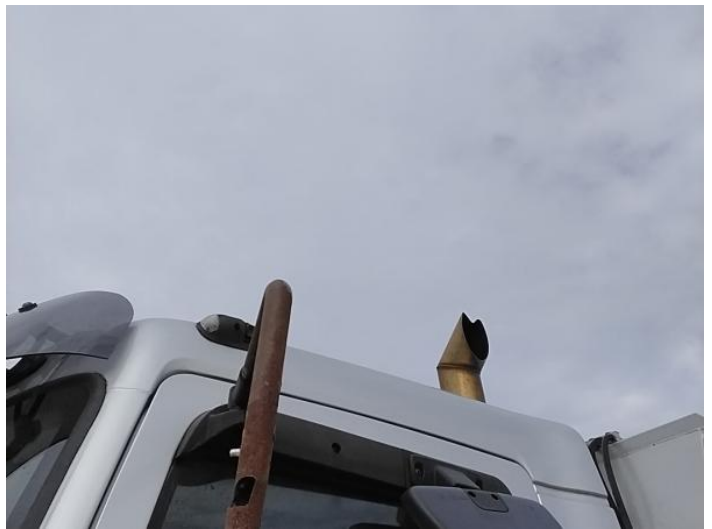
6: Door Mirror Assy nsf  
Missing  
Replace

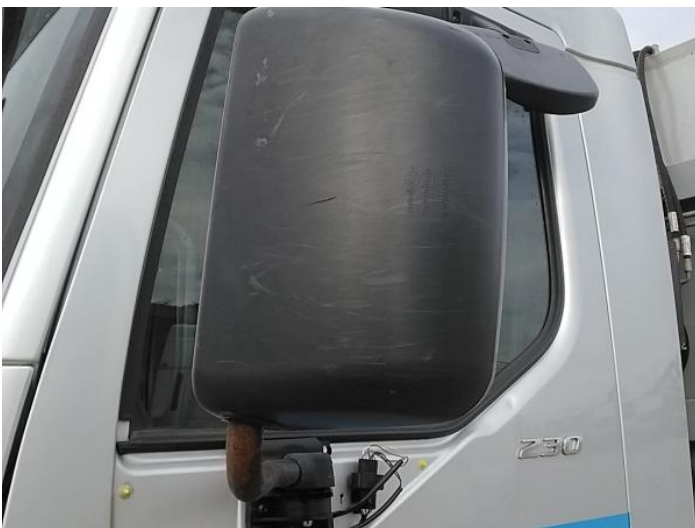
7: Door Mirror Assy nsf  
Scuffed (Unpainted)  
UpTo 100mm

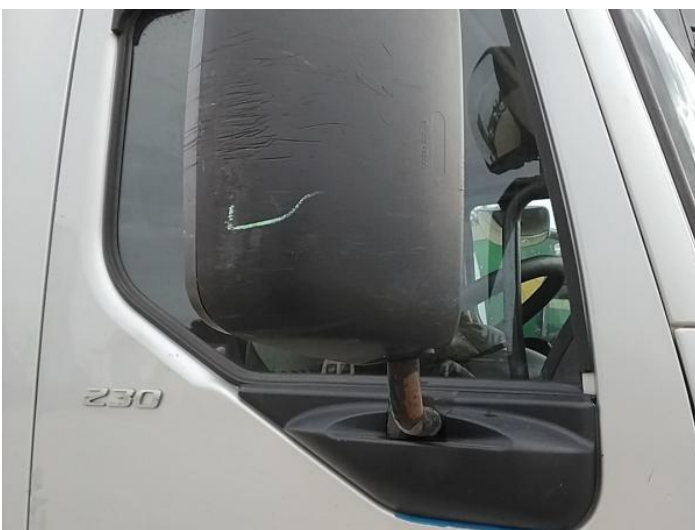
13: Door Mirror Assy osf  
Scuffed (Unpainted)  
UpTo 100mm

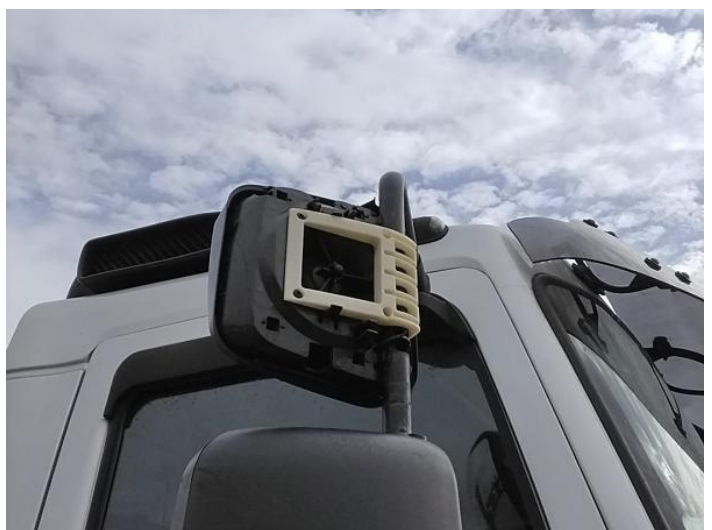
14: Door Mirror Assy osf  
Missing  
Replace

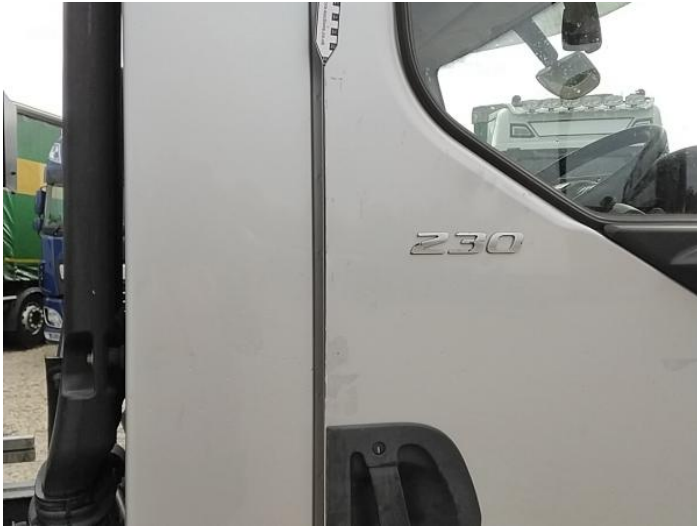
16: Door osf  
Chipped  
Edge Chip
