VEHICLE INSPECTION REPORT

SH71GHA

Fiat Doblo 1.6 Multijet 16V

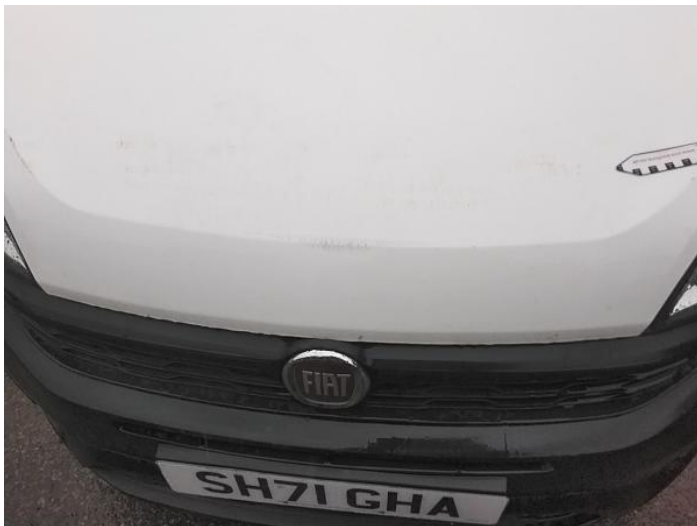
1: Bonnet
Scratched
Over 25mm Thru Paint

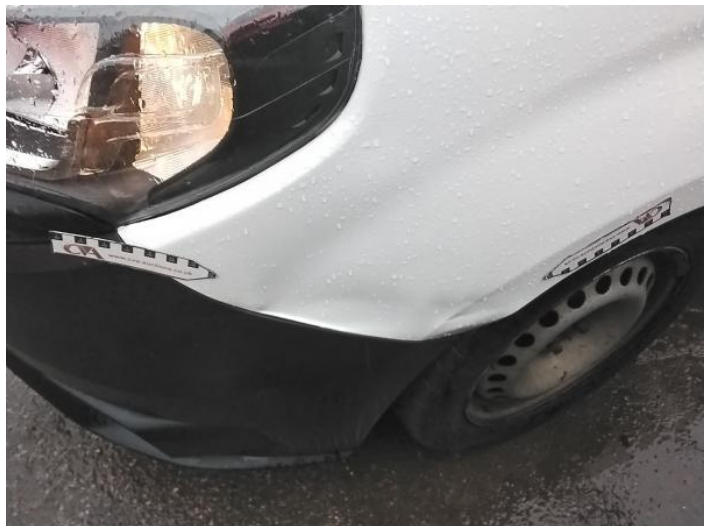
2: Wing nsf
Dented
Over 30mm

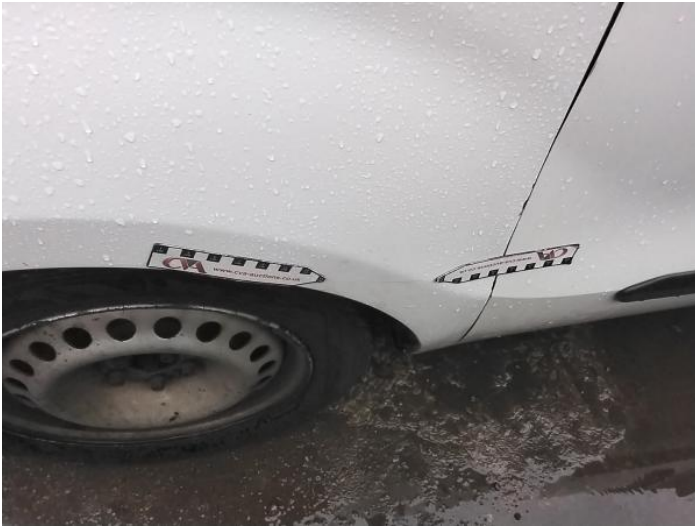
3: Wing nsf
Dented
With Paint Damage

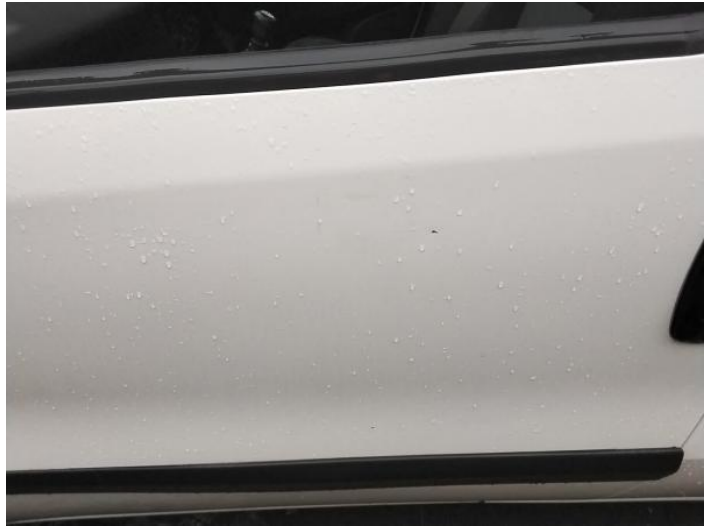
4: Door nsf
Chipped
Multiple Chips

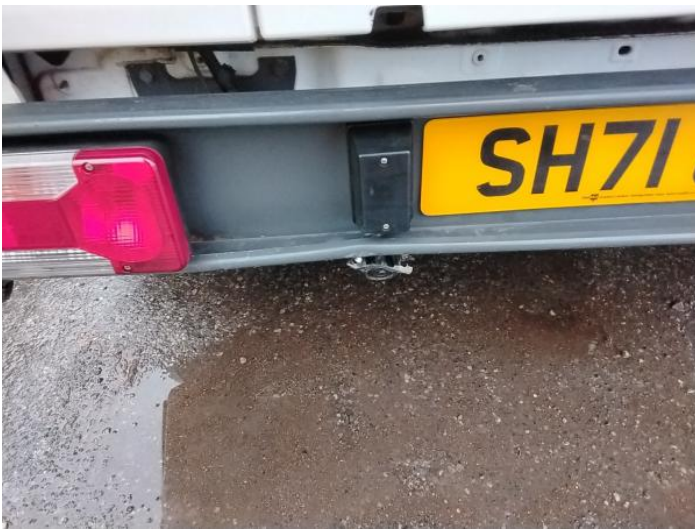
5: Bumper Rear
Dented
With Paint Damage

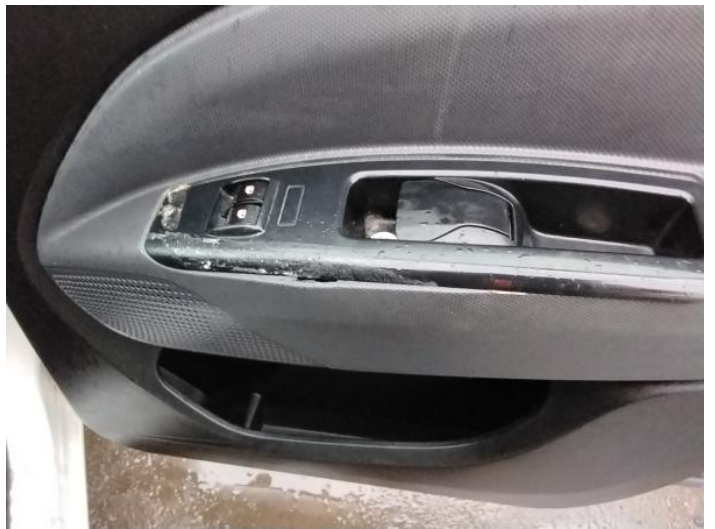
6: Door Pad osf
Broken
Replace

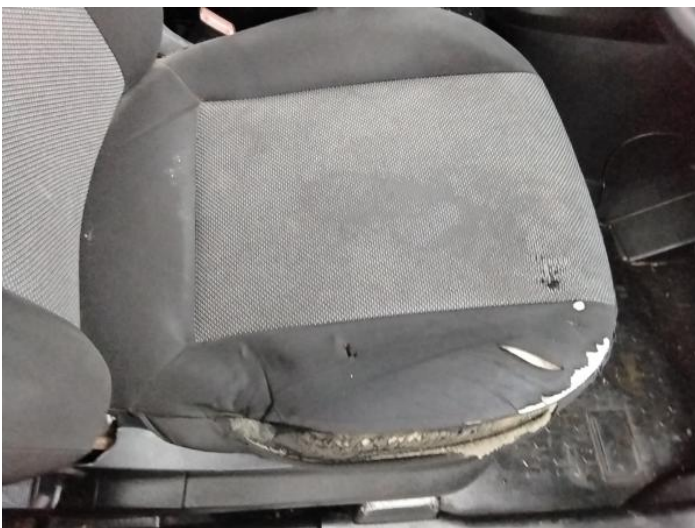
7: Seat Base Cover osf
Torn
Over 3mm

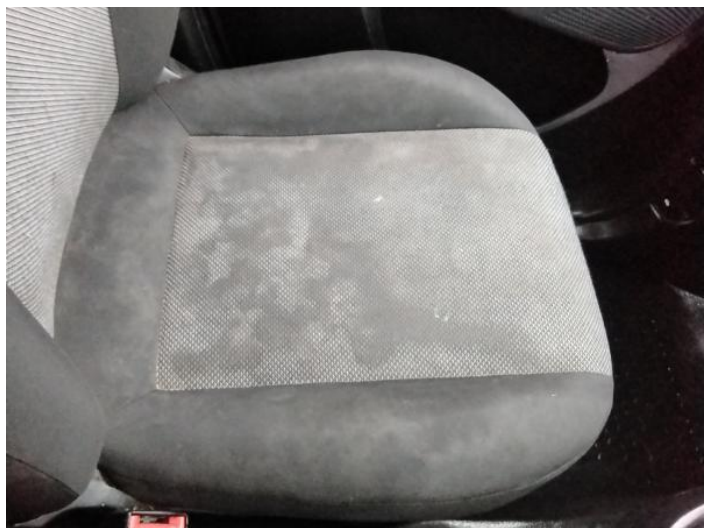
8: Seat Base Cover nsf
Soiled
Heavy

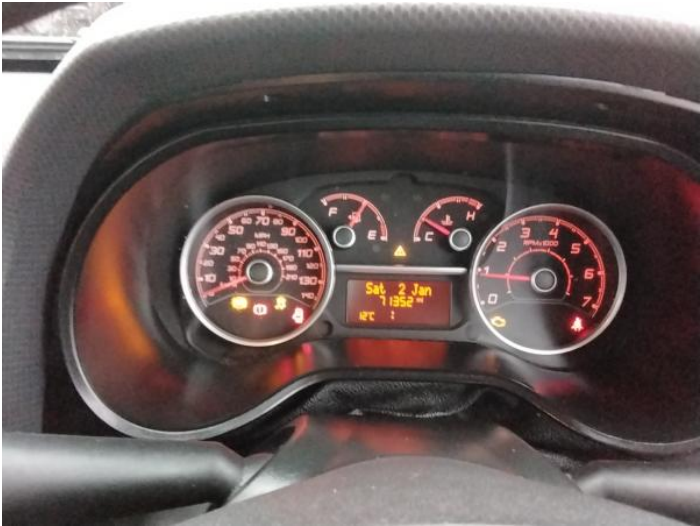
WARNING LIGHTS ON DASH AD-BLUE

9: Dash Warning Lights
Displayed
No Action
