VEHICLE INSPECTION REPORT

HK17XYF

Daf CF 330

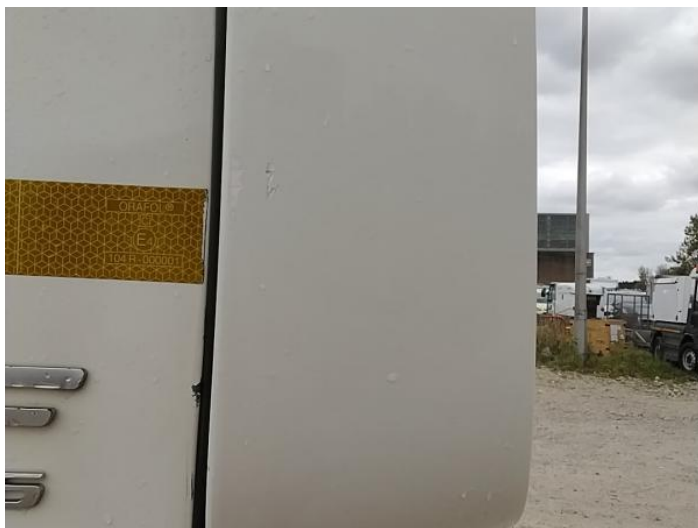
1: Wing osf
Scratched
UpTo 25mm Thru Paint

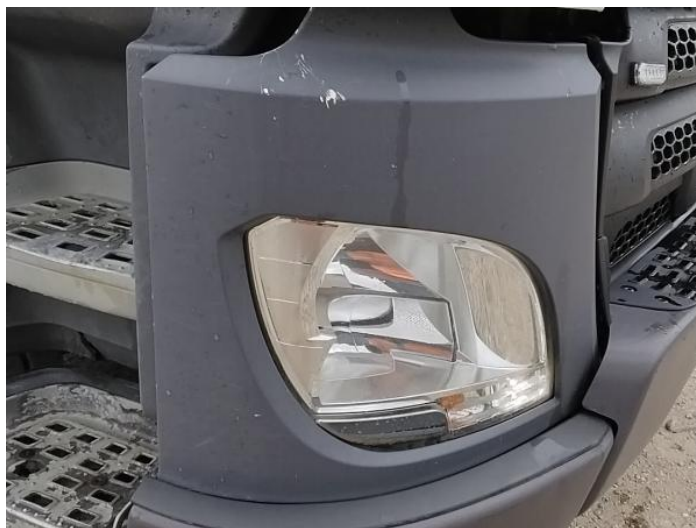
2: Fog Lamp Surround os
Scratched (Painted)
UpTo 25mm Thru Paint

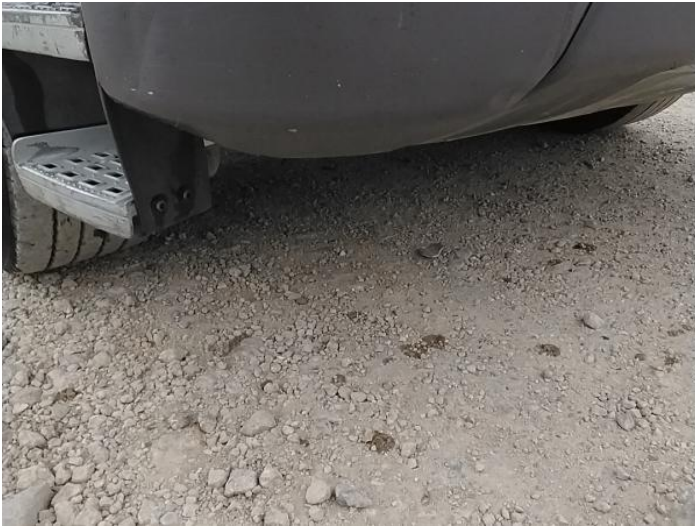
3: Bumper Front Moulding
Scratched (Painted)
UpTo 25mm Thru Paint

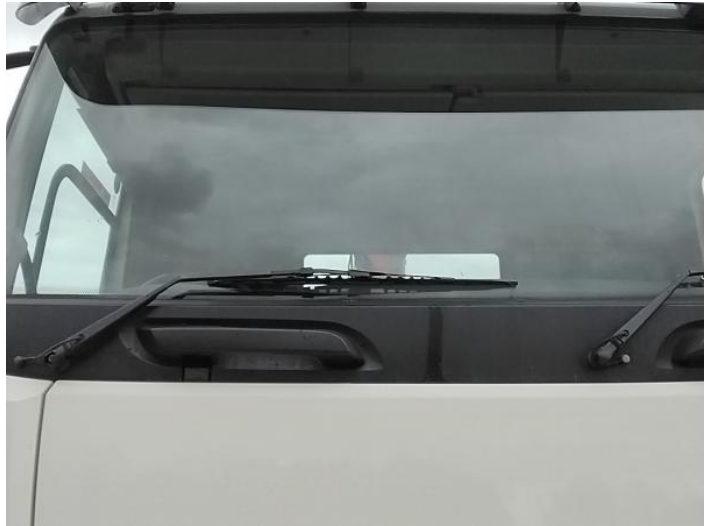
4: Screen Front
Chipped
Over 10mm

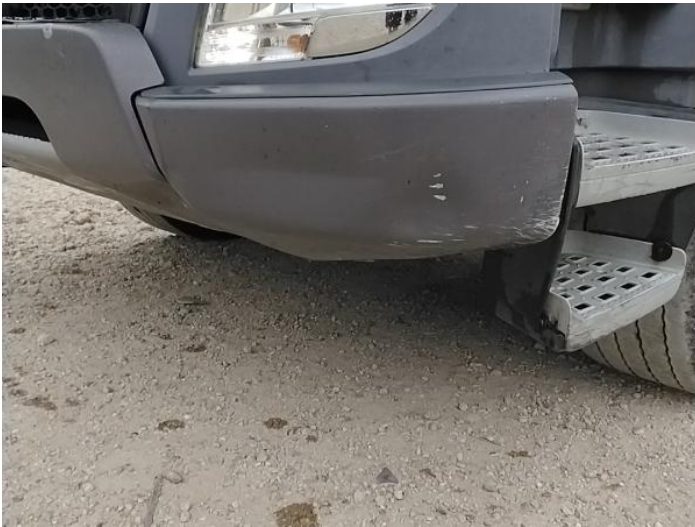
5: Bumper Front Moulding
Scratched (Painted)
Over 25mm Thru Paint

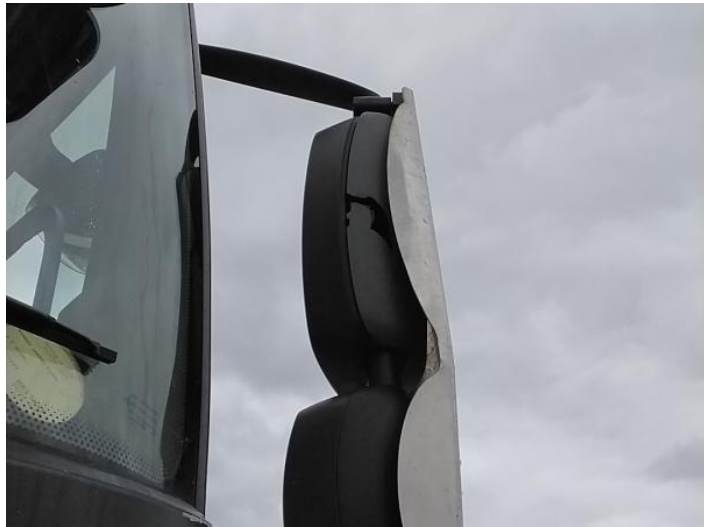
6: Door Mirror Assy nsf
Broken
Replace

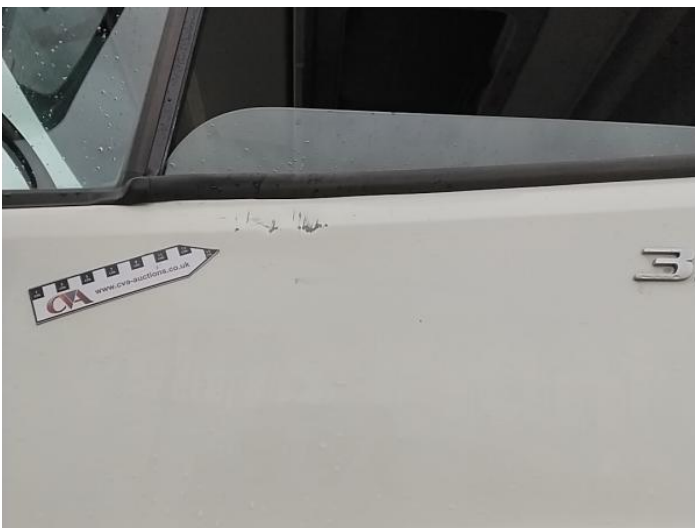
7: Door nsf
Dented
With Paint Damage

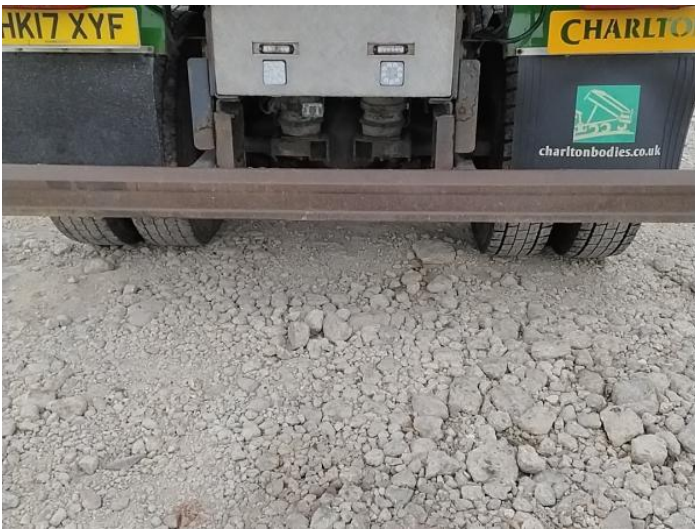
11: Bumper Rear
Rusted
Over 5mm

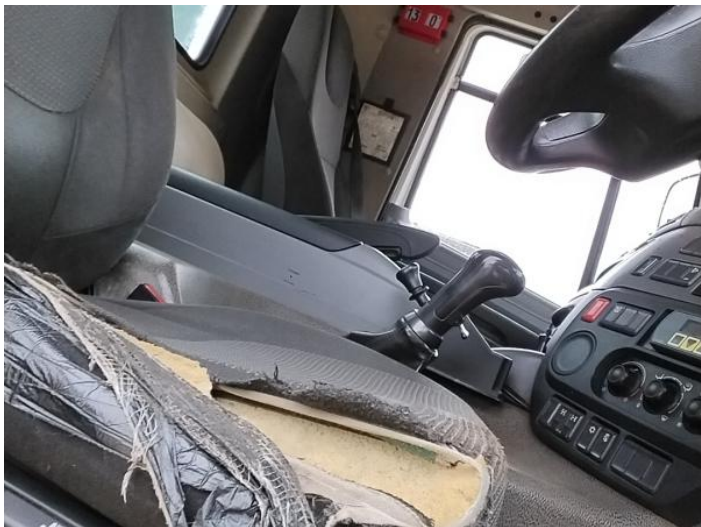
15: Seat Base Cover osf
Torn
Over 3mm
