VEHICLE INSPECTION REPORT

JP66DAF

Daf XF 460

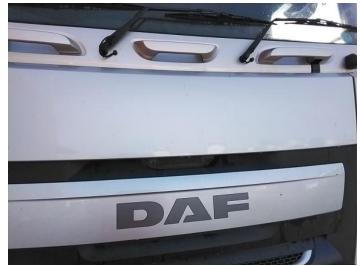
1: Bonnet Chipped Multiple Chips

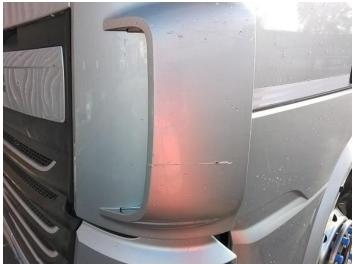
2: Panel Front Cracked Replace

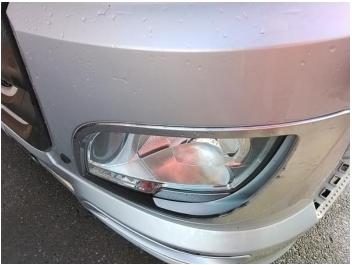
3: Bumper Front Moulding Scratched (Painted) Over 25mm Thru Paint

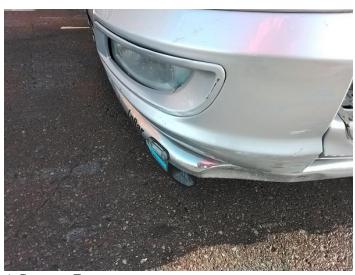
4: Bumper Front Scratched Over 100mm Thru Paint

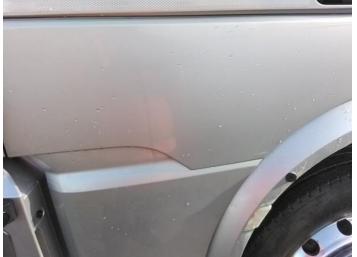
5: Door Moulding nsf Scratched (Painted) Over 25mm Thru Paint

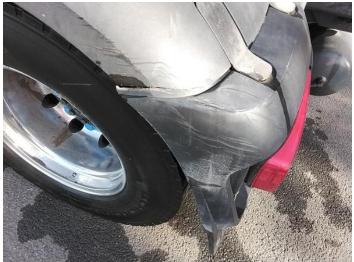
6: Qtr Panel Moulding ns Scuffed (Unpainted) Over 100mm

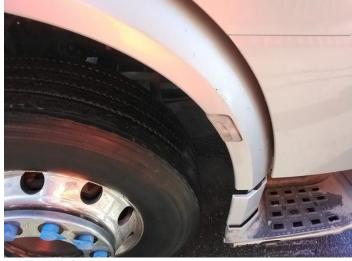
7: Wing osf Chipped Multiple Chips

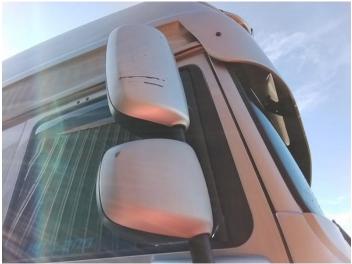
8: Door Mirror Assy osf Scratched (Painted) Over 25mm Thru Paint
