VEHICLE INSPECTION REPORT

PL66YYF

Daf CF 460

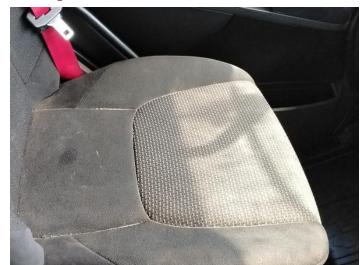
1: Seat Base Cover osf Soiled Light
