# **VEHICLE INSPECTION REPORT**

FN17BSZ

## **Daf LF 260**

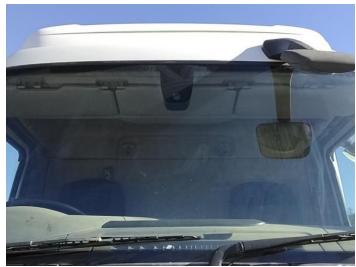
1: Screen Front Chipped UpTo 10mm

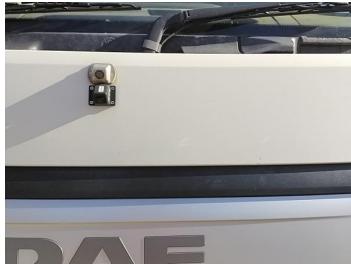
2: Bonnet Scratched UpTo 25mm Thru Paint

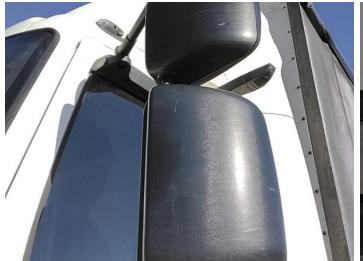
3: Door Mirror Assy nsf Scuffed (Unpainted) UpTo 100mm

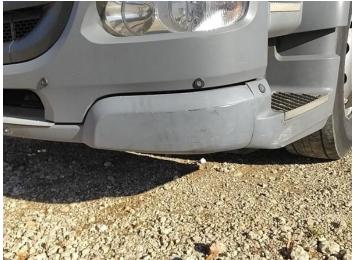
5: Bumper FrontScratched25 to 100mm Thru Paint

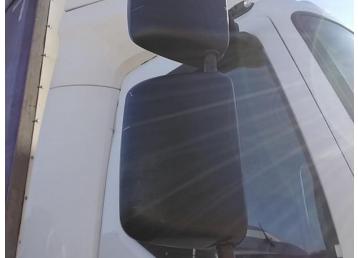
7: Door Mirror Assy osf Scuffed (Unpainted) UpTo 100mm

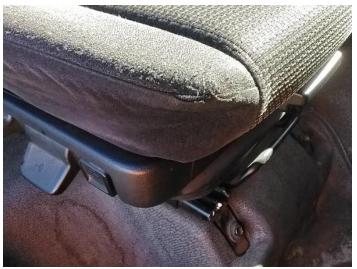
9: Seat Base Cover osf Torn Over 3mm
