VEHICLE INSPECTION REPORT

LN70XSK

Mercedes-Benz Antos

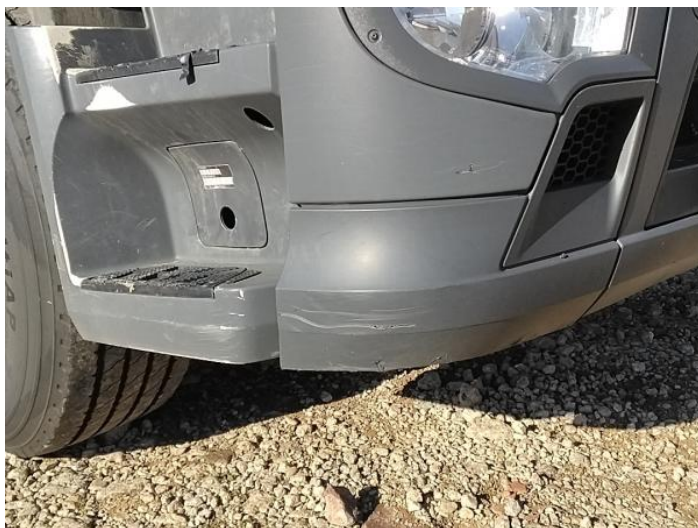
1: Bumper Front Moulding
Scuffed (Unpainted)
UpTo 100mm

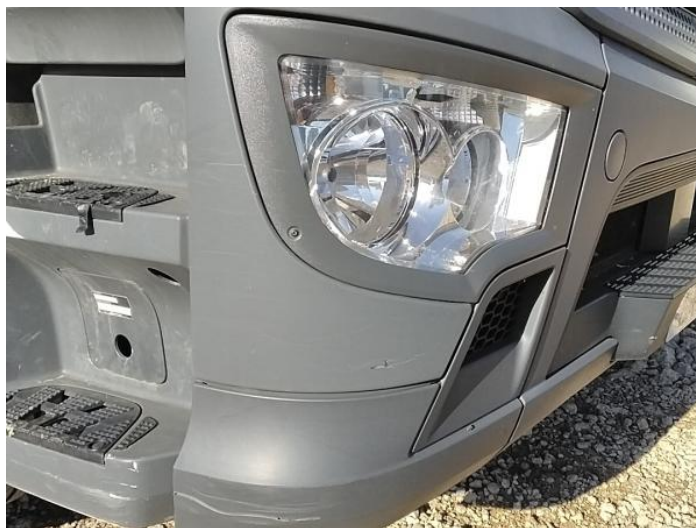
2: Fog Lamp Surround os
Scuffed (Unpainted)
UpTo 100mm

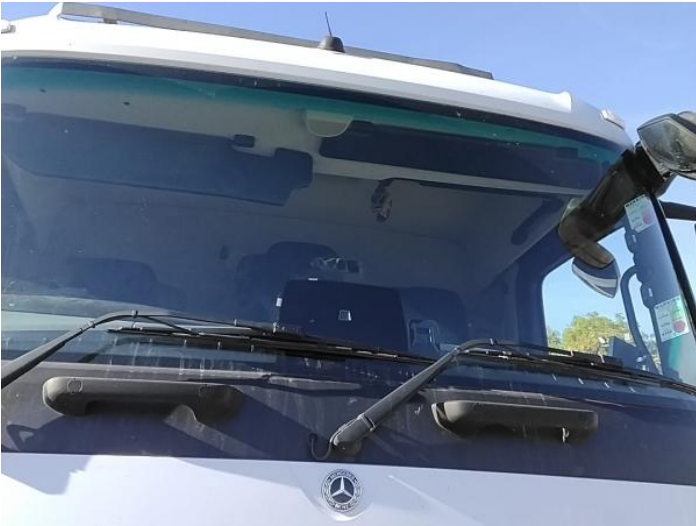
3: Screen Front
Chipped
UpTo 10mm

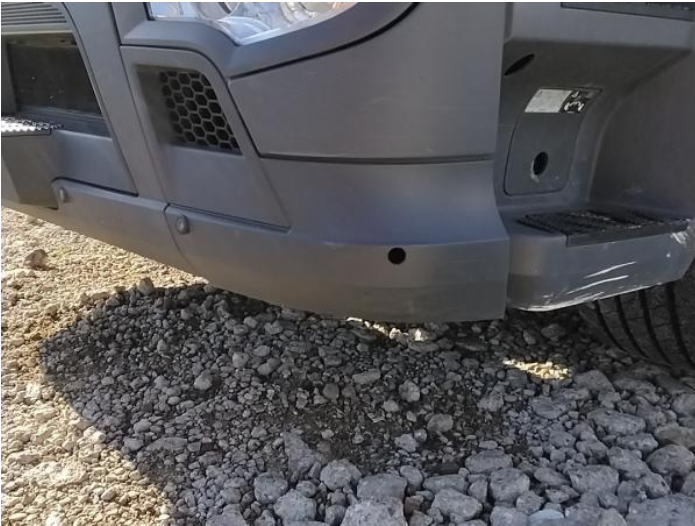
4: Bumper Front Moulding
Scuffed (Unpainted)
UpTo 100mm

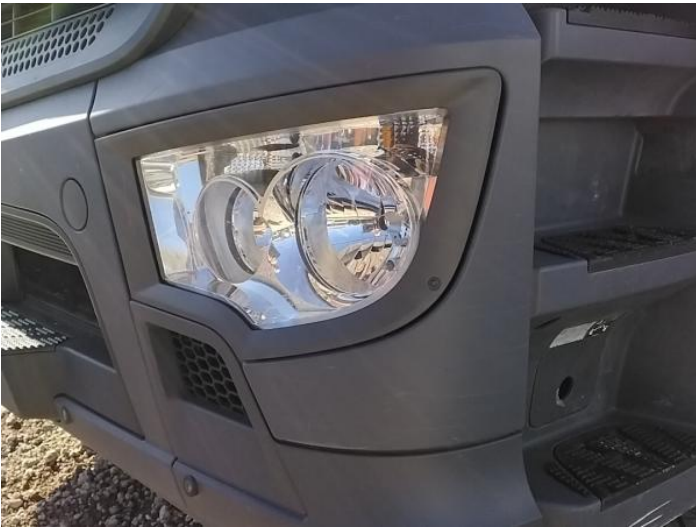
5: Fog Lamp Surround ns
Scuffed (Unpainted)
UpTo 100mm

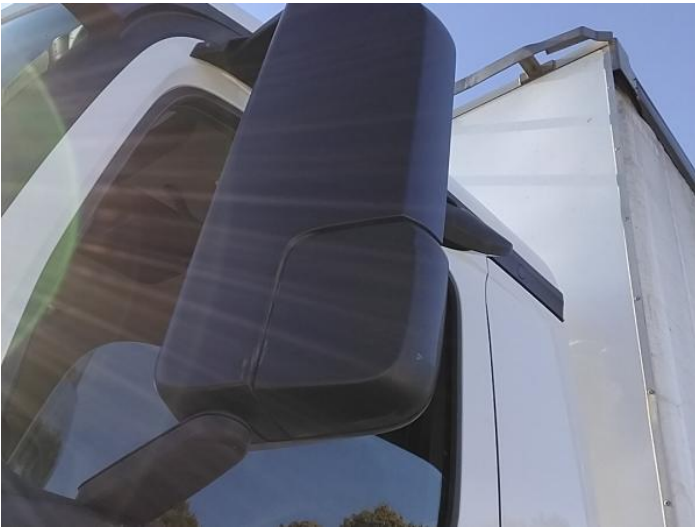
6: Door Mirror Assy nsf
Scuffed (Unpainted)
UpTo 100mm

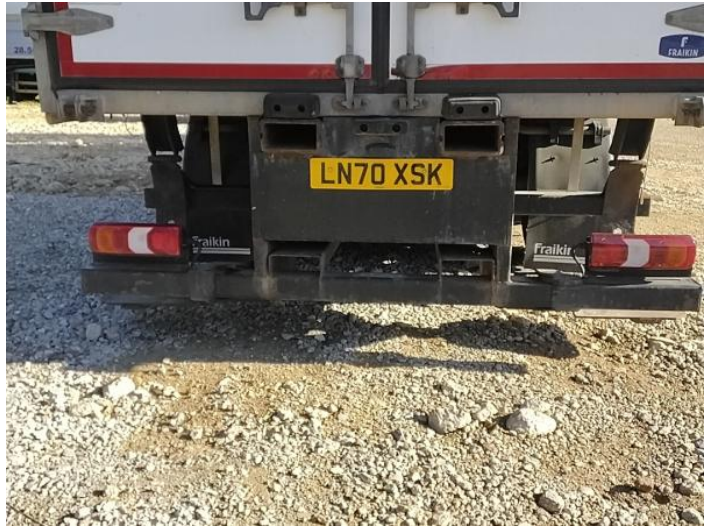
10: Bumper Rear
Rusted
Over 5mm

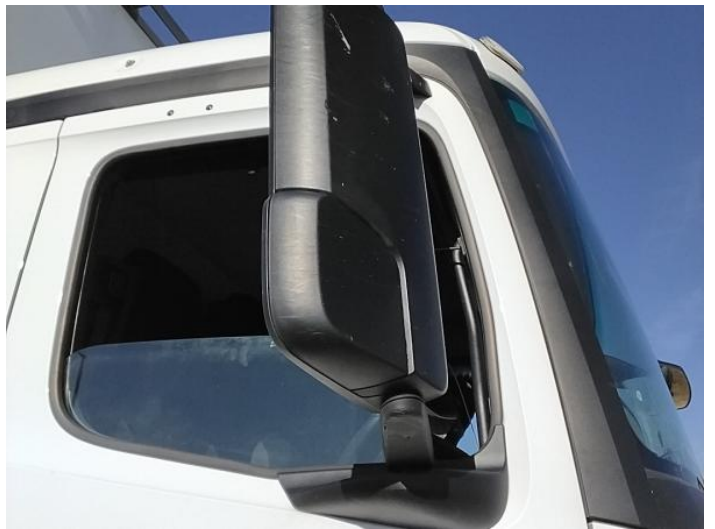
12: Door Mirror Assy osf
Scuffed (Unpainted)
UpTo 100mm

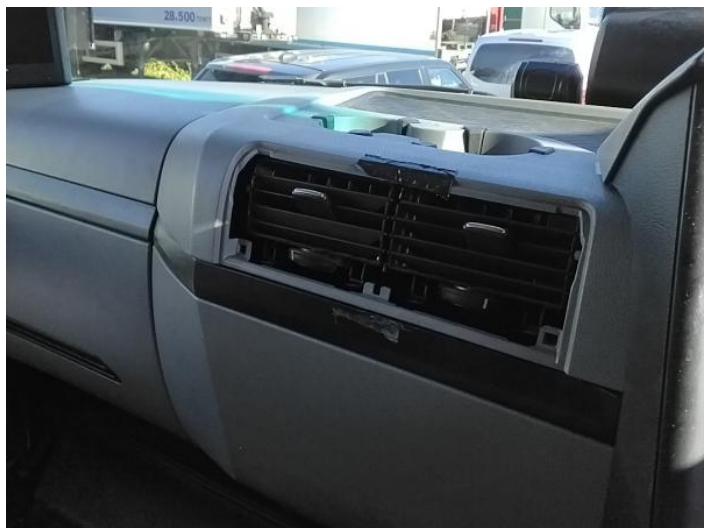
14: Air Vents nsf
Damaged
Replace
