# VEHICLE INSPECTION REPORT

**PK69ZND**

## Mercedes-Benz Sprinter 314 CDI

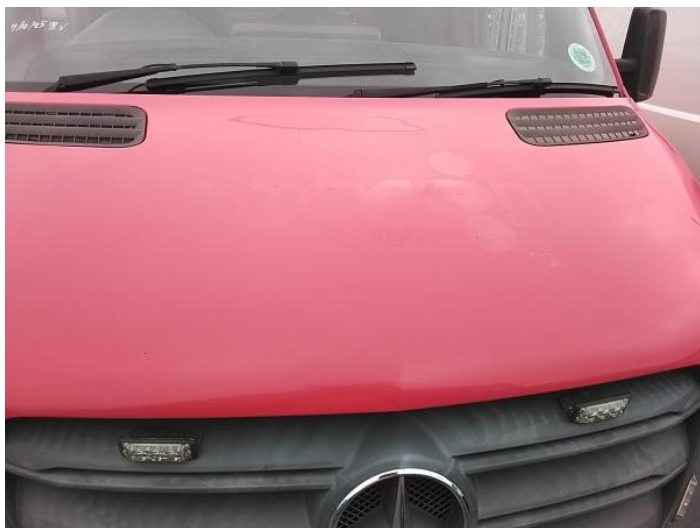
1: Bonnet  
Chipped  
Multiple Chips

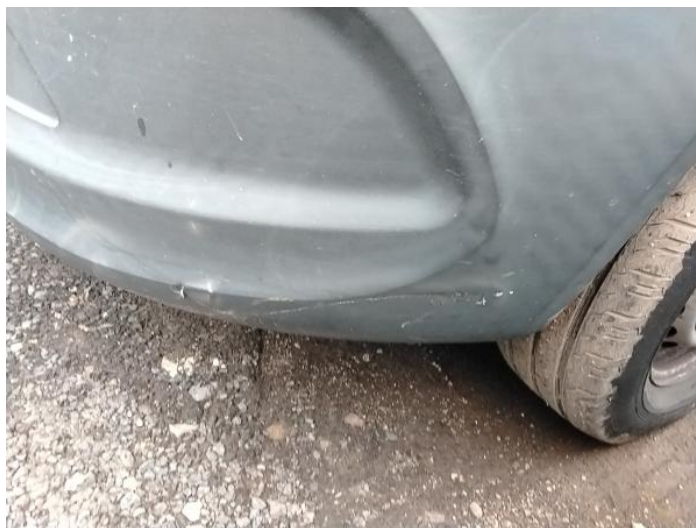
2: Bumper Front  
Scratched  
Over 100mm Thru Paint

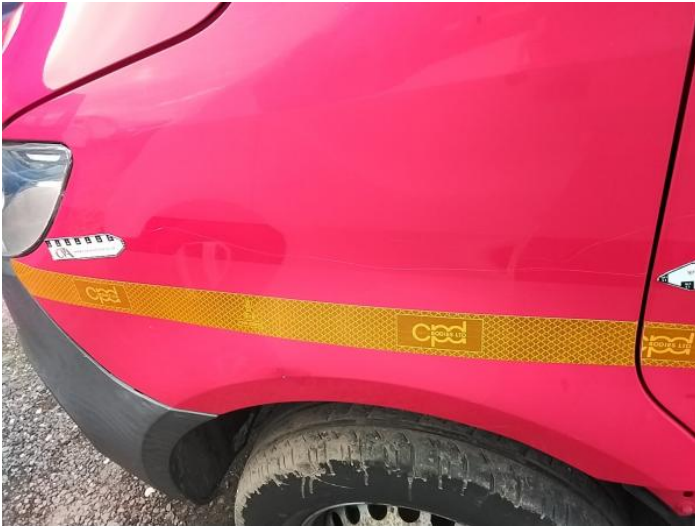
3: Wing nsf  
Scratched  
Over 25mm Thru Paint

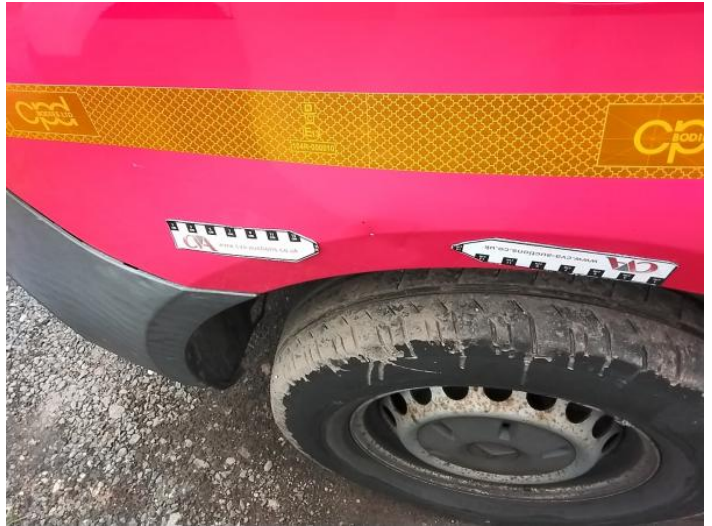
4: Wing nsf  
Dented  
With Paint Damage  
Over 25mm Thru Paint

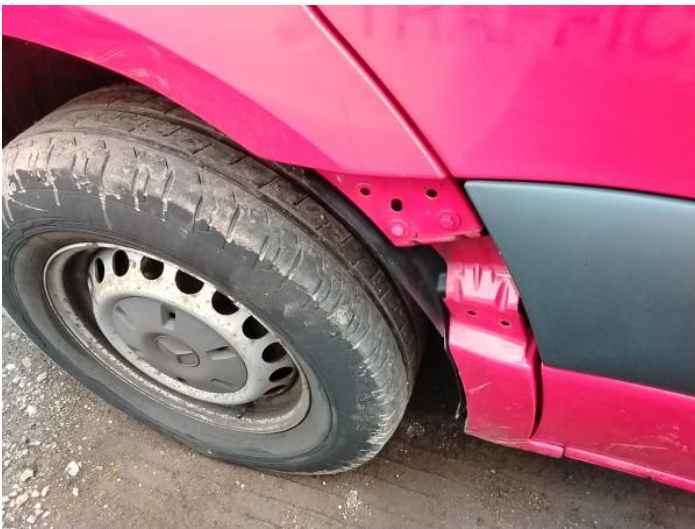
5: Door Moulding nsf  
Missing  
Replace

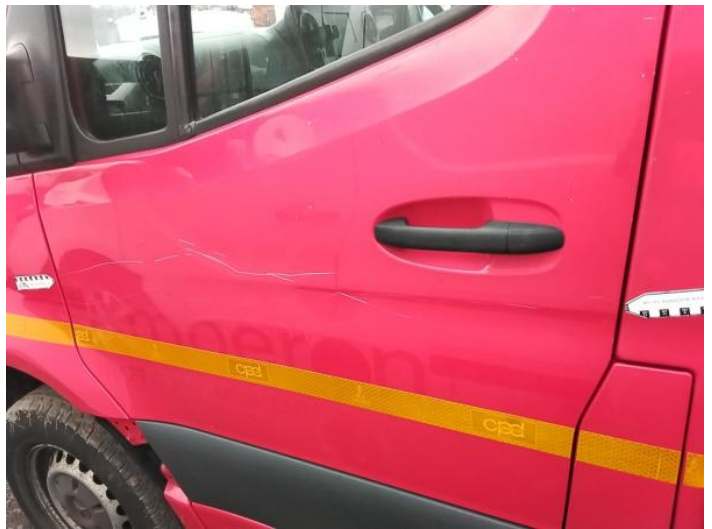
6: Door nsf  
Scratched  
Over 25mm Thru Paint

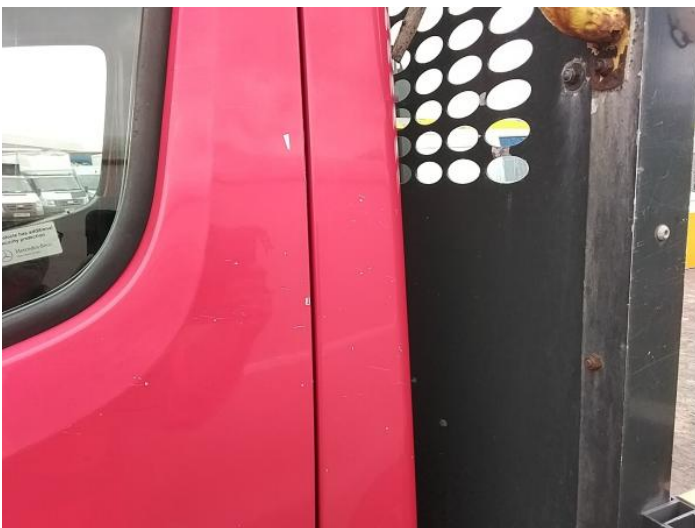
7: Door nsf  
Chipped  
Multiple Chips

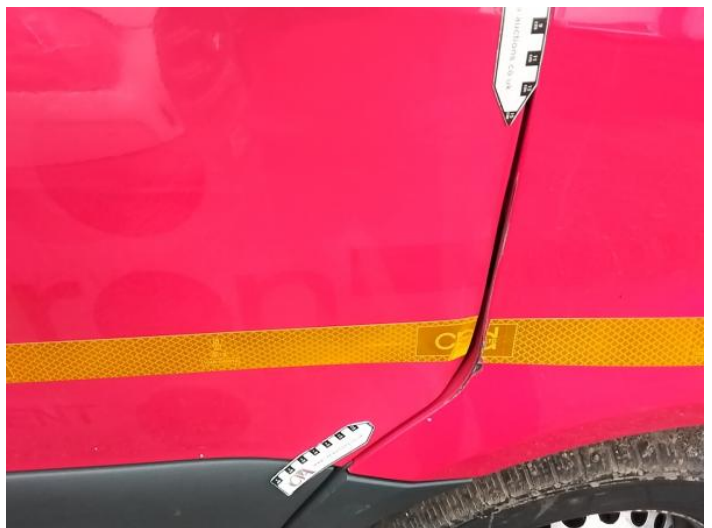
8: Door nsf  
Dented  
With Paint Damage  
Over 25mm Thru Paint

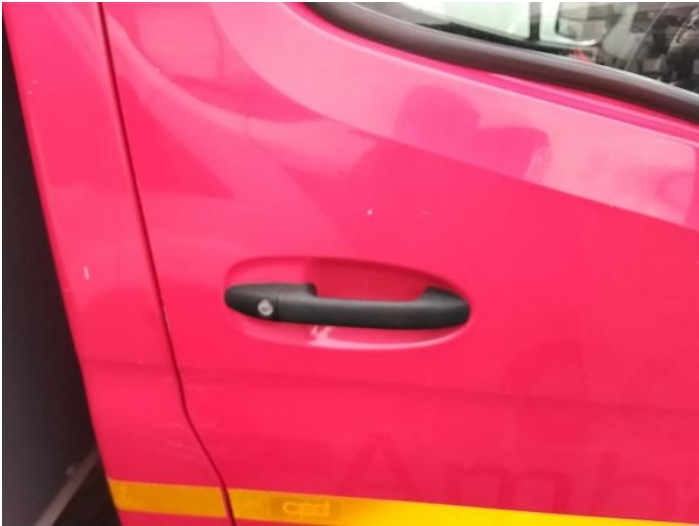
9: Door osf  
Chipped  
Multiple Chips

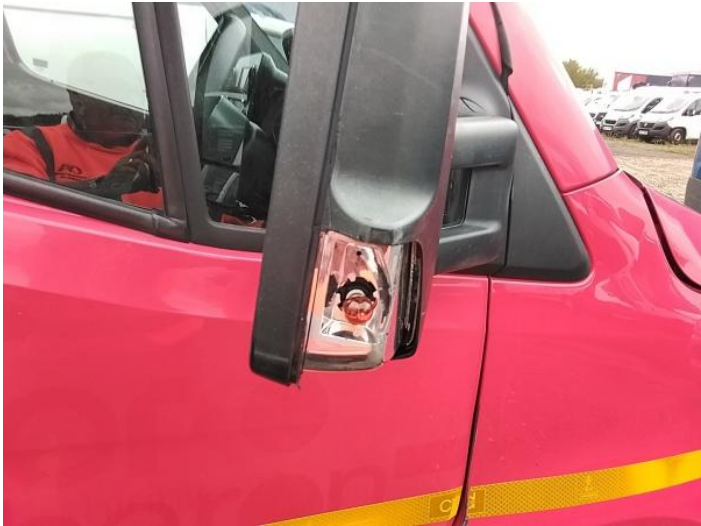
10: Door Mirror Assy osf  
Broken  
Replace

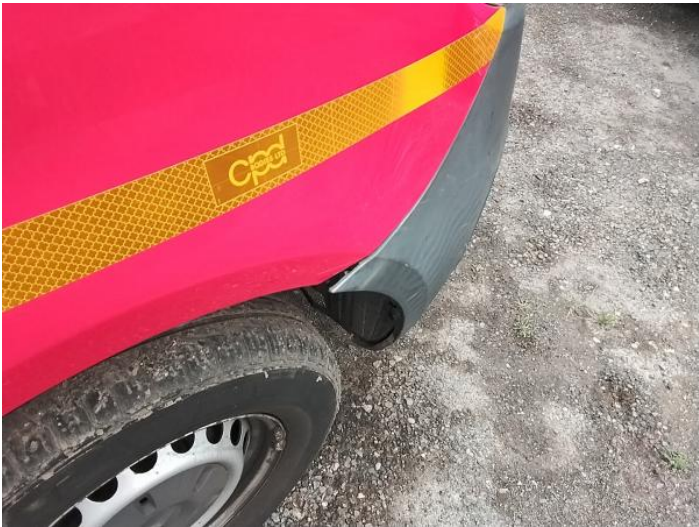
11: Bumper Front  
Insecure  
Action Required
