VEHICLE INSPECTION REPORT

LN69XVB

Isuzu N75 190

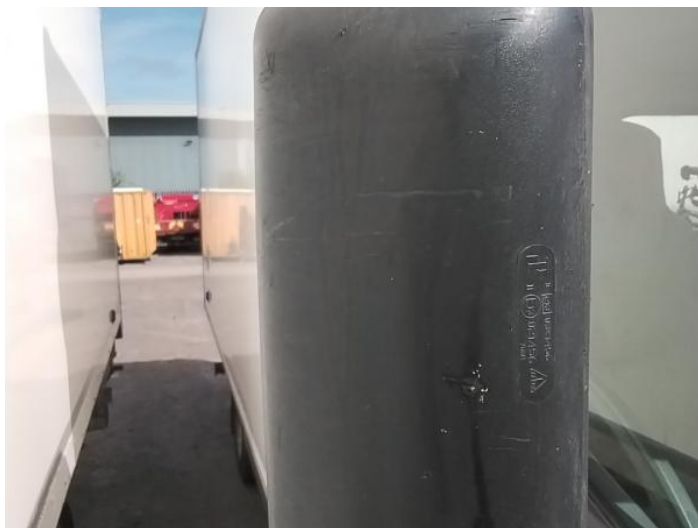
1: Door Mirror Assy nsf
Scuffed (Unpainted)
Over 100mm

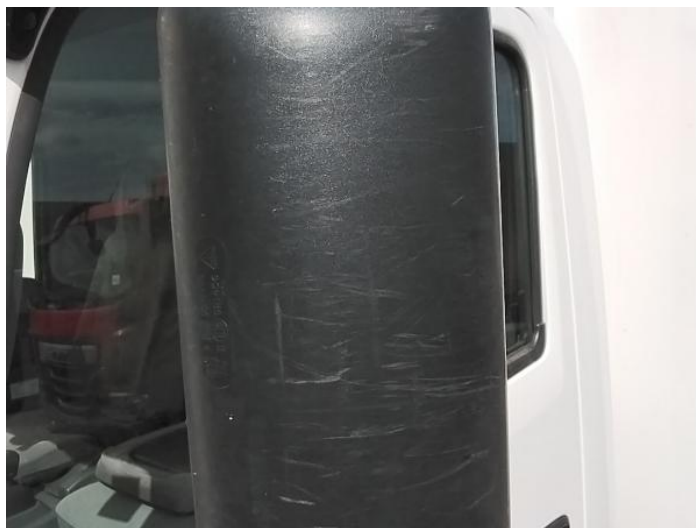
2: Door Mirror Assy osf
Scuffed (Unpainted)
Over 100mm

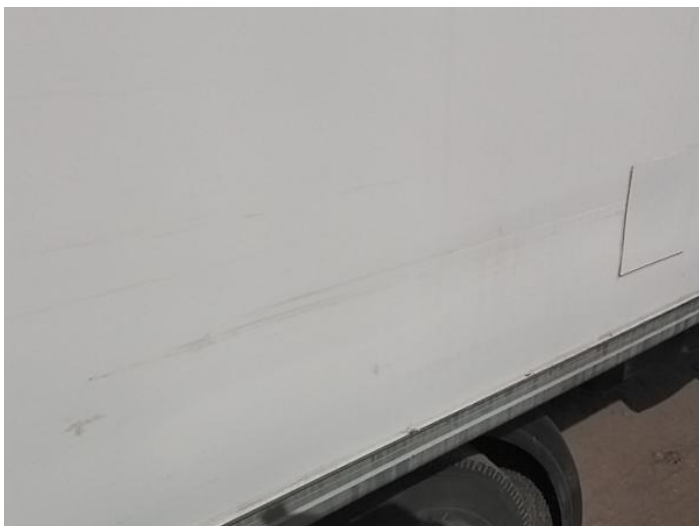
3: Panel Rear
 Scratched
 Over 25mm Not Thru Paint

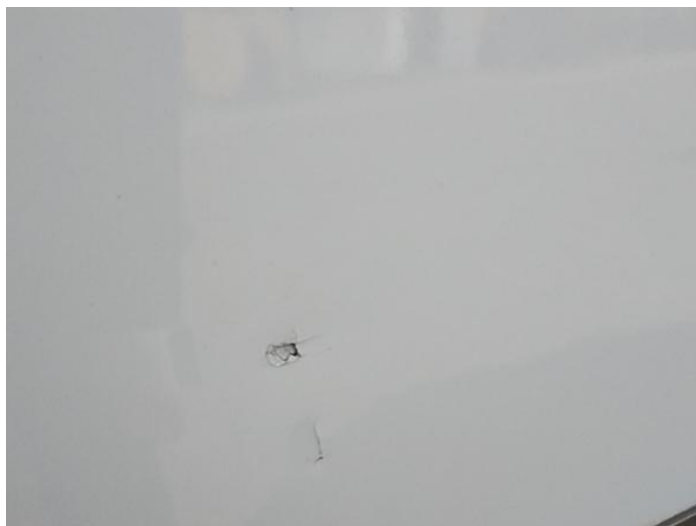
4: Door nsr
 Hole
 UpTo 10mm

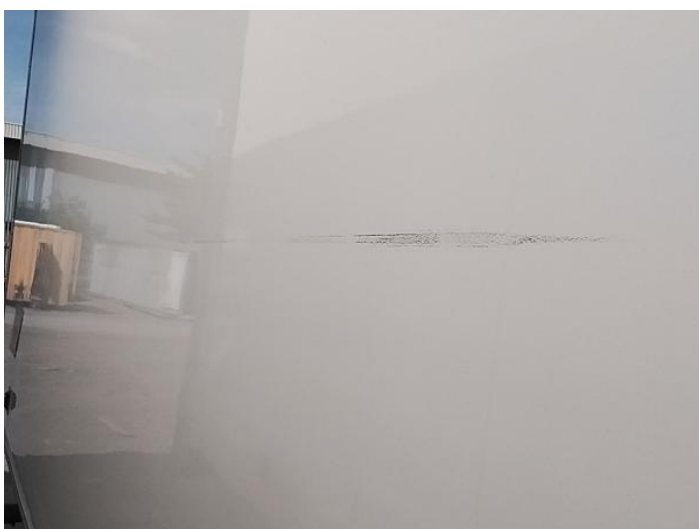
5: Panel Rear
 Scratched
 Over 25mm Not Thru Paint
