VEHICLE INSPECTION REPORT

SF16CLD

Vauxhall Movano F3500 2.3 CDTI 136ps

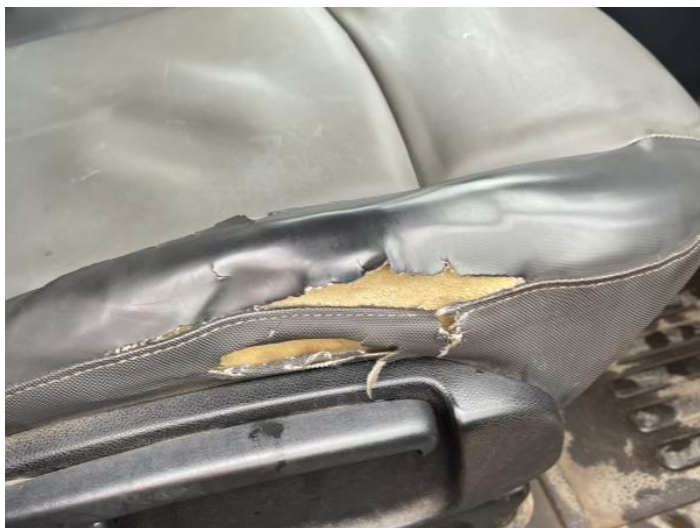
1: Seat Base Cover of
Torn
Over 3mm

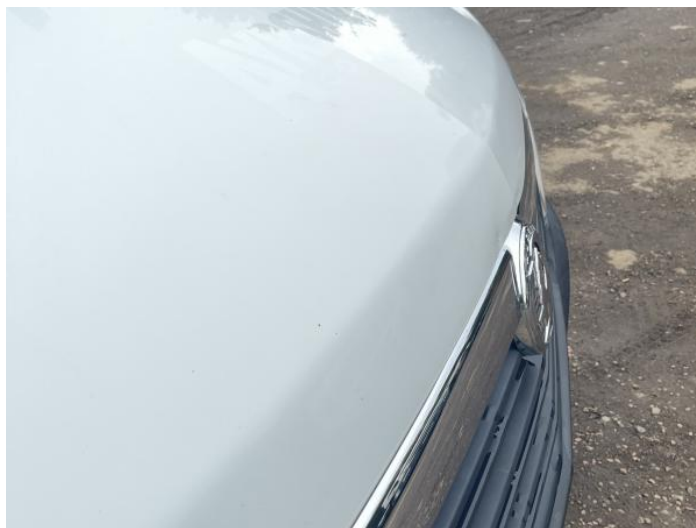
2: Bonnet
Dented
With Paint Damage

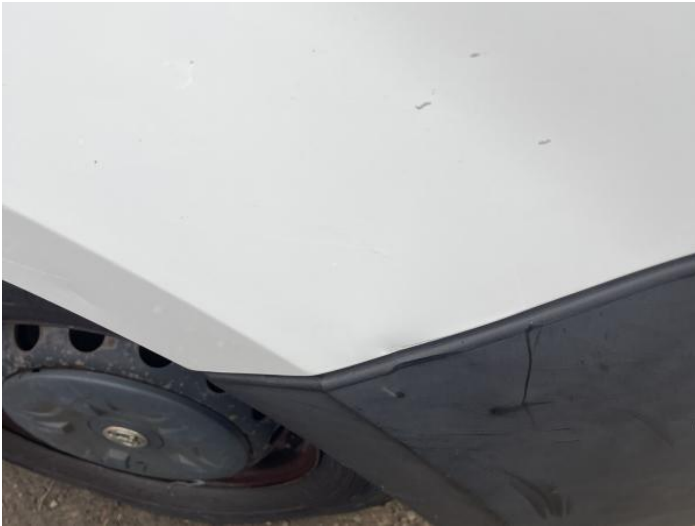
3: Wing osf
Dented
With Paint Damage

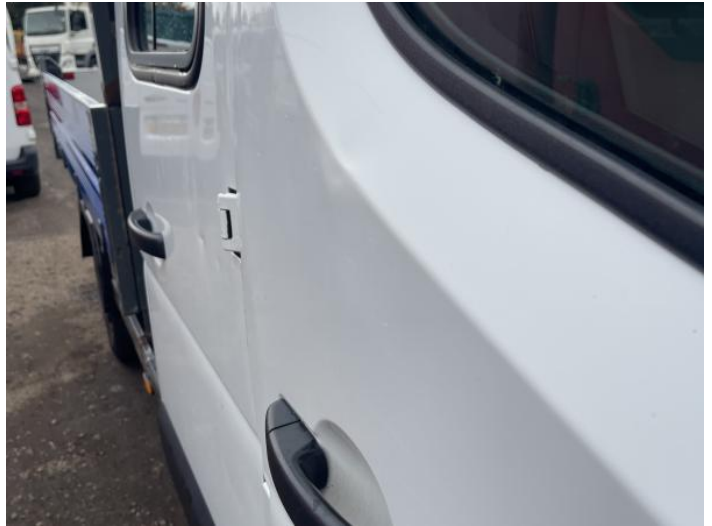
4: Door osf
Dented
With Paint Damage

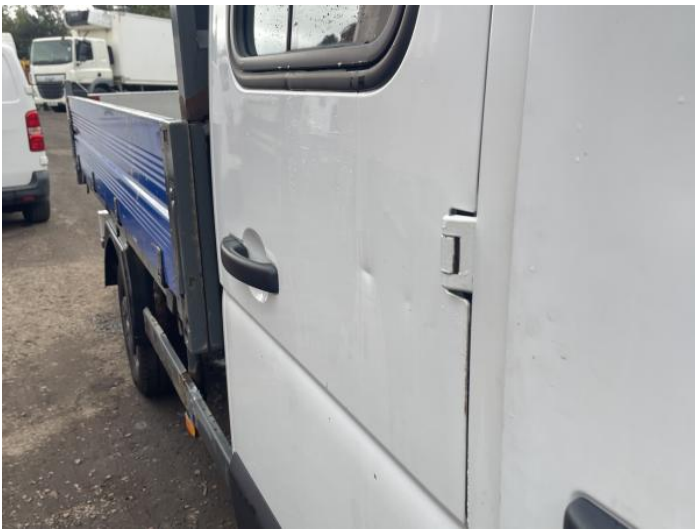
5: Door osr
Dented
With Paint Damage

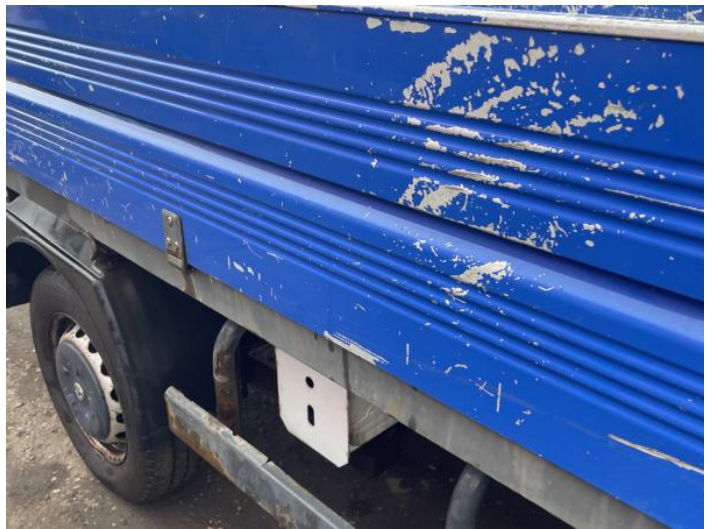
6: Qtr Panel osr
Dented
With Paint Damage

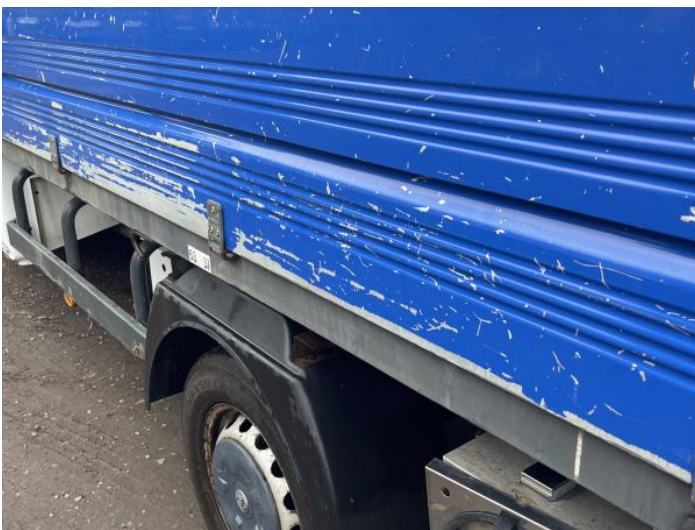
7: Qtr Panel nsr
Dented
With Paint Damage

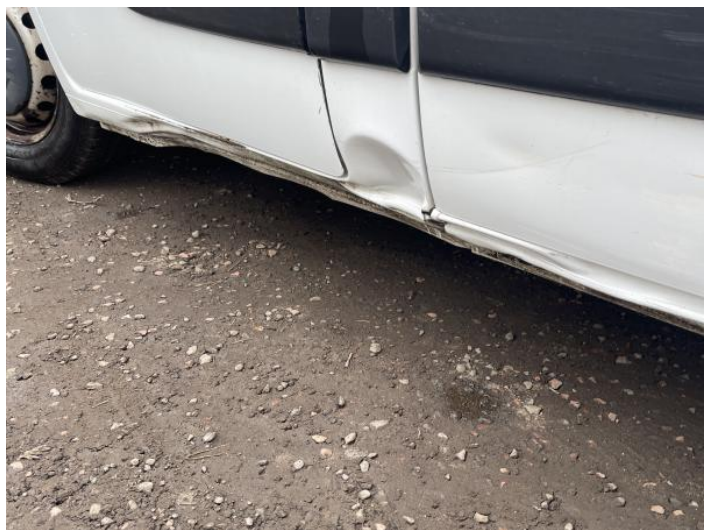
8: Sill ns
Dented
With Paint Damage

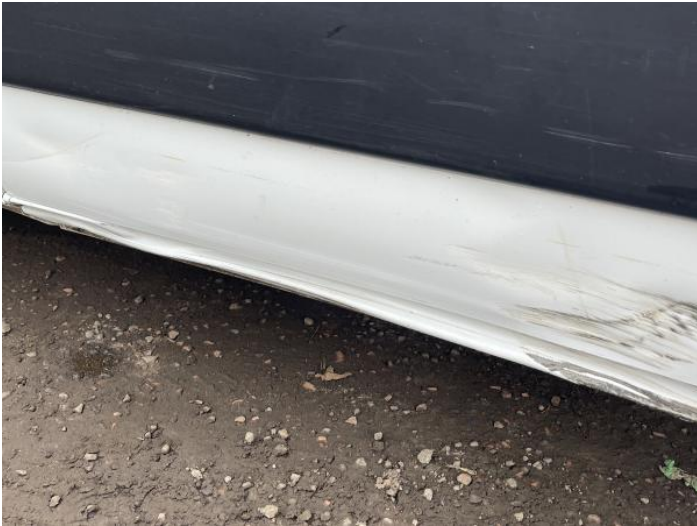
9: Door nsr
Dented
With Paint Damage

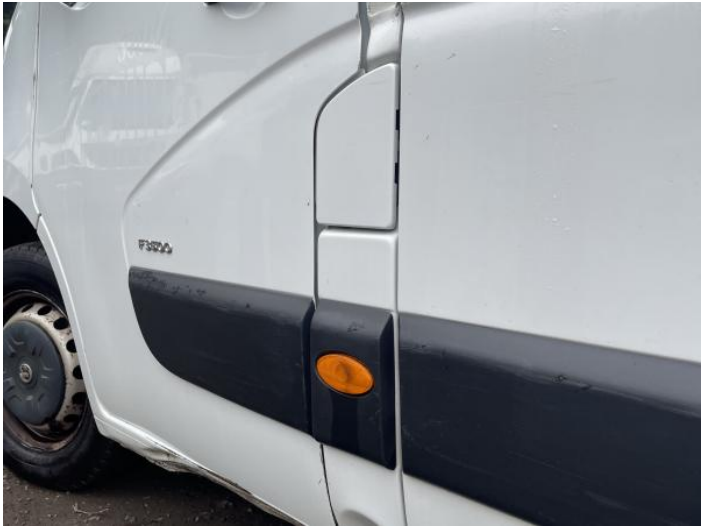
10: B Post ns
Dented
With Paint Damage

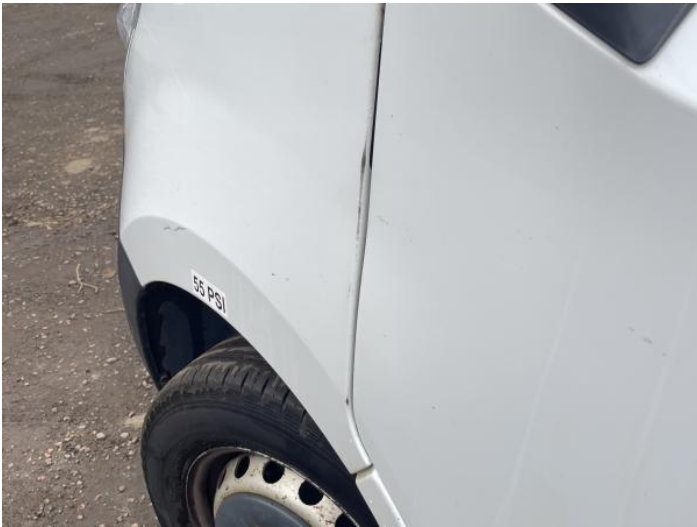
11: Wing nsf
Dented
With Paint Damage
