# **VEHICLE INSPECTION REPORT**

**CN69VXM**

### **Mercedes-Benz Sprinter 314 CDI**

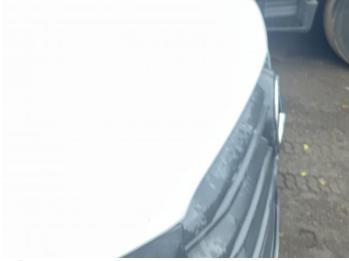
1: Bonnet Dented Over 30mm

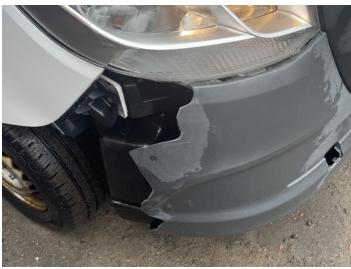
2: Bumper Front Moulding Broken Replace

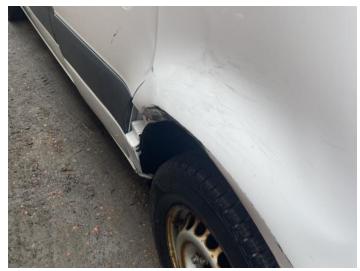
3: Wing nsf Dented With Paint Damage

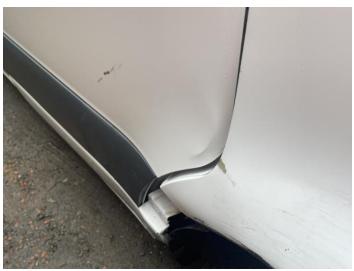
4: Door osf Dented Over 30mm

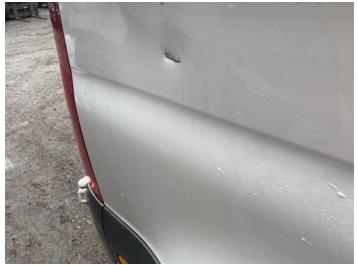
5: Qtr Panel osr Dented With Paint Damage

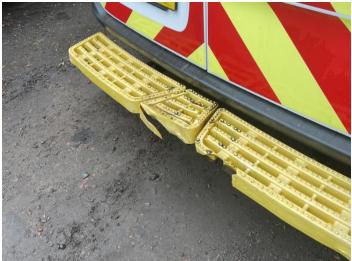
6: Bumper Rear Moulding Broken Replace

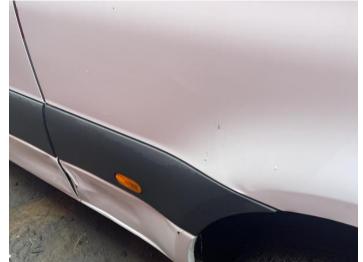
7: Qtr Panel nsr Dented With Paint Damage

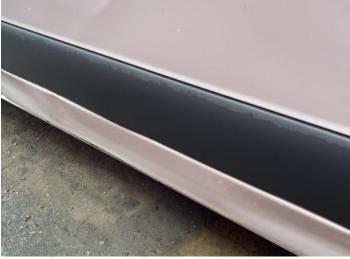
8: Door nsr Dented Over 30mm
