VEHICLE INSPECTION REPORT

KU13KWO

Daf LF 55.220

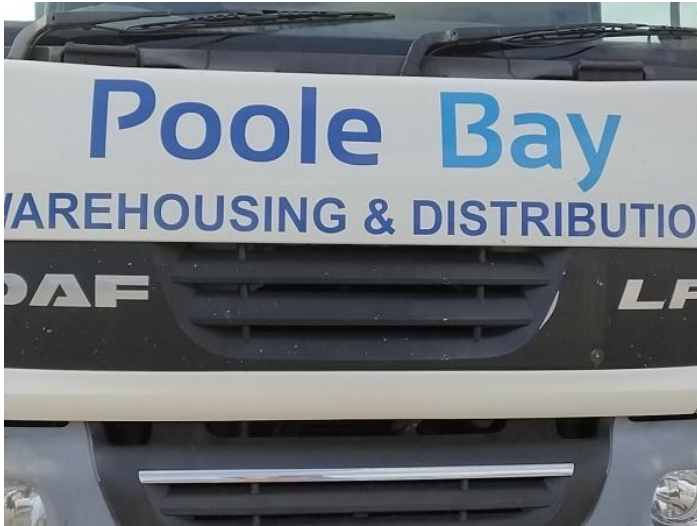
3: Grille Front
Scratched (Painted)
UpTo 25mm Thru Paint

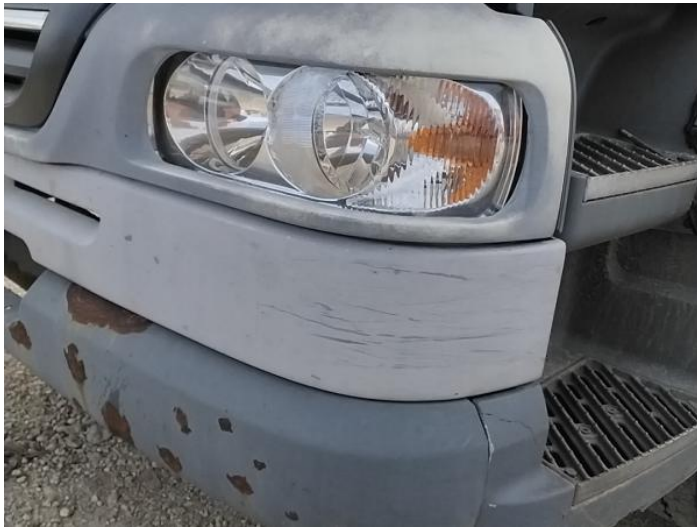
5: Bumper Front Moulding
Scuffed (Unpainted)
Over 100mm

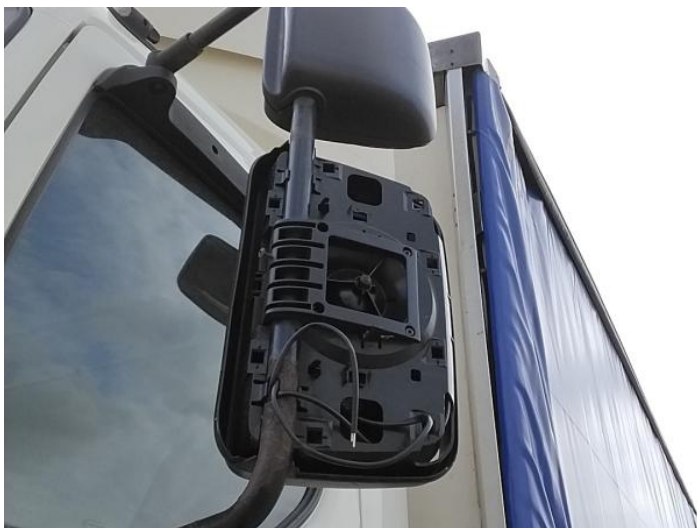
7: Door Mirror Assy nsf
Missing
Replace

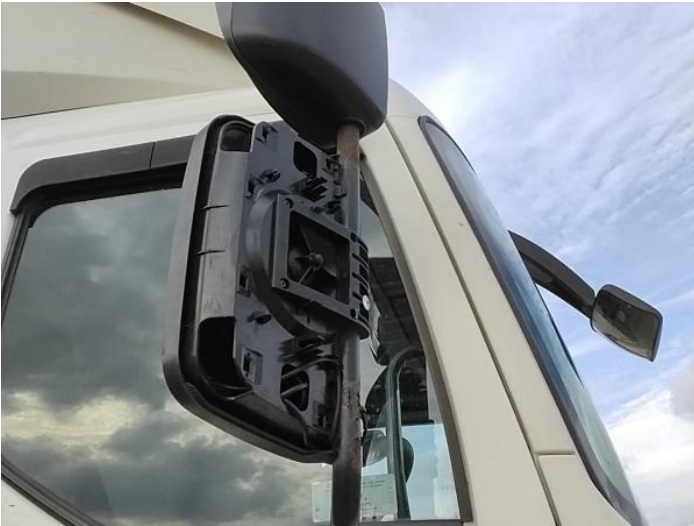
15: Door Mirror Assy osf
Missing
Replace

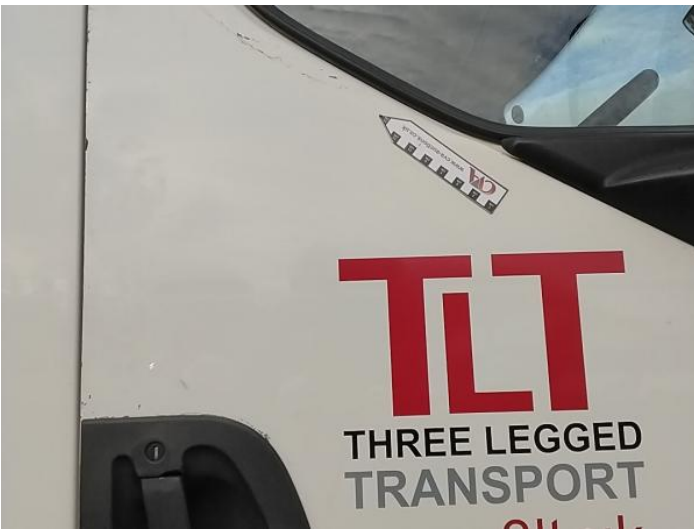
17: Door osf
Scratched
UpTo 25mm Thru Paint

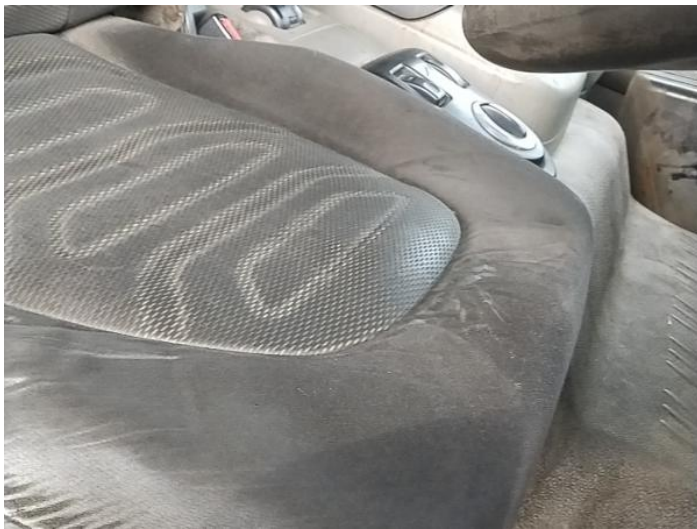
21: Seat Base Cover osf
Burn
Over 3mm

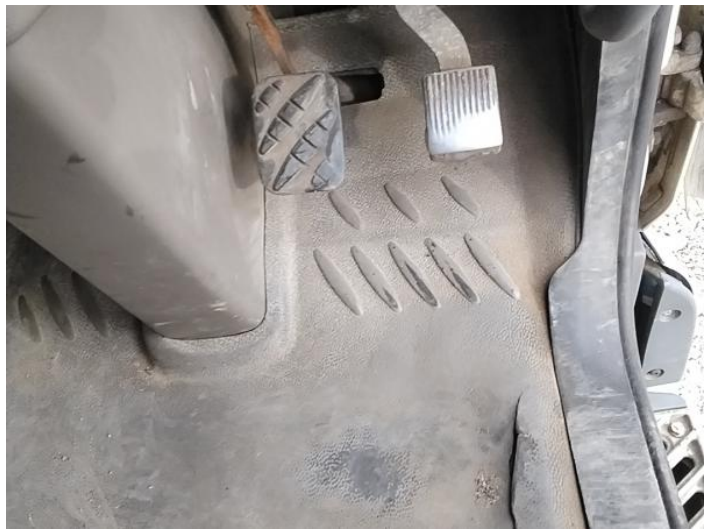
22: Carpets Front
Torn
Over 10mm
