VEHICLE INSPECTION REPORT

KU13KWT

Daf LF 55.220

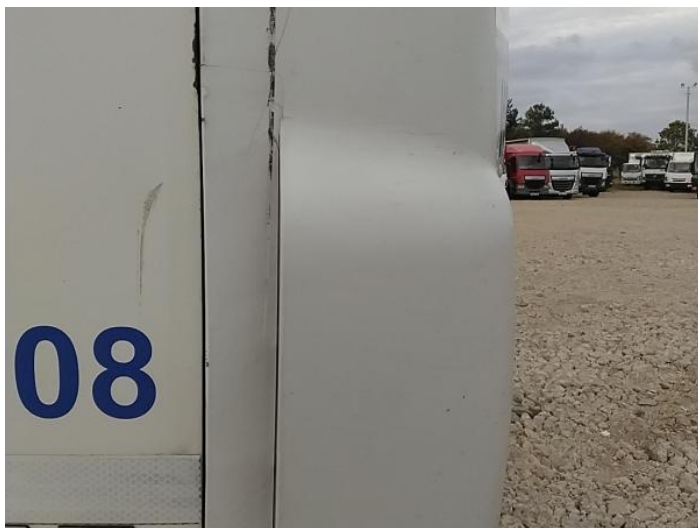
1: Wing osf
Cracked
Replace

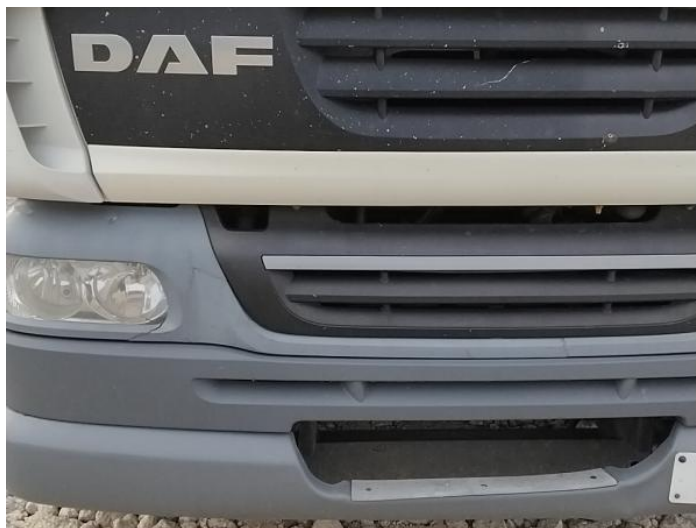
2: Fog Lamp Surround os
Broken
Replace

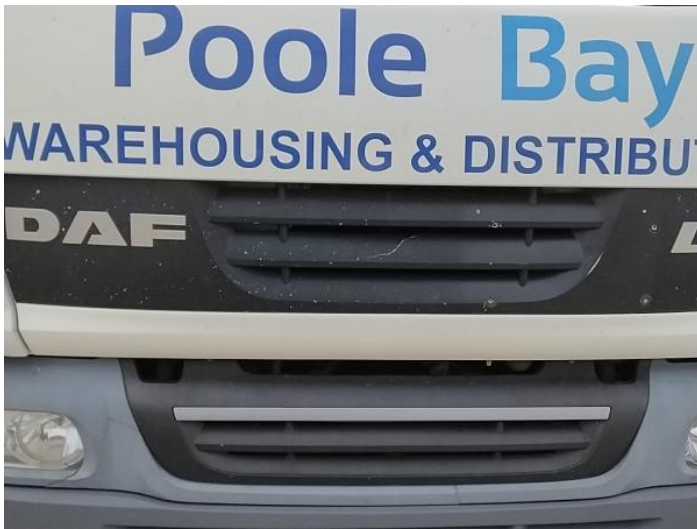
3: Grille Front
Broken
Replace

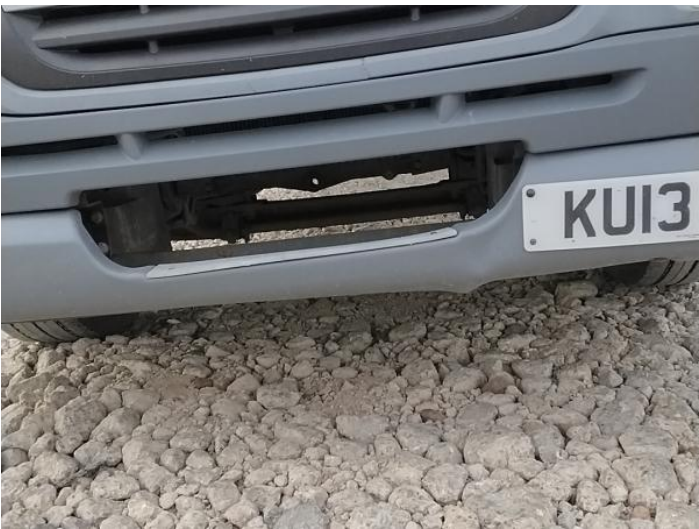
4: Bumper Front
Dented
Between 10mm + 30mm

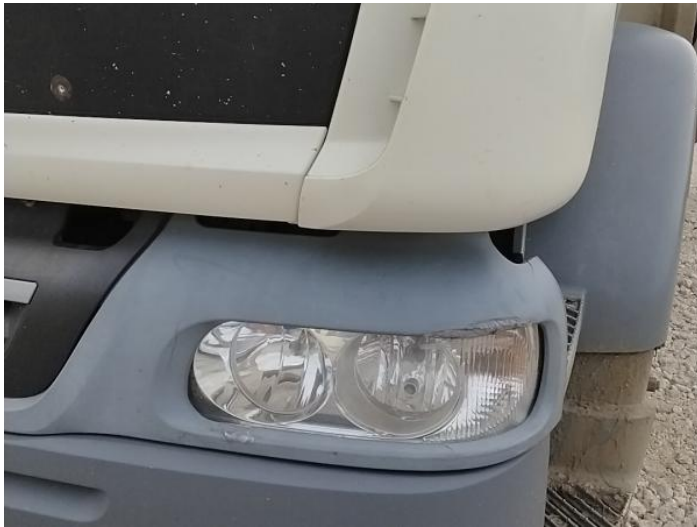
5: Fog Lamp Surround ns
Broken
Replace

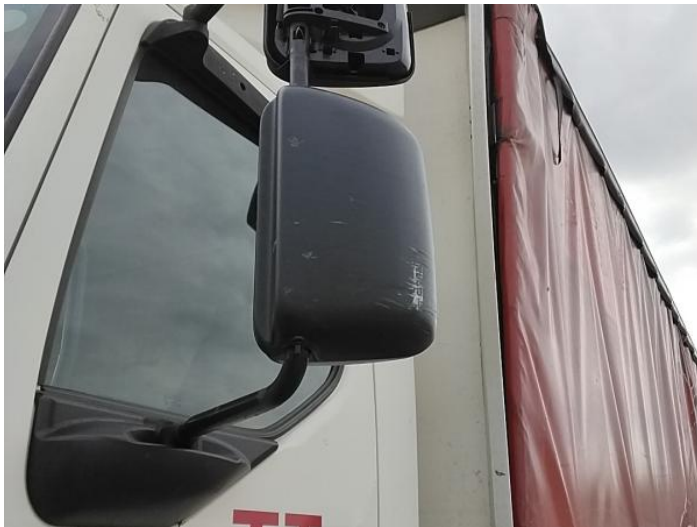
7: Door Mirror Assy nsf
Scuffed (Unpainted)
UpTo 100mm

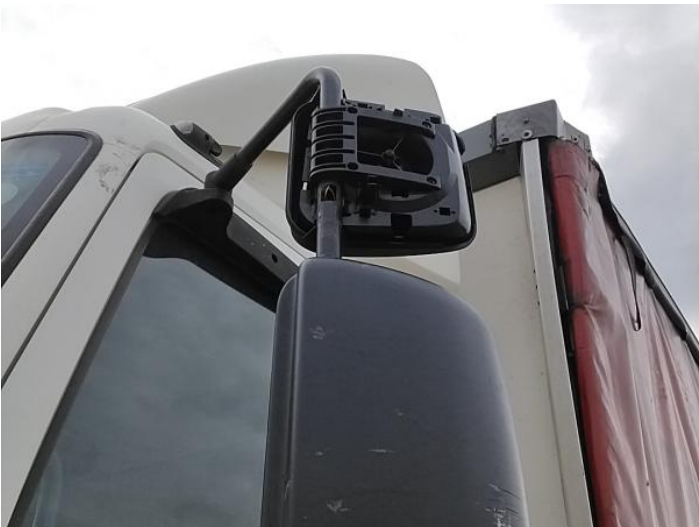
8: Door Mirror Assy nsf
Missing
Replace

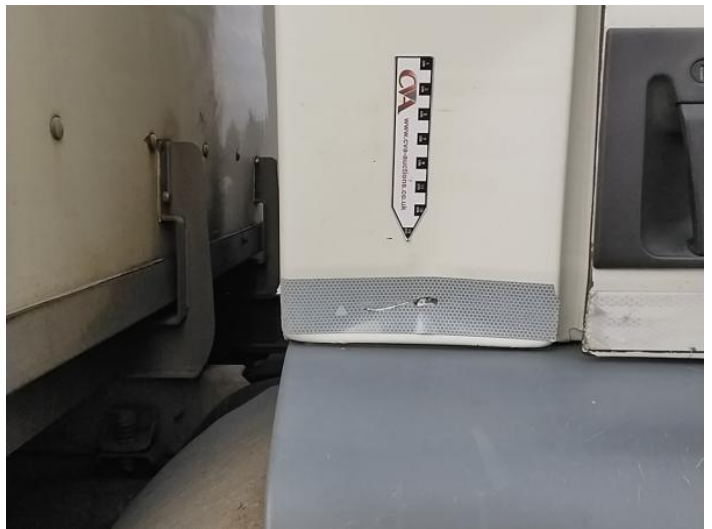
12: B Post os
Dented
With Paint Damage

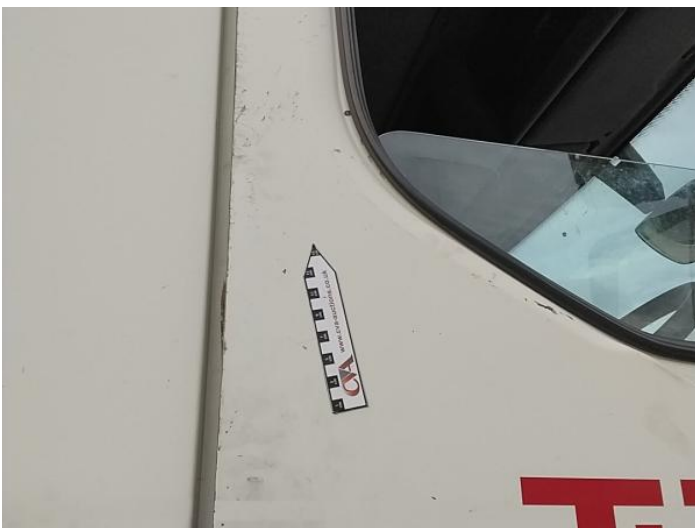
13: Door osf
Scratched
Over 25mm Thru Paint

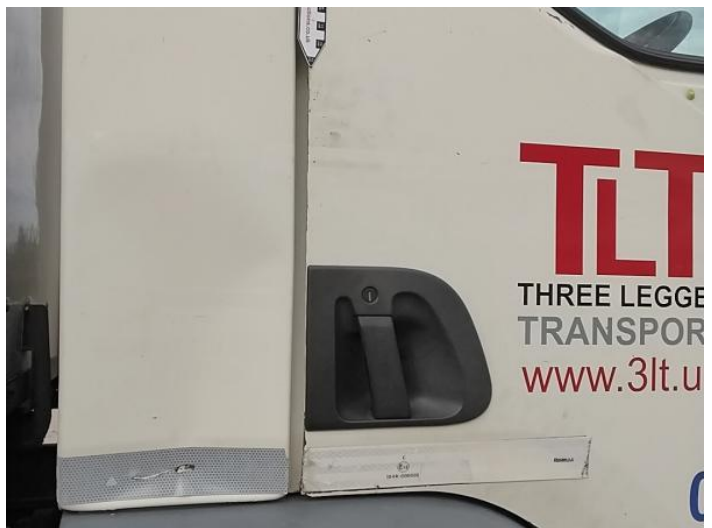
14: Door osf
Chipped
Edge Chip

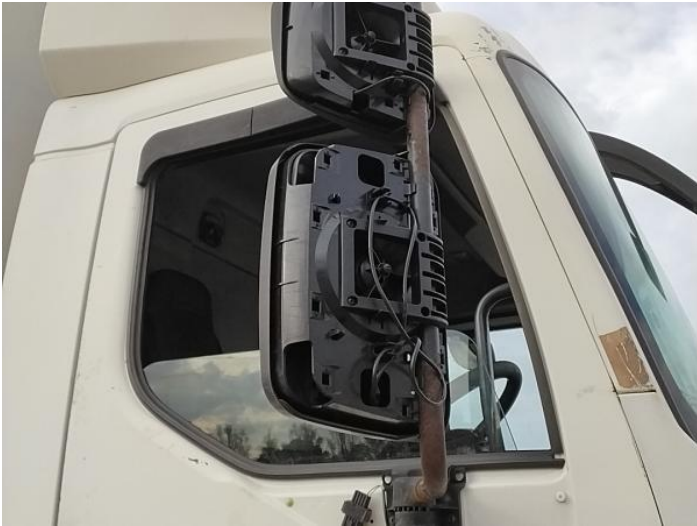
15: Door Mirror Assy osf
Missing
Replace
