# VEHICLE INSPECTION REPORT

**KU13KWR**

## Daf LF 55.220

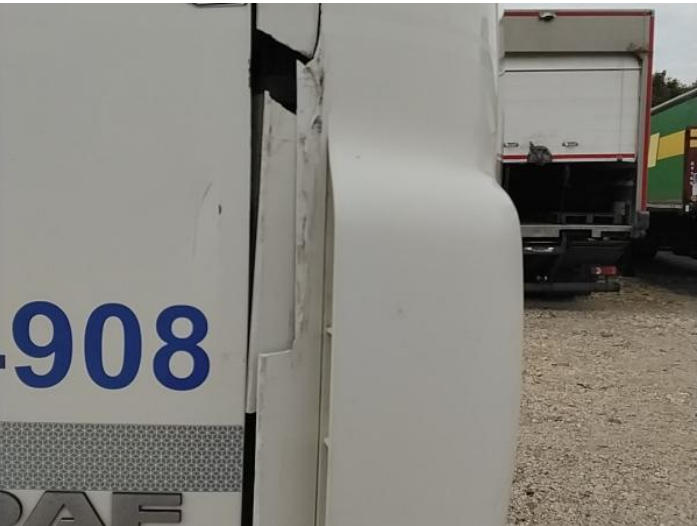
1: Wing of  
Hole  
Over 10mm

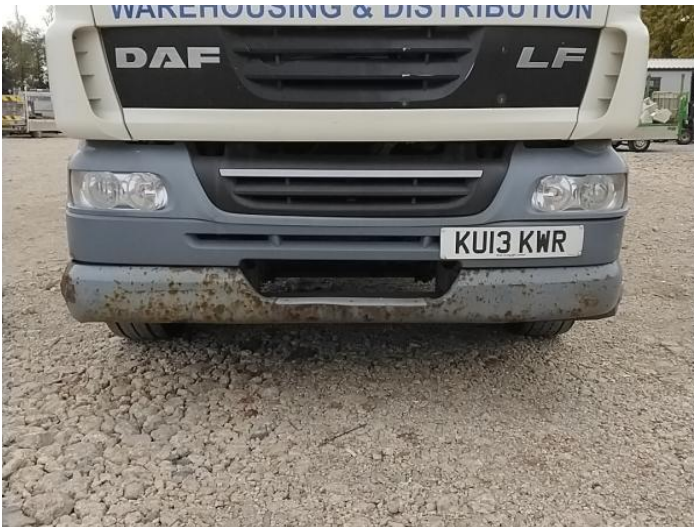
3: Bumper Front  
Rusted  
Over 5mm

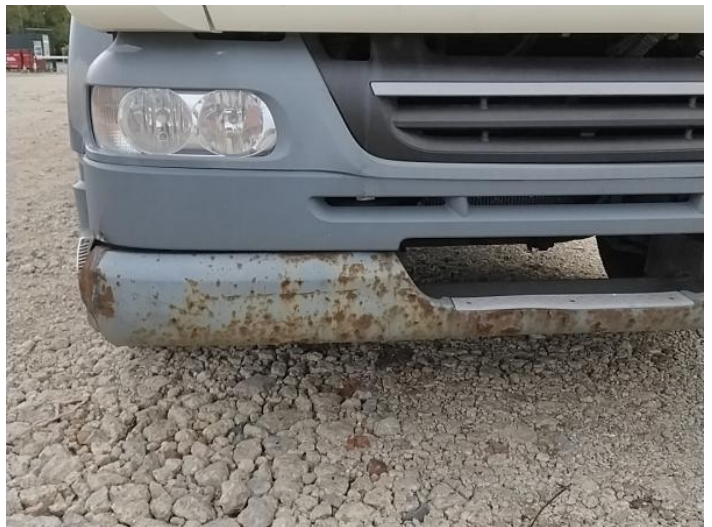
4: Bumper Front Moulding  
Broken  
Replace

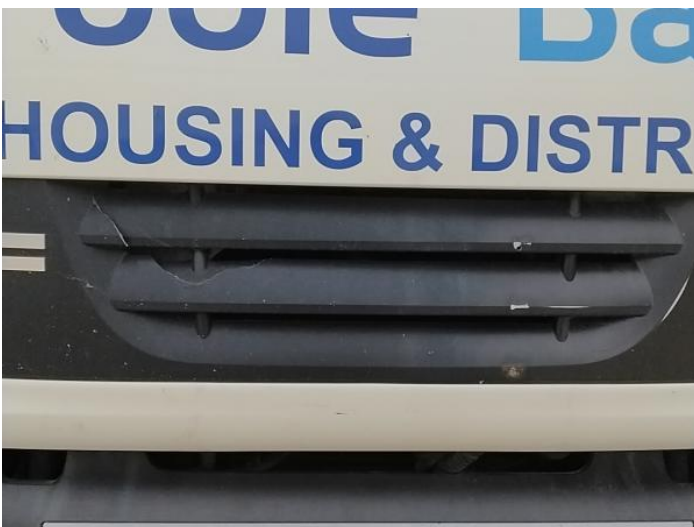
5: Grille Front  
Broken  
Replace

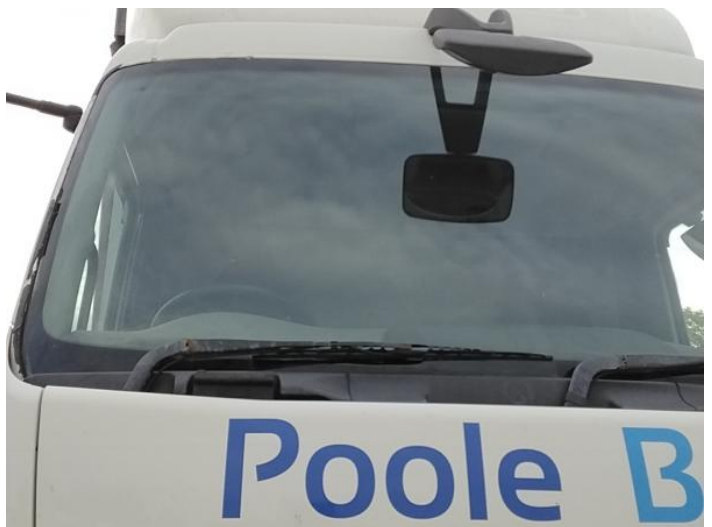
6: Screen Front  
Chipped  
Over 10mm

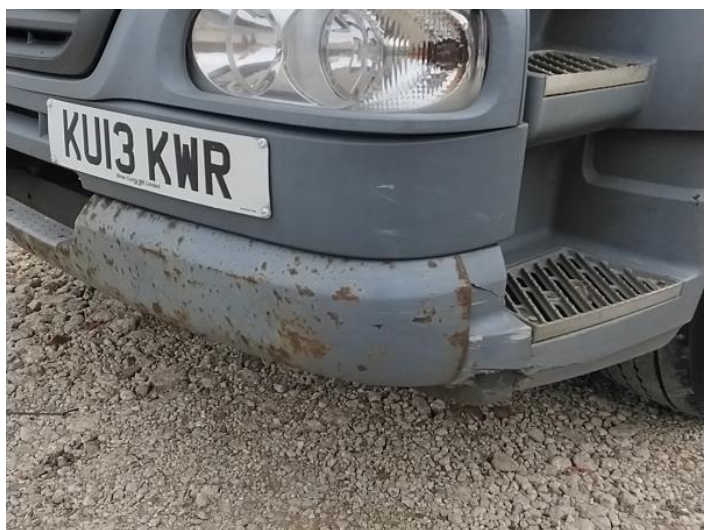
8: Bumper Front Moulding  
Scuffed (Unpainted)  
UpTo 100mm

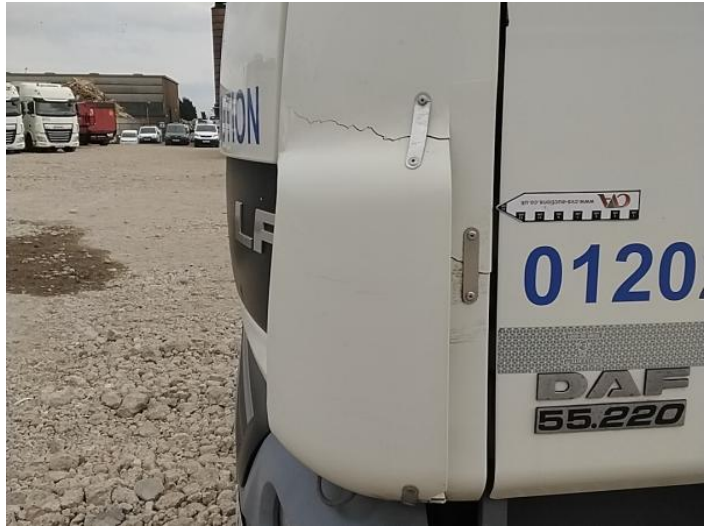
10: Wing nsf  
Cracked  
Replace

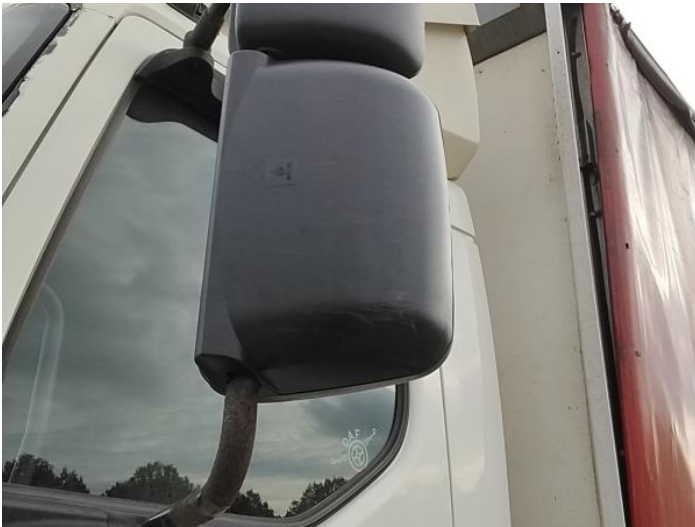
11: Door Mirror Assy nsf  
Scuffed (Unpainted)  
UpTo 100mm

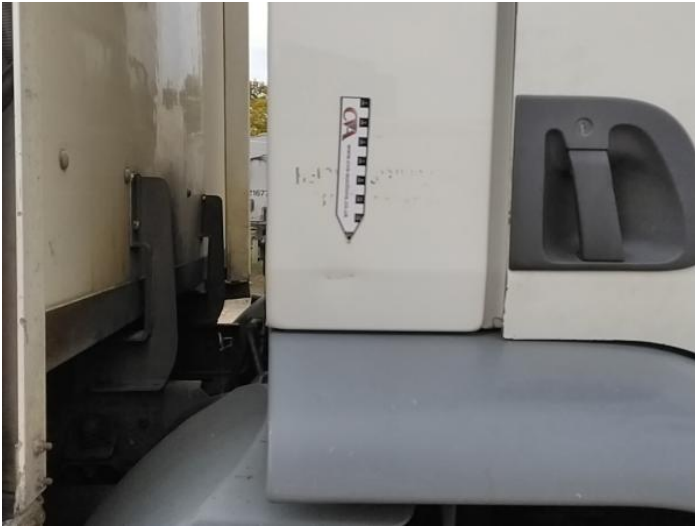
15: B Post os  
Dented  
With Paint Damage

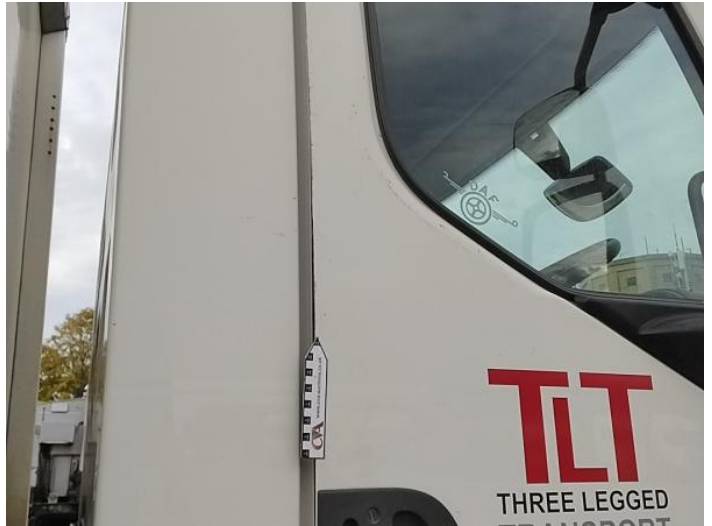
16: Door osf  
Chipped  
Edge Chip

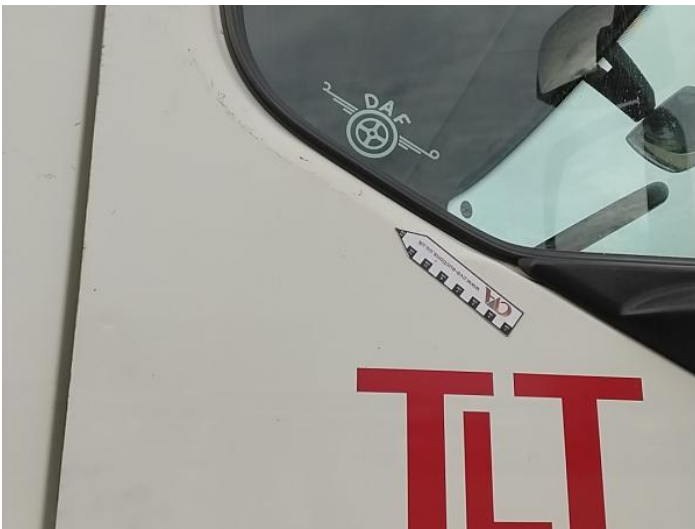
17: Door osf  
Scratched  
UpTo 25mm Thru Paint

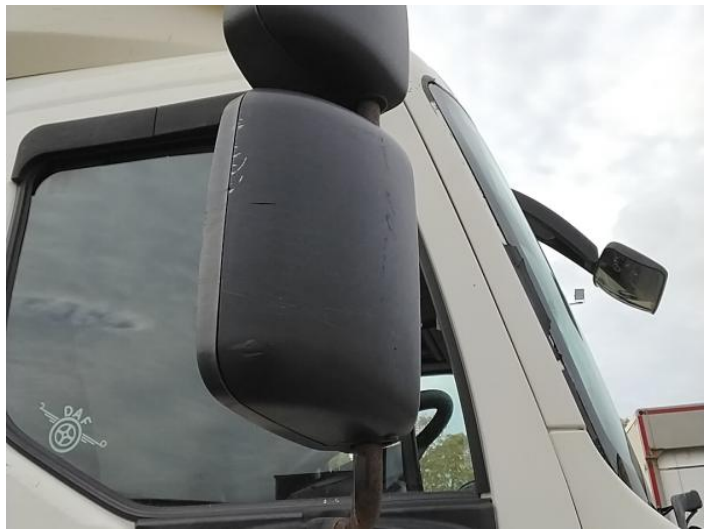
18: Door Mirror Assy osf  
Scuffed (Unpainted)  
UpTo 100mm

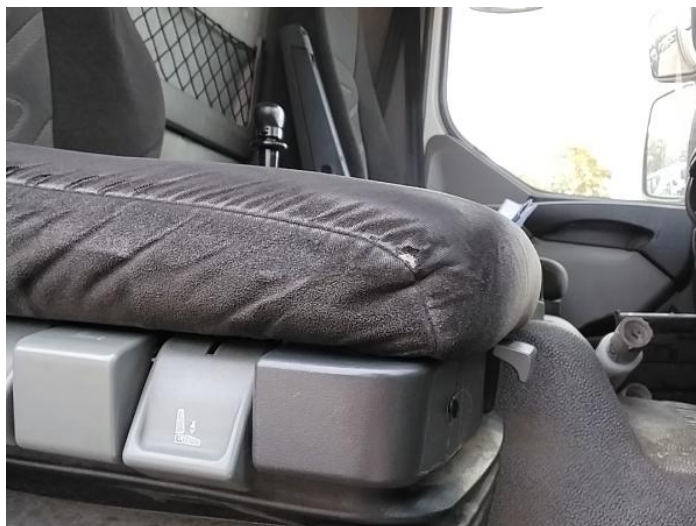
22: Seat Base Cover osf  
Holed  
Over 3mm

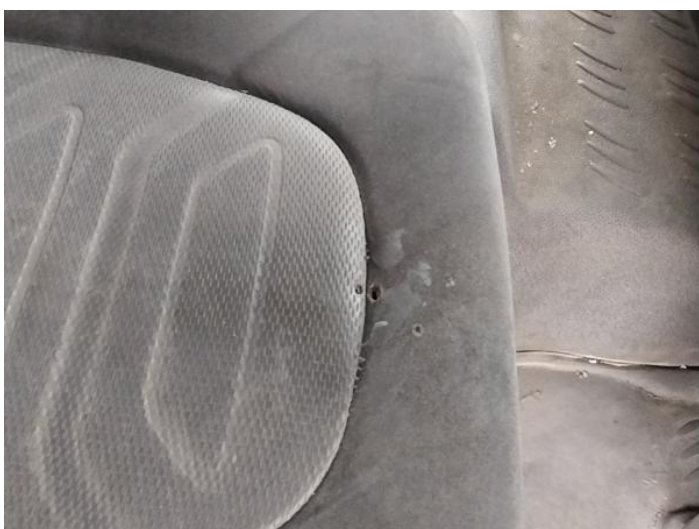
23: Seat Base Cover osf  
Burn  
Over 3mm
