VEHICLE INSPECTION REPORT

YT65TZH

Mercedes-Benz Antos 1824

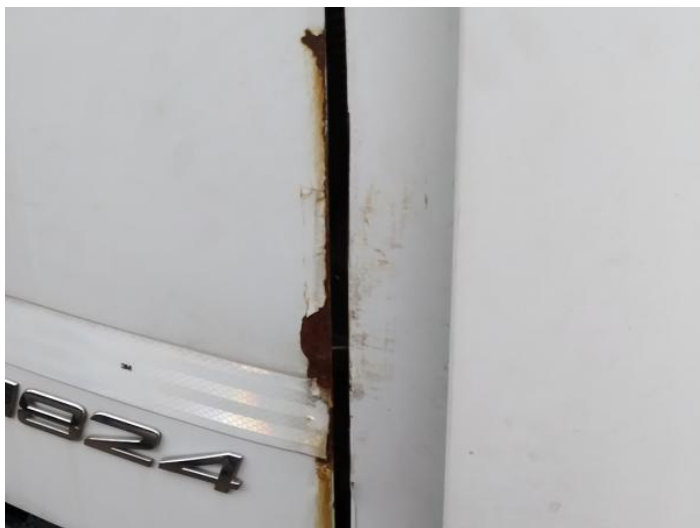
1: Door nsf
Chipped
Edge Chip

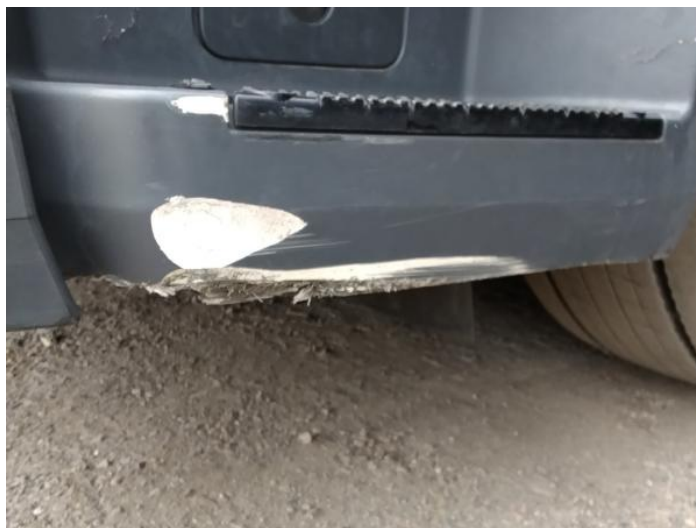
2: Bumper Front Moulding
Scratched (Painted)
Over 25mm Thru Paint

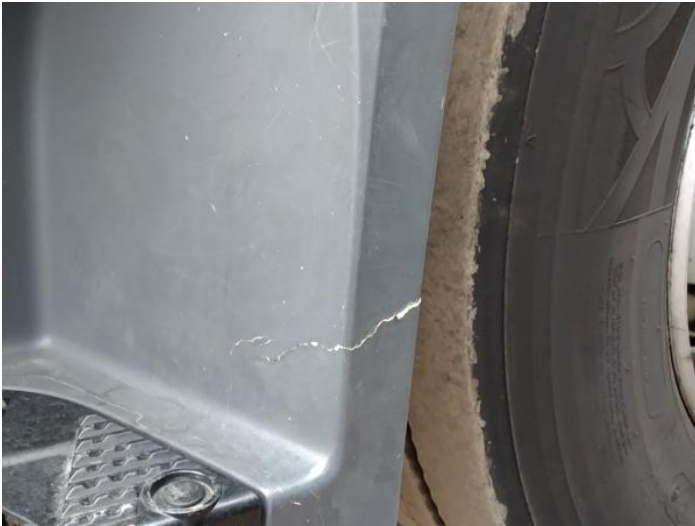
3: Moulding onsf Wing
Broken
Replace

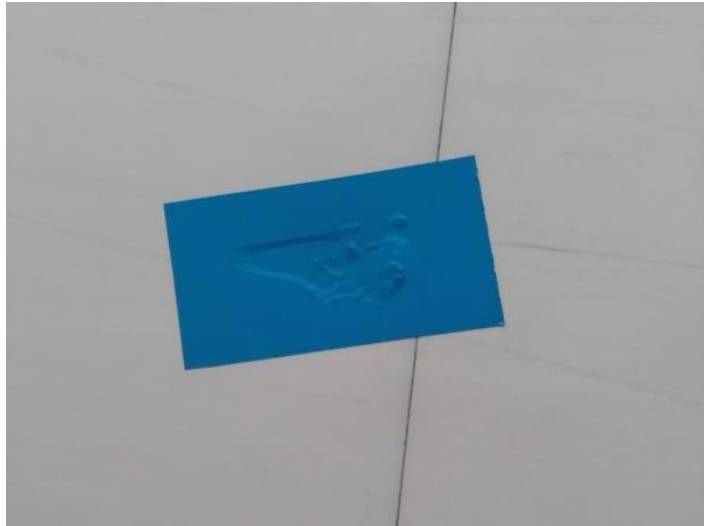
4: Panel Front
Hole
Over 10mm

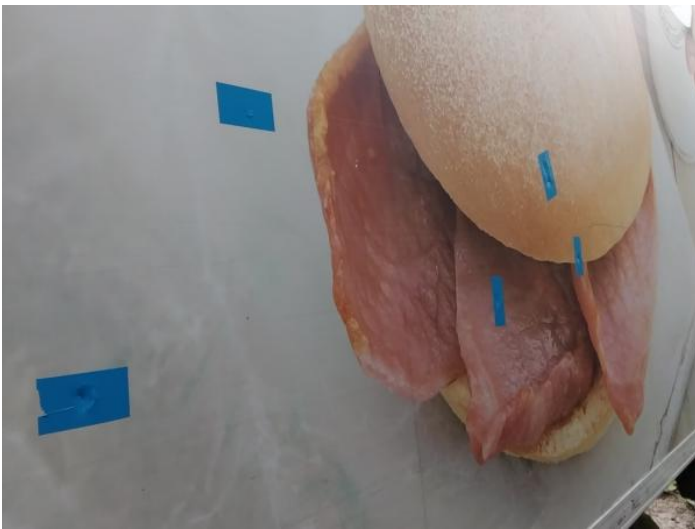
5: Panel Rear
Hole
Over 10mm

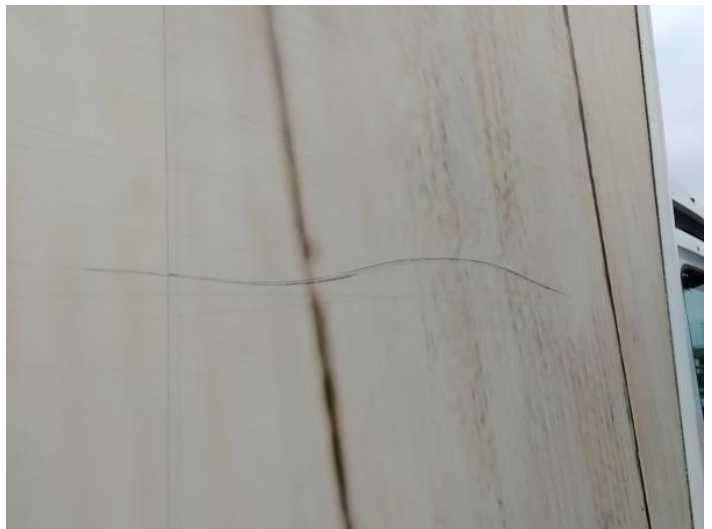
6: Panel Front
Scratched
Over 25mm Not Thru Paint

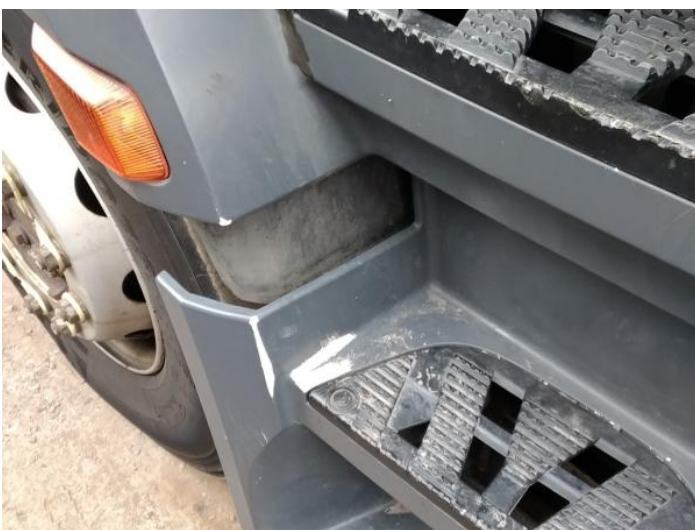
7: Moulding nsf Wing
Scuffed (Unpainted)
Over 100mm
