VEHICLE INSPECTION REPORT

PO70YLJ

Mercedes-Benz Antos

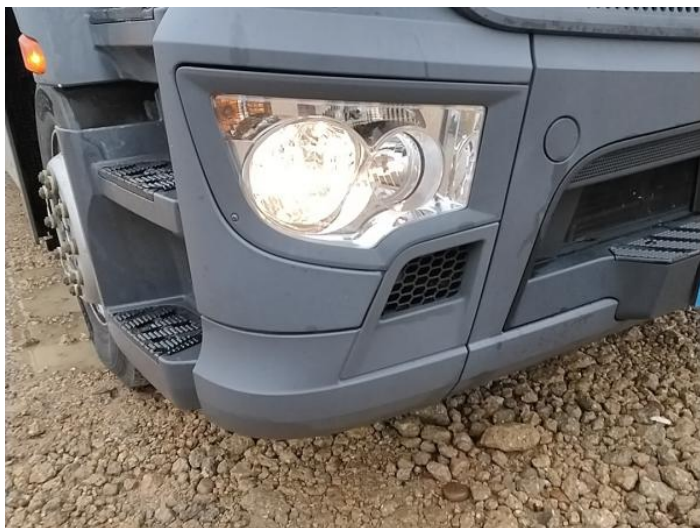
1: Bumper Front
Chipped
Multiple Chips

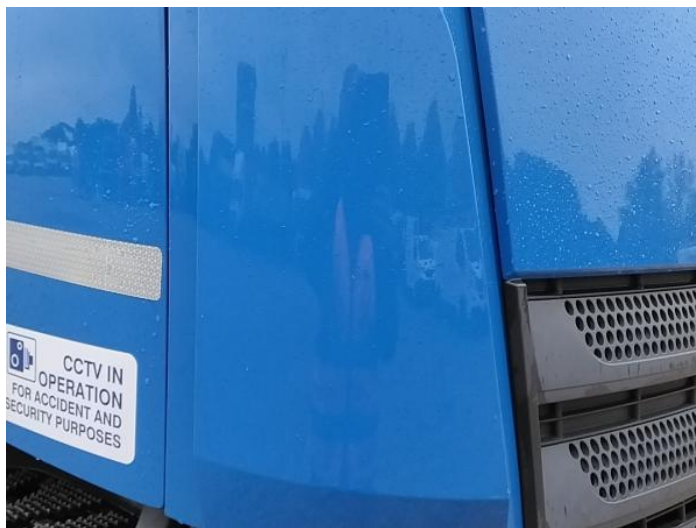
2: Wing osf
Chipped
Multiple Chips

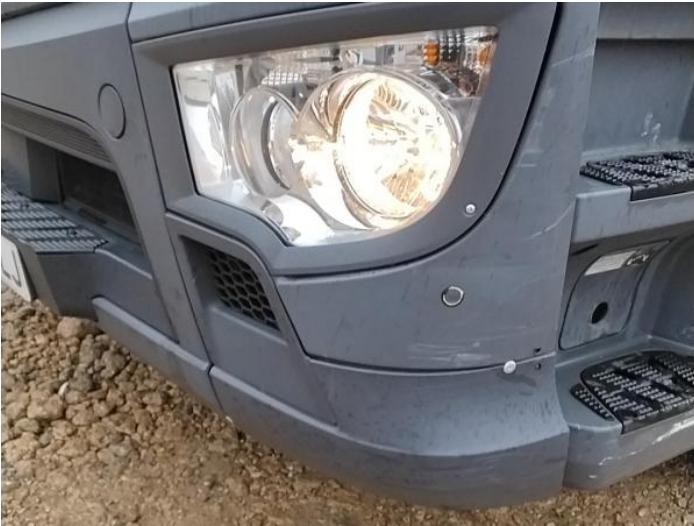
3: Bumper Front Moulding
Scuffed (Unpainted)
UpTo 100mm

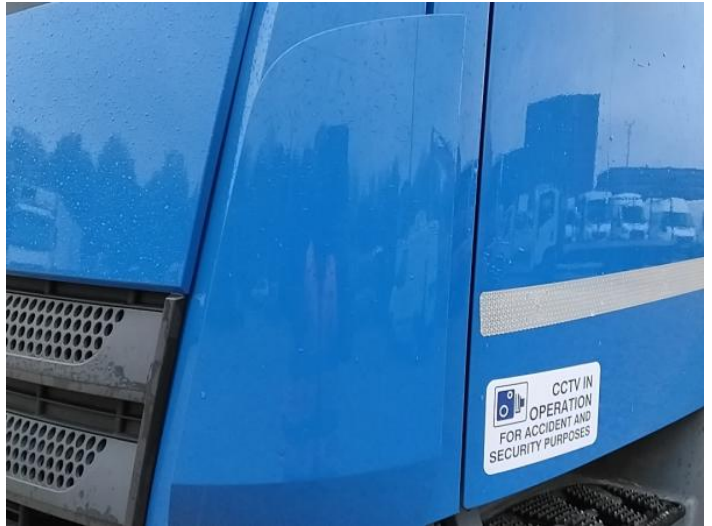
4: Wing nsf
Scratched
UpTo 25mm Not Thru Paint

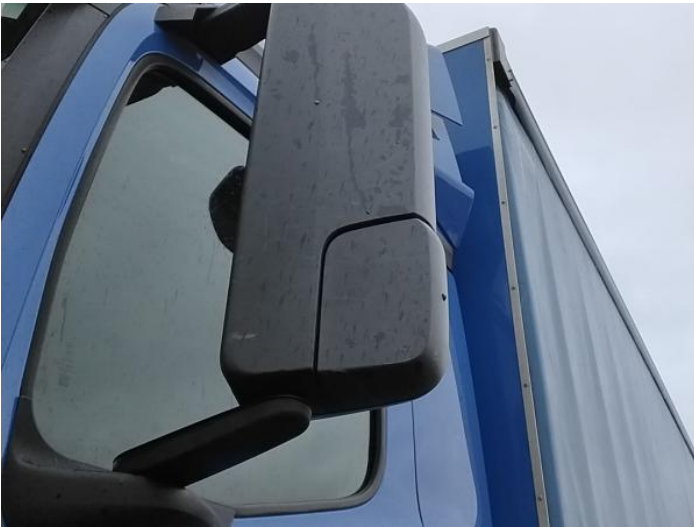
5: Door Mirror Assy nsf
Scuffed (Unpainted)
UpTo 100mm

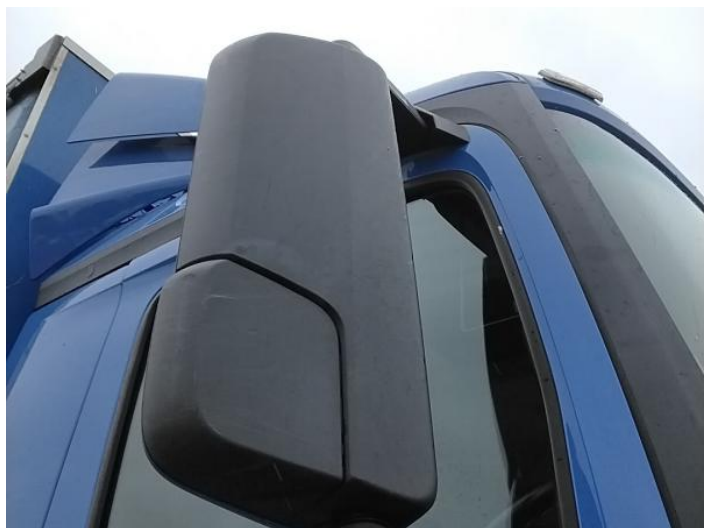
8: Door Mirror Assy osf
Scuffed (Unpainted)
UpTo 100mm

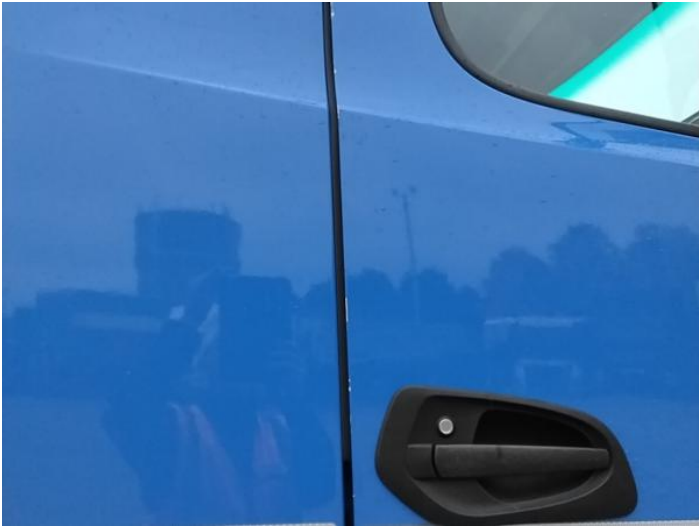
9: Door osf
Chipped
Edge Chip

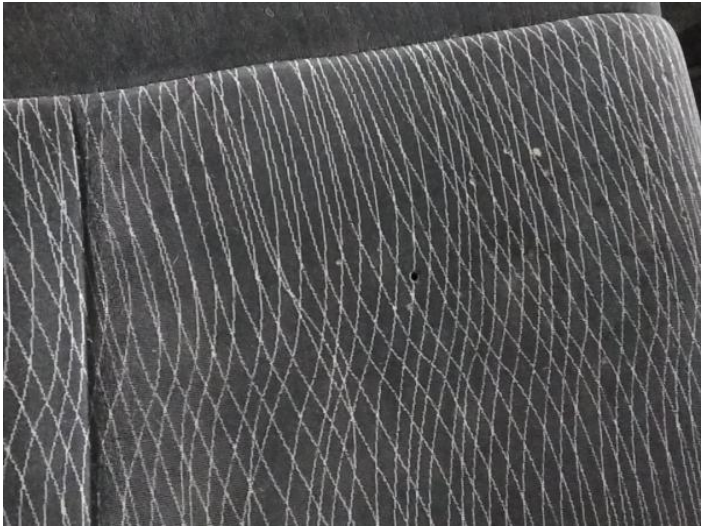
10: Seat Base Cover osf
Burn
Over 3mm
