# VEHICLE INSPECTION REPORT

**SA71KJJ**

## Fiat Doblo Work Up 16V II 1.6 MULTIJET

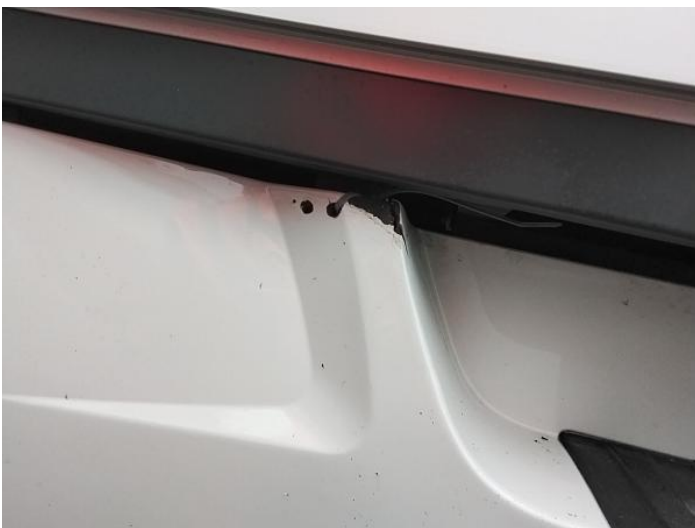
7: Qtr Panel osr  
Cracked  
Replace

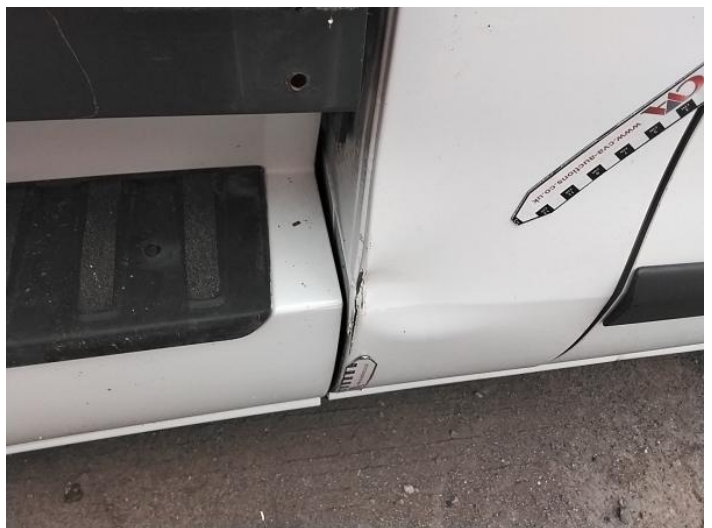
8: B Post os  
Dented  
With Paint Damage

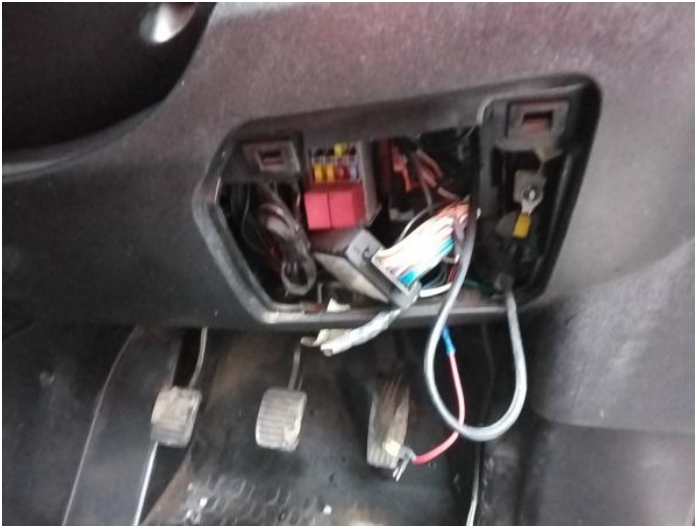
15: Fascia Panel  
Missing  
Replace

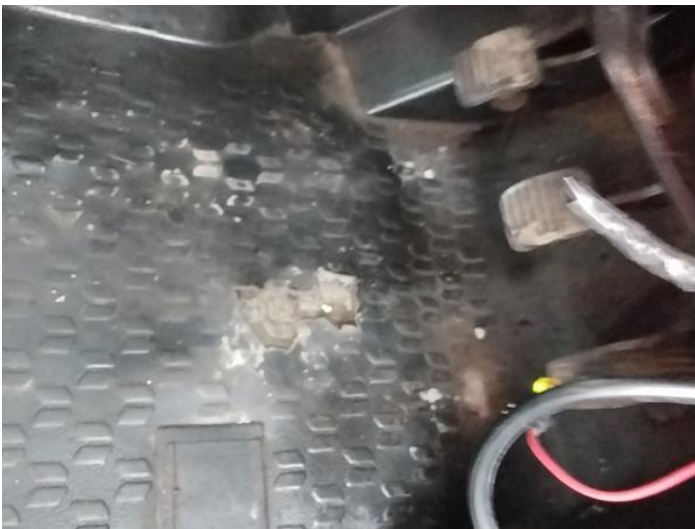
17: Carpets Front  
Holed  
Over 3mm

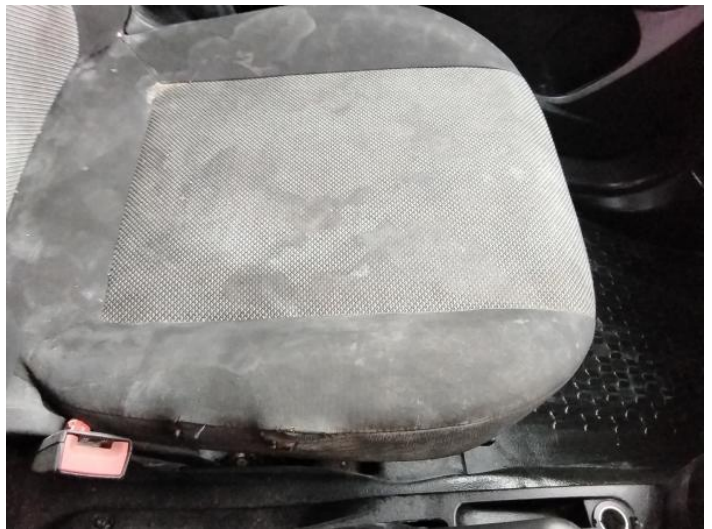
18: Seat Base Cover nsf  
Torn  
Over 3mm

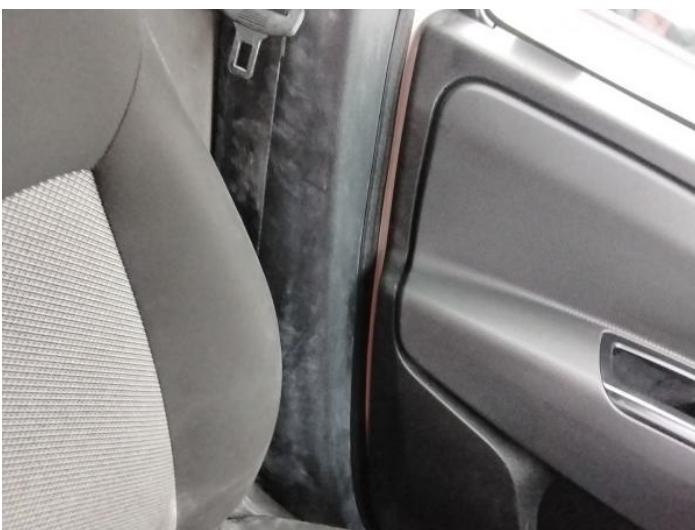
19: Fascia Panel  
Soiled  
Heavy
