VEHICLE INSPECTION REPORT

SA71KKD

Fiat Doblo Work Up 16V II 1.6 MULTIJET

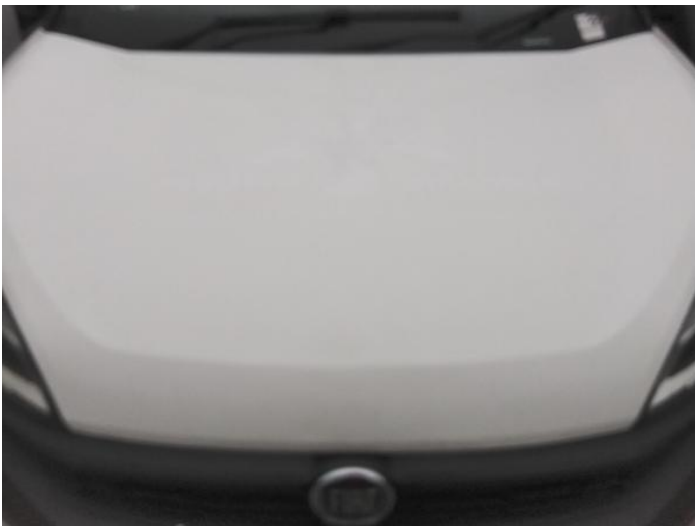
1: Bonnet
Chipped
Multiple Chips

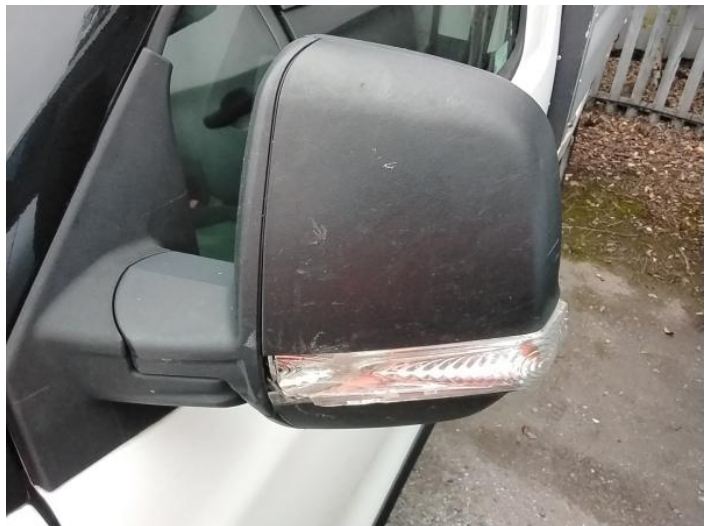
2: Door Mirror Assy nsf
Broken
Replace

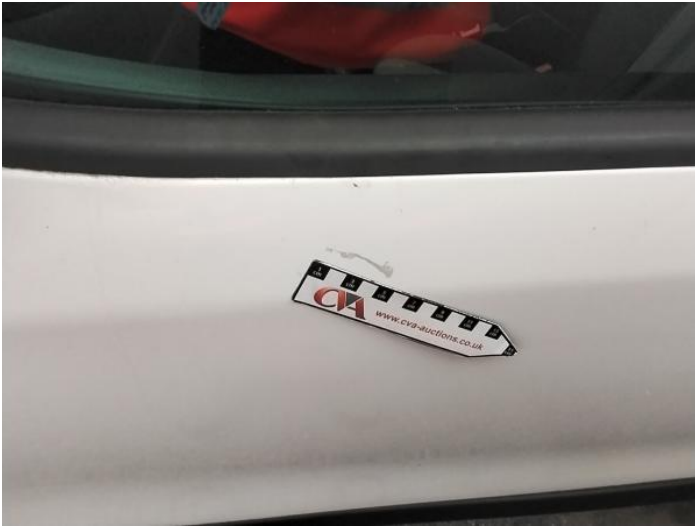
3: Door nsf
Scratched
Over 25mm Thru Paint

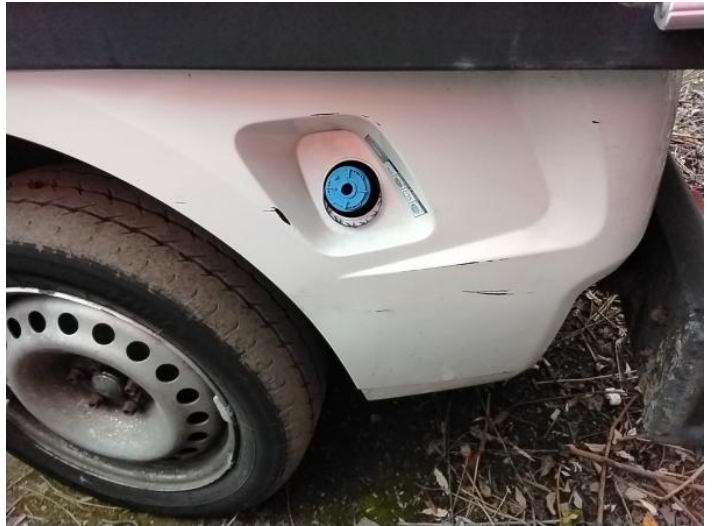
4: Qtr Panel nsr
Scratched
Over 25mm Thru Paint

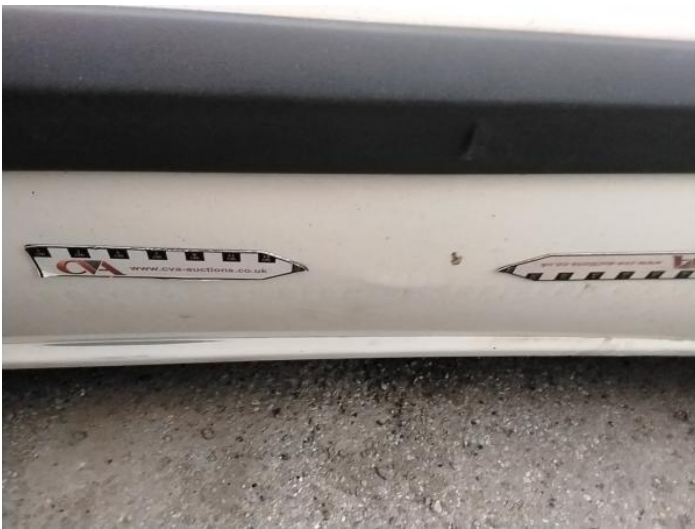
5: Door osf
Dented
Over 30mm

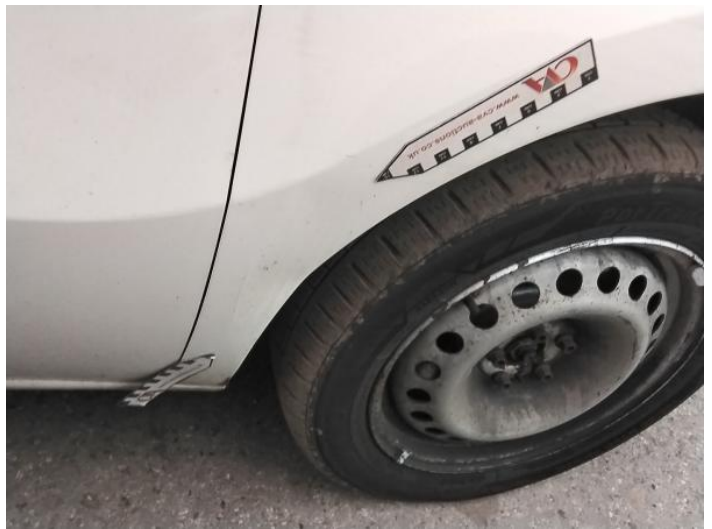
6: Wing osf
Dented
Over 30mm

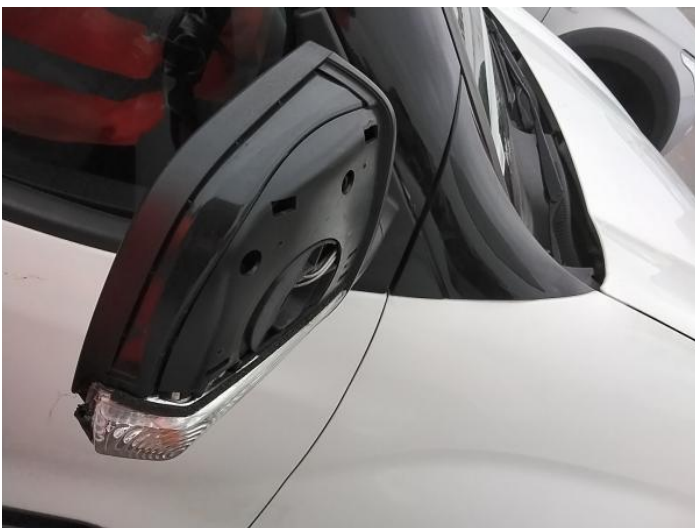
7: Door Mirror Assy osf
Broken
Replace

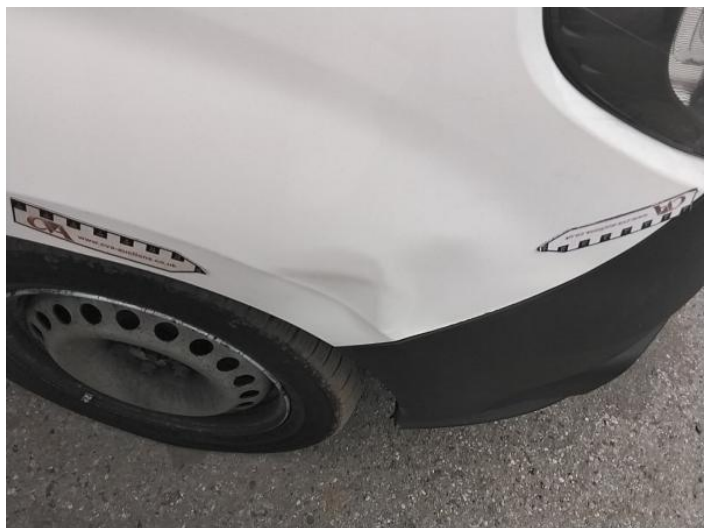
8: Wing osf
Dented
Over 30mm

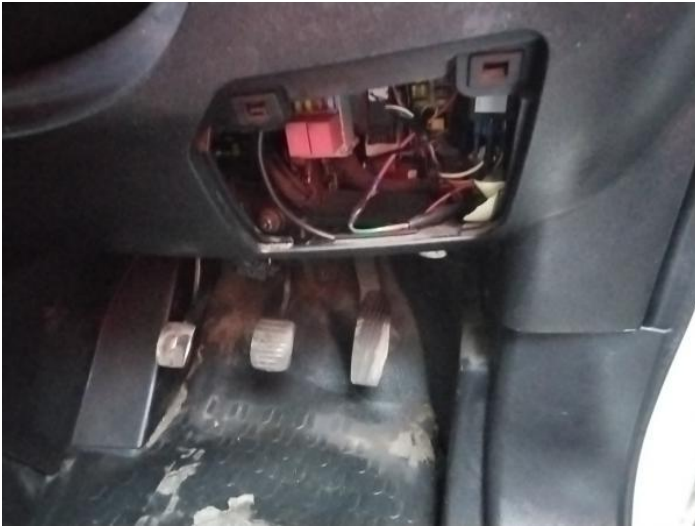
9: Fascia Panel
Missing
Replace

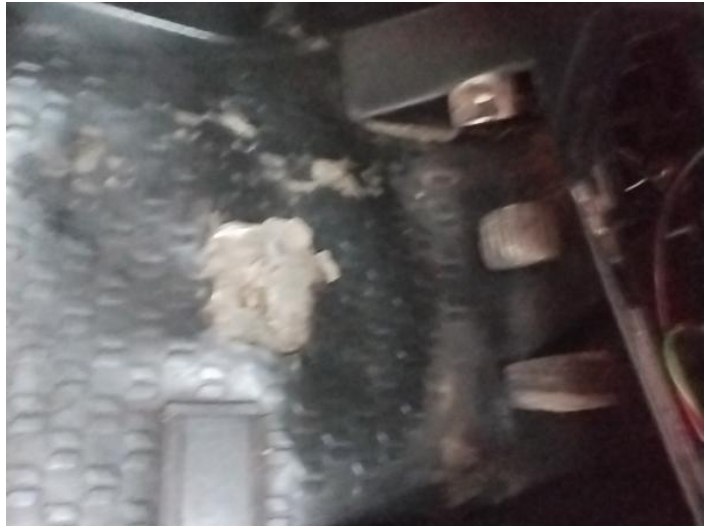
10: Carpets Front
Holed
Over 3mm

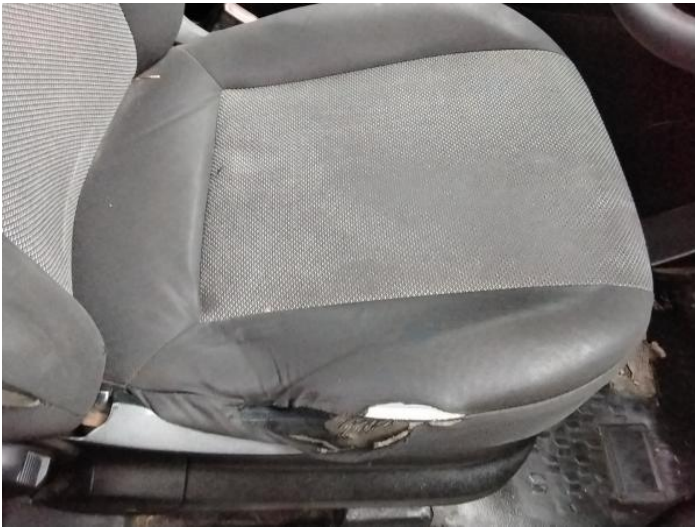
11: Seat Base Cover osf
Torn
Over 3mm

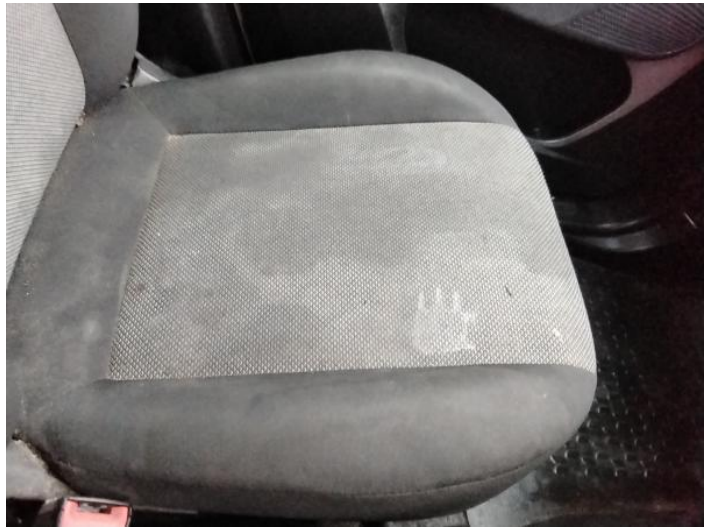
12: Seat Base Cover nsf
Soiled
Heavy

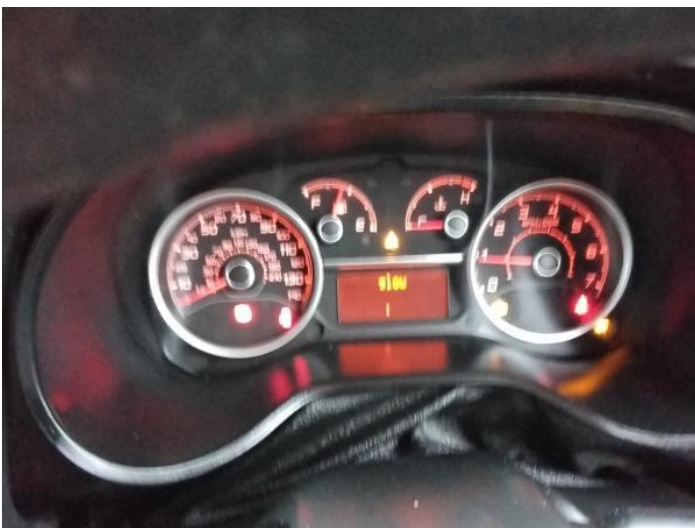
WARNING LIGHT ON DASH AD-BLUE

13: Dash Warning Lights
Displayed
No Action
