# VEHICLE INSPECTION REPORT

**PN71BVO**

## Fiat Doblo 16V II 1.6 MULTIJET

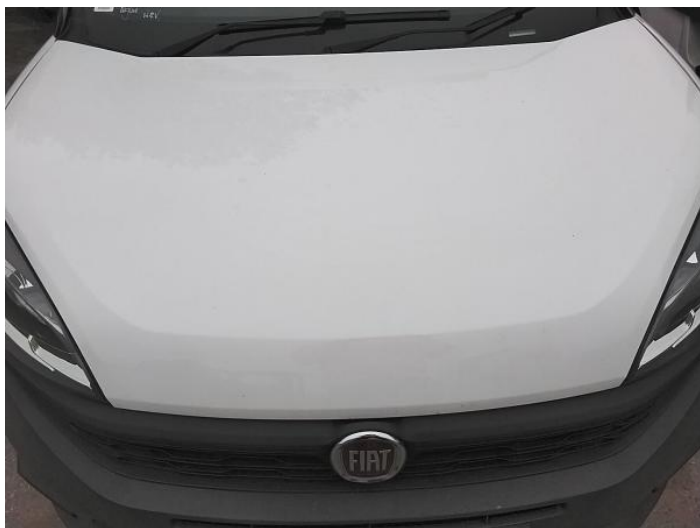
1: Bonnet  
Chipped  
Multiple Chips

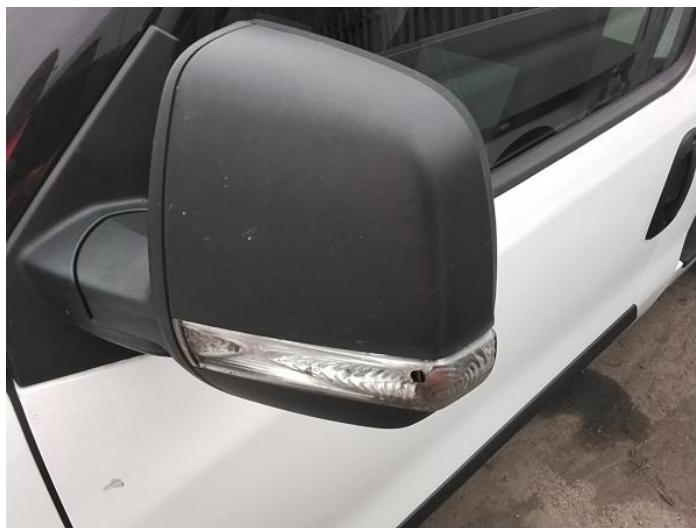
2: Door Mirror Assy nsf  
Broken  
Replace

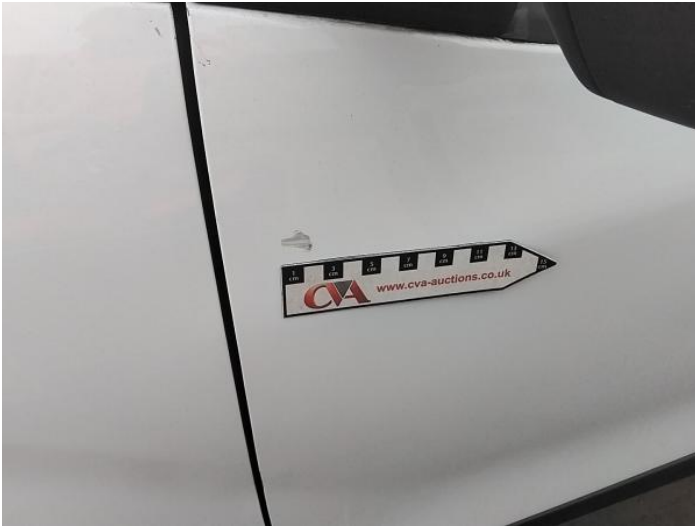
3: Door nsf  
Scratched  
UpTo 25mm Thru Paint

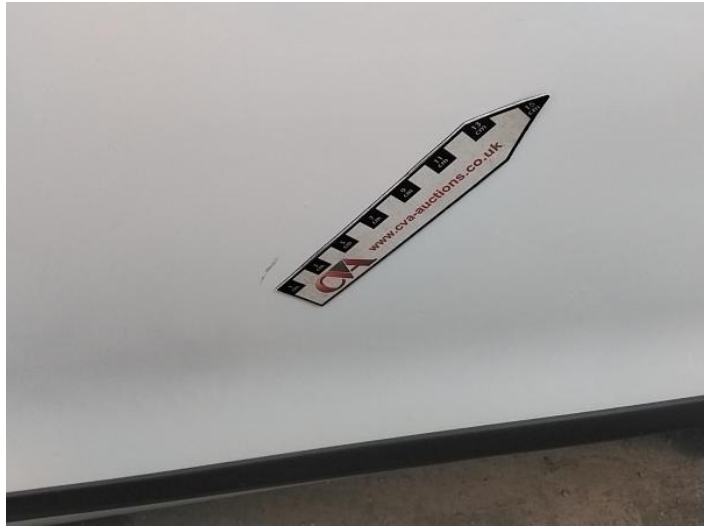
4: Door nsf  
Scratched  
Over 25mm Thru Paint

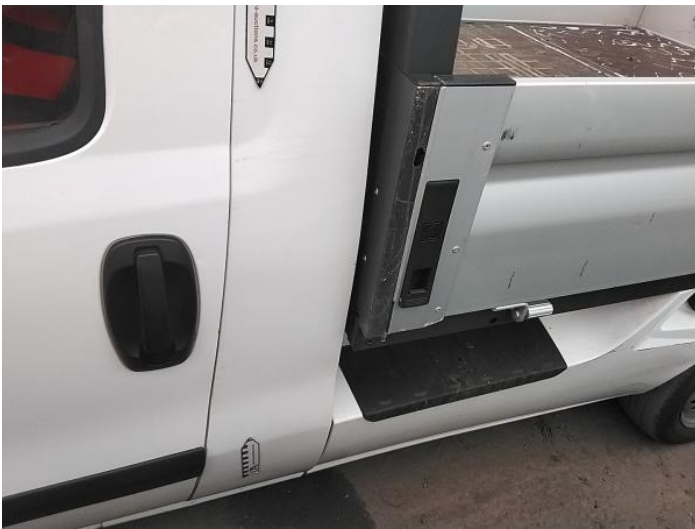
5: B Post ns  
Scratched  
Over 25mm Not Thru Paint

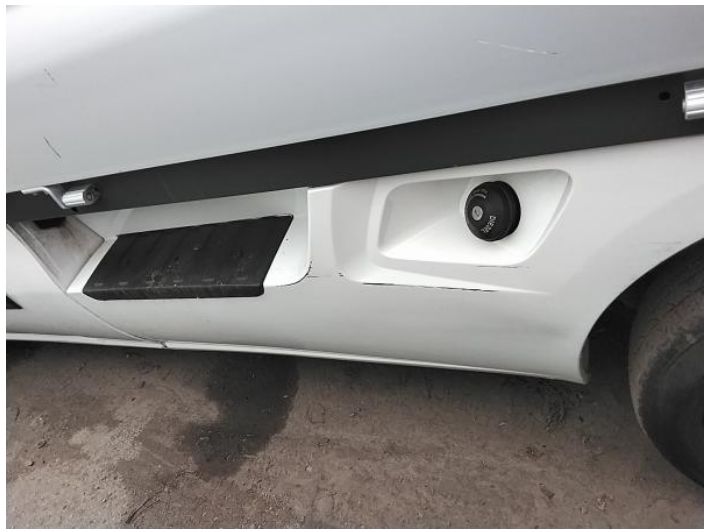
6: Qtr Panel nsr  
Scratched  
Over 25mm Thru Paint

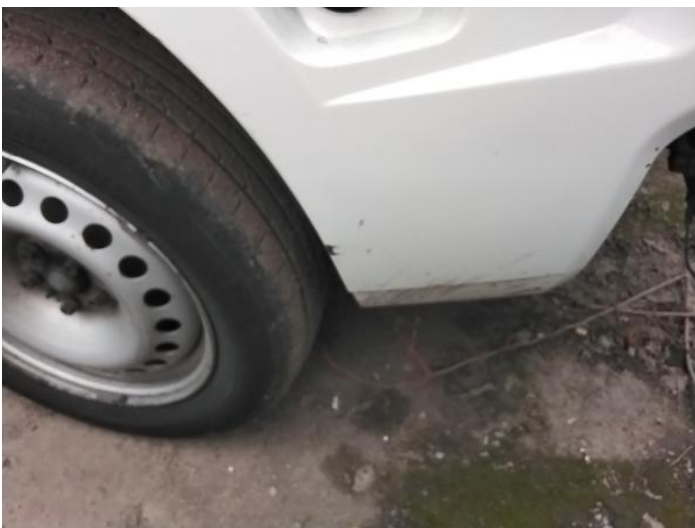
7: Qtr Panel nsr  
Scratched  
Over 25mm Thru Paint

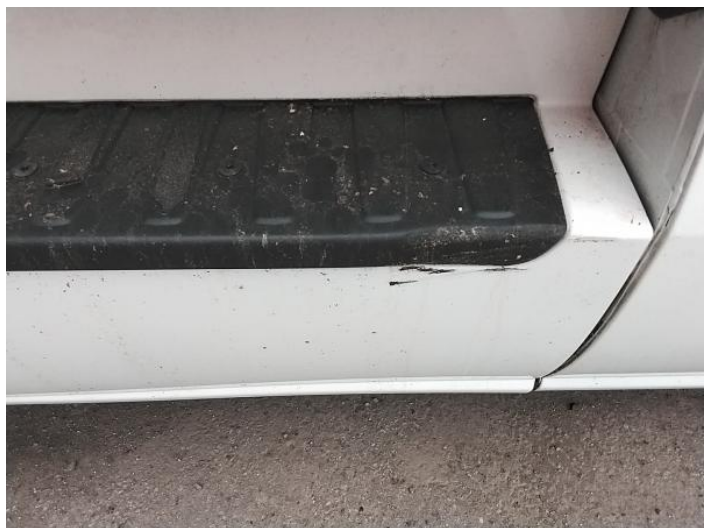
8: Qtr Panel osr  
Scratched  
Over 25mm Thru Paint

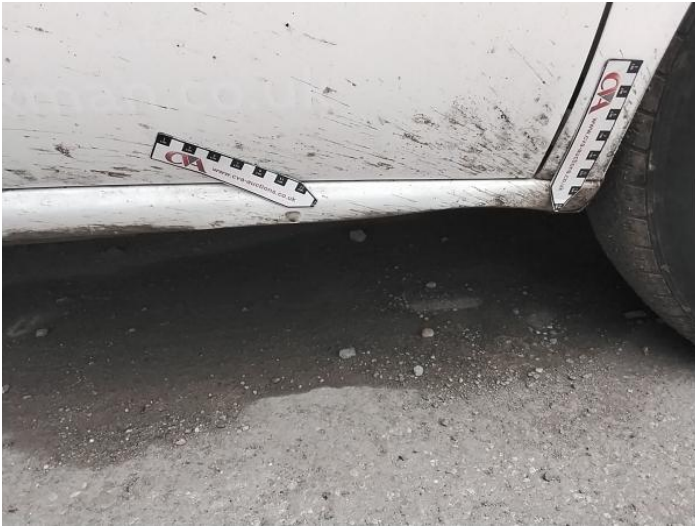
9: Sill os  
Dented  
With Paint Damage

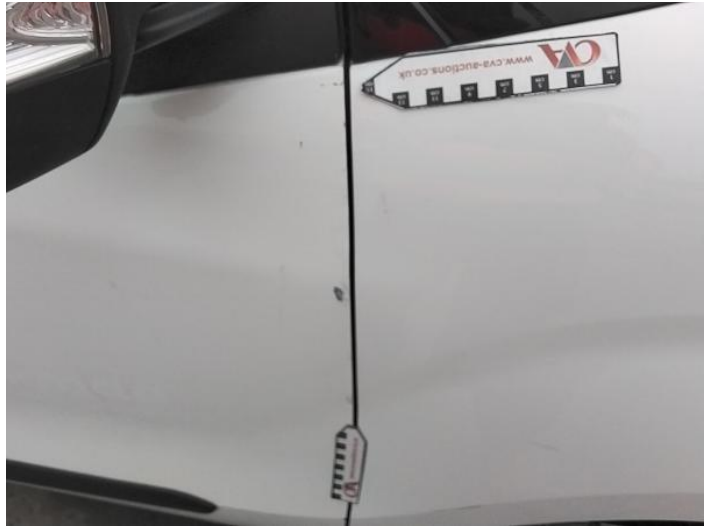
10: Door osf  
Scratched  
Over 25mm Thru Paint

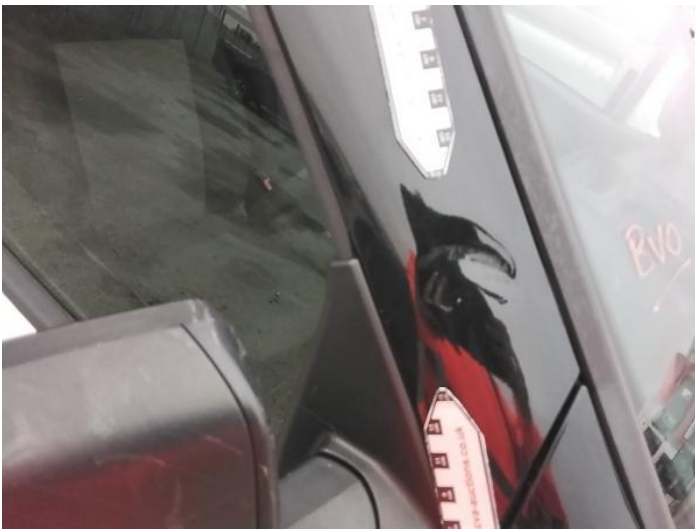
11: A Post os  
Dented  
With Paint Damage

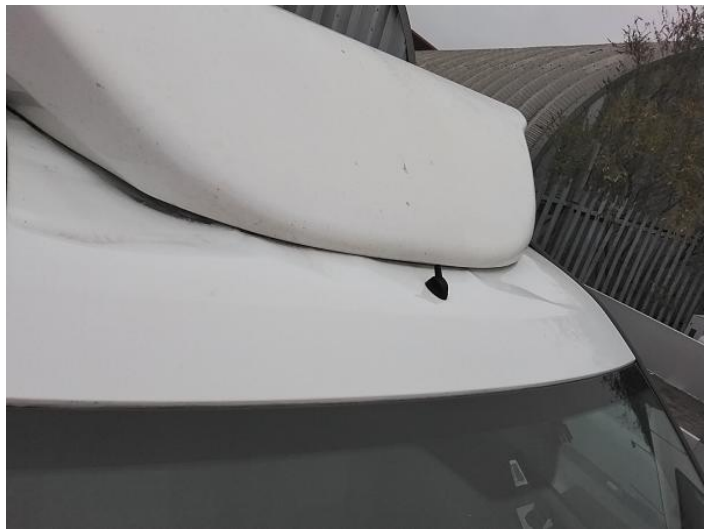
12: Roof  
Dented  
Over 30% Of Panel

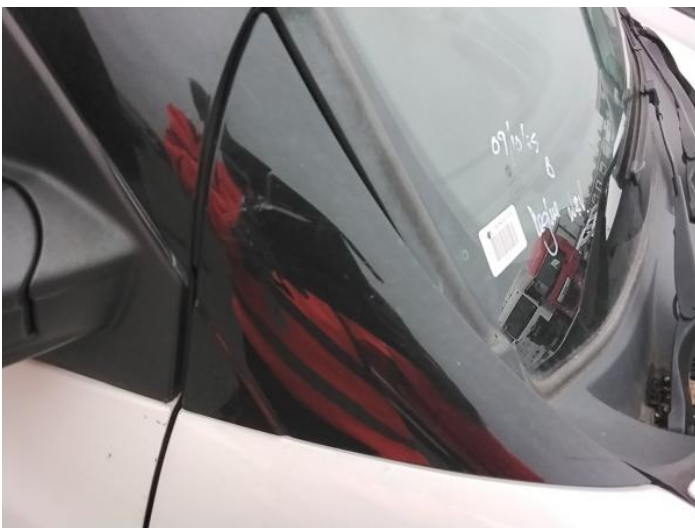
13: Door Moulding osf  
Broken  
Replace

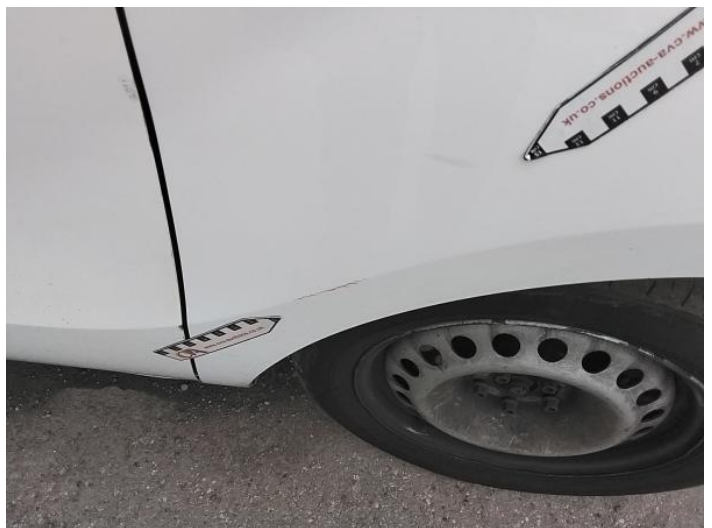
14: Wing osf  
Scratched  
Over 25mm Thru Paint

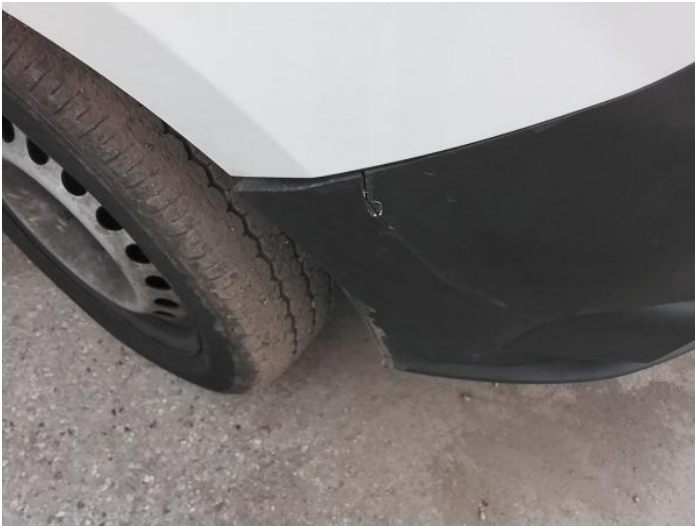
15: Bumper Front  
Cracked  
Over 25mm

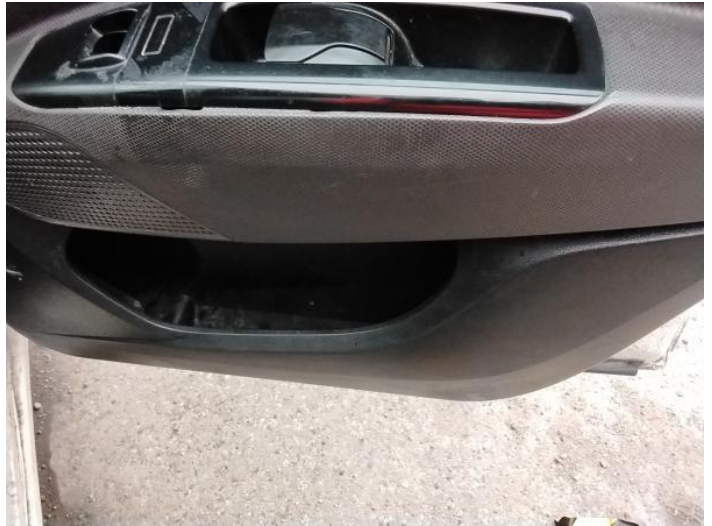
16: Door Pad osf  
Broken  
Replace

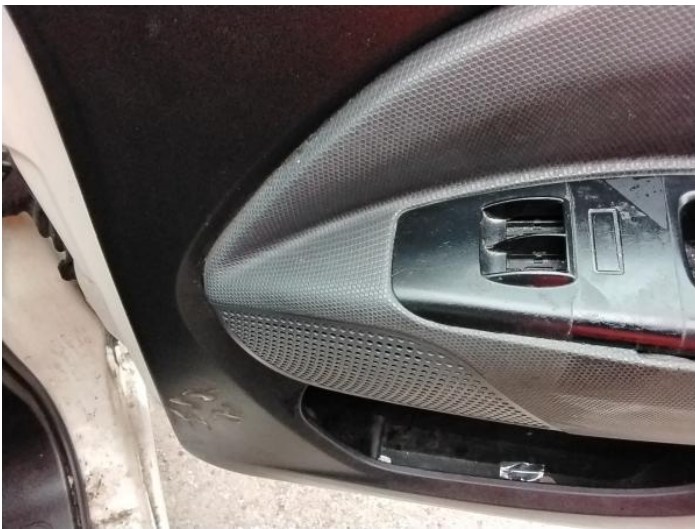
17: Switches And Controls  
Broken  
Replace

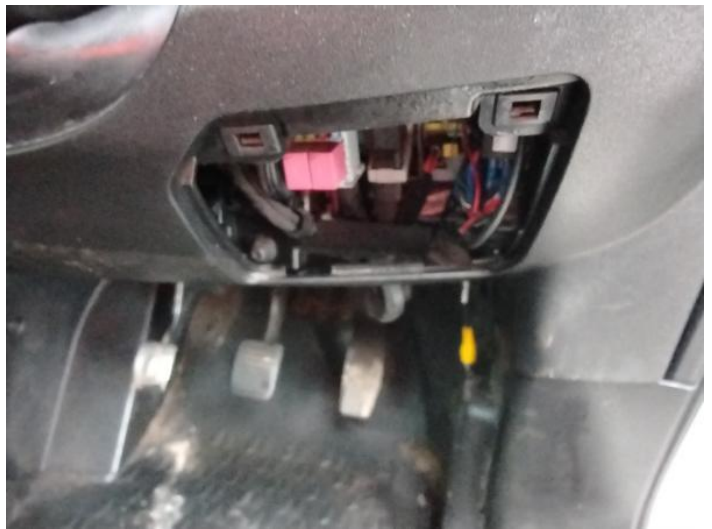
18: Fascia Panel  
Missing  
Replace

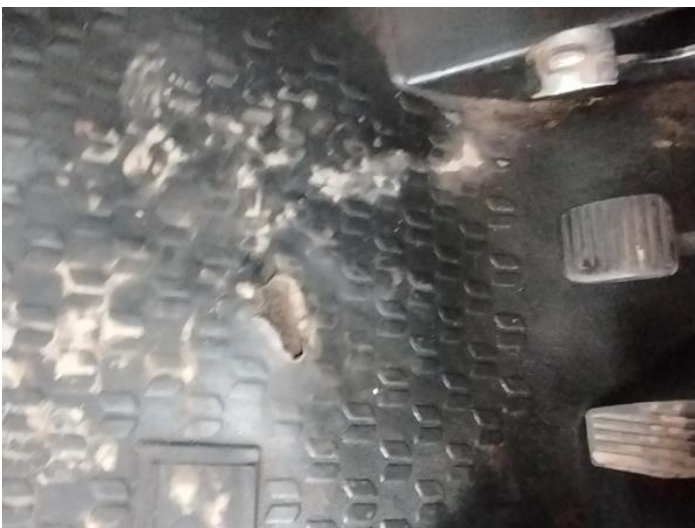
19: Carpets Front  
Holed  
Over 3mm

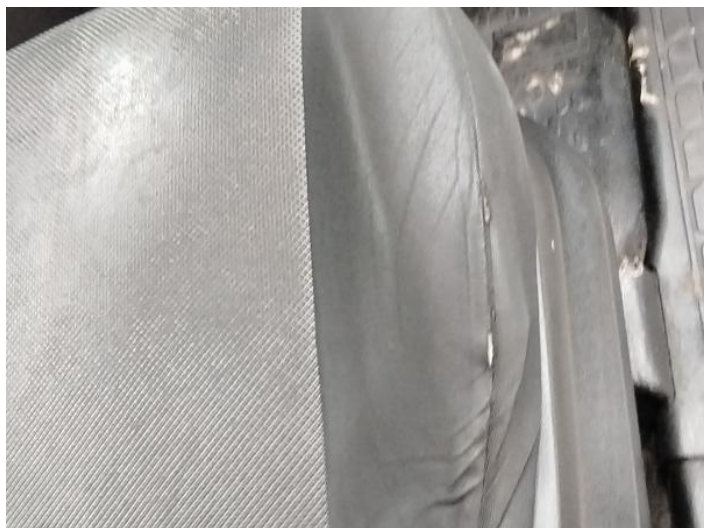
20: Seat Base Cover osf  
Torn  
Over 3mm

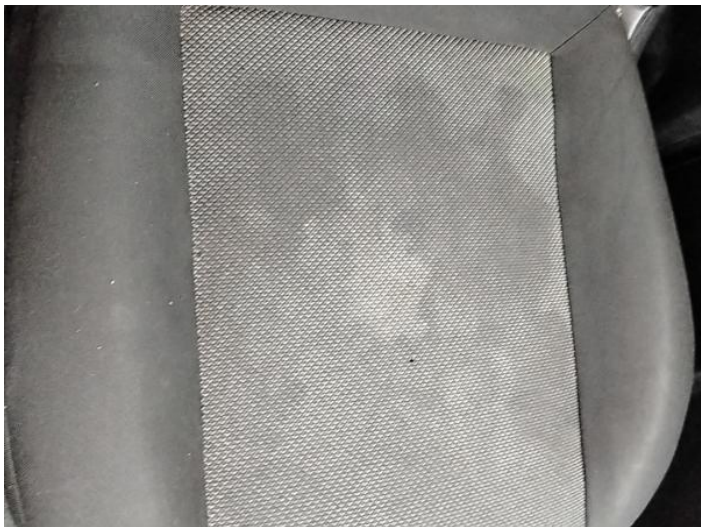
21: Seat Base Cover nsf  
Burn  
Over 3mm
