# VEHICLE INSPECTION REPORT

**HX16FZK**

## Mercedes-Benz Antos 1824

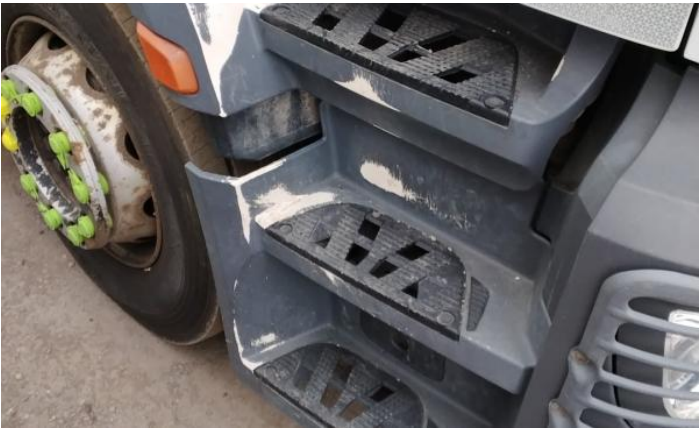
1: Qtr Panel Arch Extension ns  
Scuffed (Unpainted)  
Over 100mm

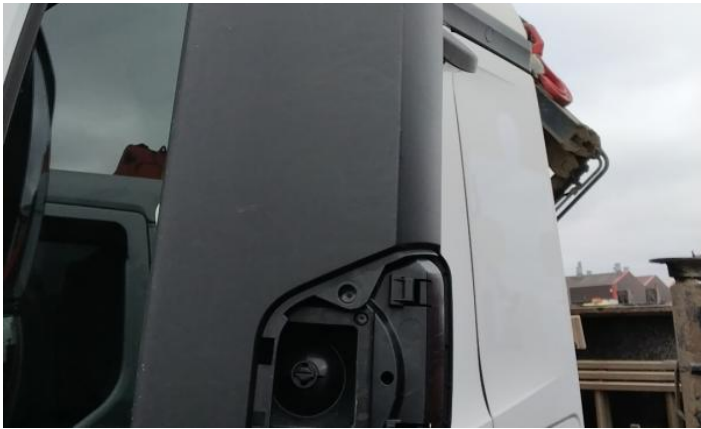
2: Door Mirror Assy osf  
Broken  
Replace
