VEHICLE INSPECTION REPORT

Man TGS 26.330

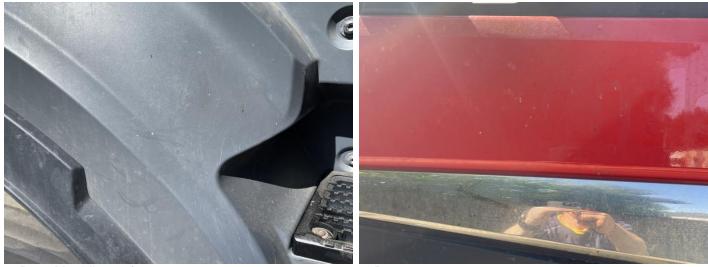
1: Door Moulding osf Scuffed (Unpainted) Over 100mm

2: Bonnet Chipped Multiple Chips

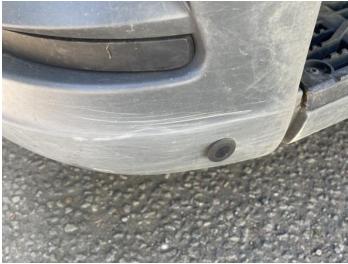
3: Bumper Front Moulding Scuffed (Unpainted) Over 100mm

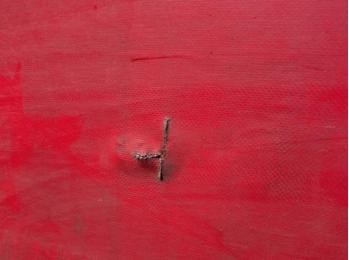
4: Qtr Panel osr Dented Over 30mm
