VEHICLE INSPECTION REPORT

FN18PZT

Daf LF 230

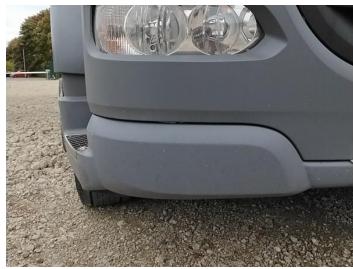
1: Bumper Front Chipped Multiple Chips

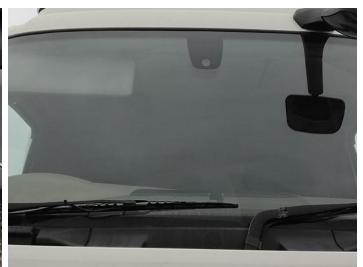
2: Screen Front Chipped Over 10mm

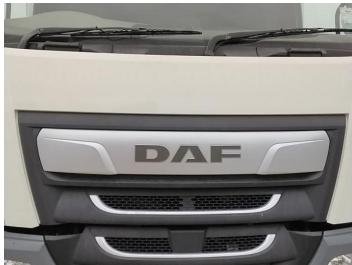
3: Bonnet Chipped Multiple Chips

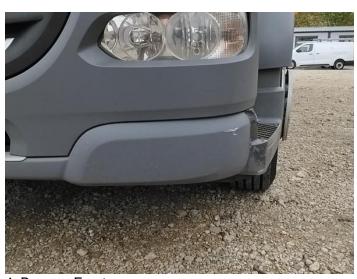
4: Bumper Front Scratched UpTo 25mm Thru Paint

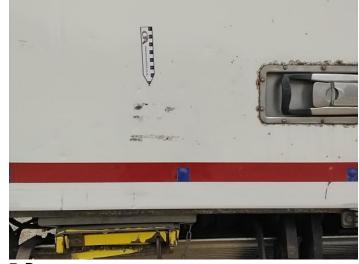
7: Door nsr Scratched Over 25mm Thru Paint

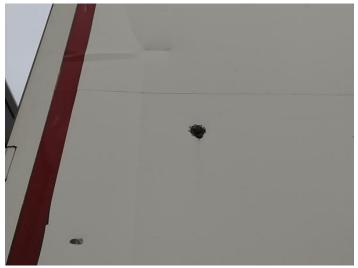
8: Door nsr Dented Between 10mm + 30mm

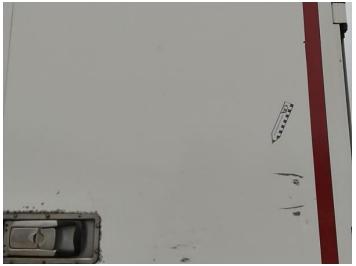
9: Door osr Scratched Over 25mm Thru Paint

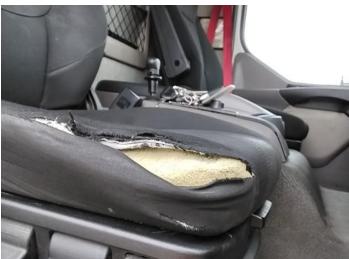
12: Seat Base Cover osf Holed Over 3mm
